# Lightning Interference in Multiple Antennas Wireless Communication Systems

**Abstract:** This paper analyzes the interference of lightning flashes with multiple antennas wireless communication systems operating in the microwave band at 2.4 GHz and 5.2 GHz. A bit error rate (BER) measurement method was used to evaluate BER and packet error rate (PER) during 5 heavy thunderstorms on January 25 and March 17 to 20, 2011, respectively. In addition, BER measurements also were done on January 21 and March 30, 2011 under fair weather (FW) conditions providing a baseline for comparison. The Transmitter-Receiver separation was fixed at 10 meter with line-of-sight (LOS) consideration. We infer that lightning interfered with the transmitted digital pulses which resulted in a higher recorded BER. The maximum recorded BER was  $9.9 \cdot 10^{-1}$  and the average recorded BER and PER were  $2.07 \cdot 10^{-2}$  and  $2.44 \cdot 10^{-2}$  respectively during the thunderstorms with the average fair weather BER and PER values under the influence of adjacent channel interference (ACI) and co-channel interference (CCI) being  $1.75 \cdot 10^{-5}$  and  $7.35 \cdot 10^{-6}$  respectively. We conclu

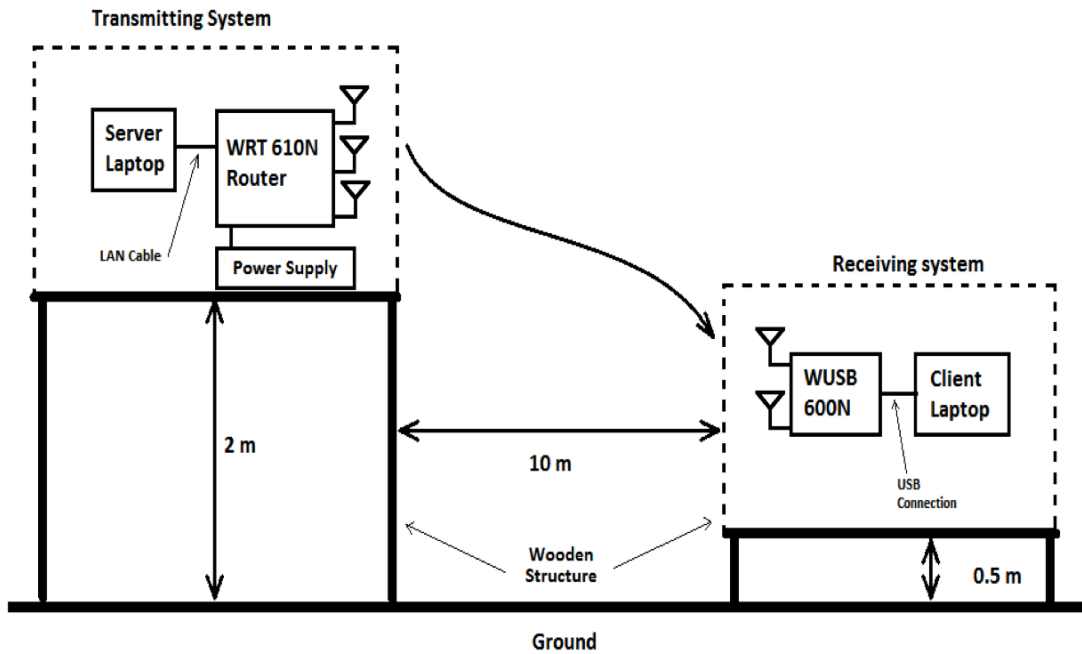
Fig. (1). Wireless router, server and client configurations used in this study.

A Dual-band Linksys WRT610N router [10] was connected through LAN cables to a laptop acting as a server. Another laptop acted as a client and was connected to the router wirelessly. A Dual-band Cisco WUSB600N wireless network card [11] was attached to the client laptop through USB interface. The router and the client laptop were equipped with three and two antennas respectively to realize multiple antennas technology. The router was connected to a power outlet available on the outer wall of an adjacent building and other devices were battery-powered.

The transmitting system (server laptop, router and antennas) was positioned on a wooden structure two meters above ground and the receiving system (client laptop, wireless network card and antennas) was positioned on a wooden structure half a meter above ground. Both the transmitting and receiving systems were covered from rain by a roof structure. The 'ground' in Fig. (1) refers to Earth's surface only. A ten meters distance separated the transmitting system from the receiving system. Fig. (1)

illustrates these configurations. Both the transmitter and the receiver were operating either at 2.4 GHz or 5.2 GHz. Adaptive modulations were chosen. Taking ten meters of LOS range into consideration, most probably 64-quadrature amplitude modulation (QAM) was fully utilized.

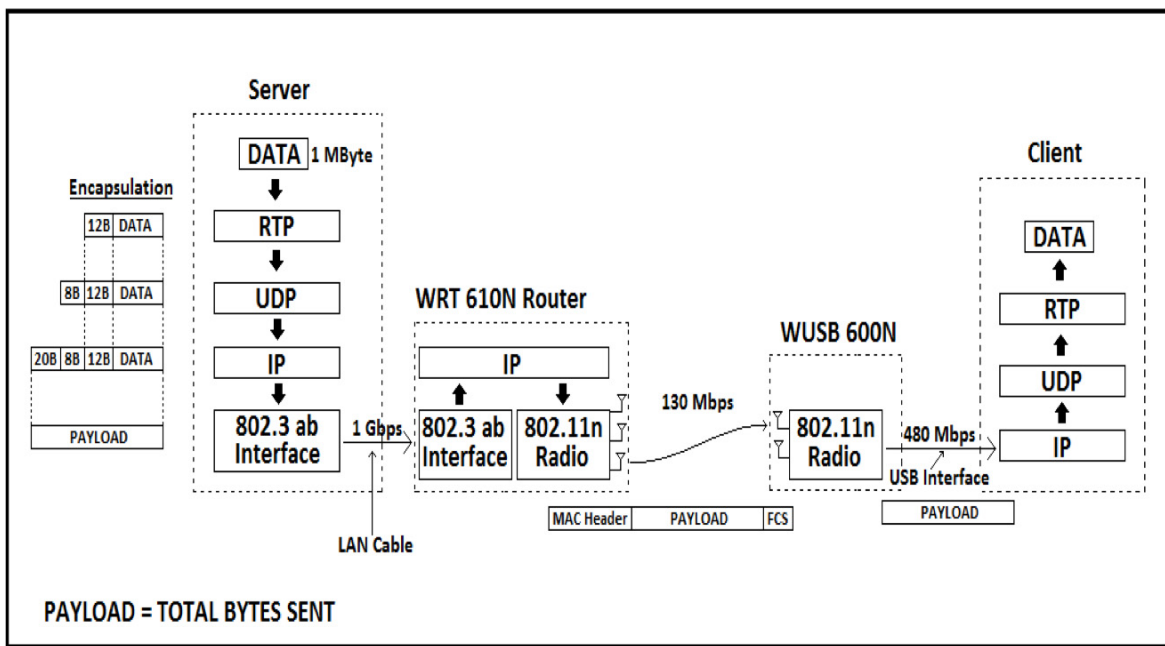
Fig. (2). A networking description of the payload generation, transmission and reception.

The application layer at the server of the transmitting system emulated a RealAudio application broadcasting audio content from a multimedia CD-ROM. The average sending data rate was 80 Kbps. The size of the audio data was 1 Mbytes. This data was transmitted using real time protocol (RTP) [12] over user datagram protocol/Internet protocol (UDP/IP) as shown in Fig. (2). The payload type of the RTP was G.729 [13]. The total overhead added to a single audio data packet was 40 bytes (from RTP, UDP and IP headers). However datagram segmentation at the UDP layer and packet fragmentation at the IP layer could increase more the total overhead added to the audio data packet. Thus the total number of bytes sent from the server was 1 Mbytes audio data including the total overhead depending on how many datagrams was generated.

These network layer packets were transmitted to the router by using 802.3ab physical interface [14] with a maximum sending data rate of 1 Gbps. The router forwarded these packets to the receiving system over the wireless communication link by using 802.11n radio interface [15] with a maximum sending rate of 130 Mbps. Distributed coordinated function (DCF) protocol without the request-to-send/clear-to-send (RTS/CTS) mechanism was chosen for the operation of 802.11n radio. The handshaking mechanism was disabled after the hidden node problem was eliminated completely. Also other measures to eliminate hidden node problem had been taken such as providing strong LOS path, shorter Transmitter-Receiver separation and the usage of omni-directional antenna.

The 802.11n radio interface at the receiving system received the transmitted bytes and forwarded them to the client laptop through USB interface with a maximum data rate of 480 Mbps. Forward error correction (FEC) mechanism was used in the 802.11n radio interface to correct any detected error in the received bytes. The Frame Check Sequence (FCS) at the end of each frame detects most of the errors that are not corrected by the FEC scheme. These errors are corrected by retransmissions at the MAC layer. Any bit that cannot be corrected by the FEC and FCS was counted as an error at the IP layer. At the UDP layer, a packet with a certain number of error bytes was considered damaged and discarded. The report of the total number of bytes and packets in error was transmitted to the server after the run time was completed.

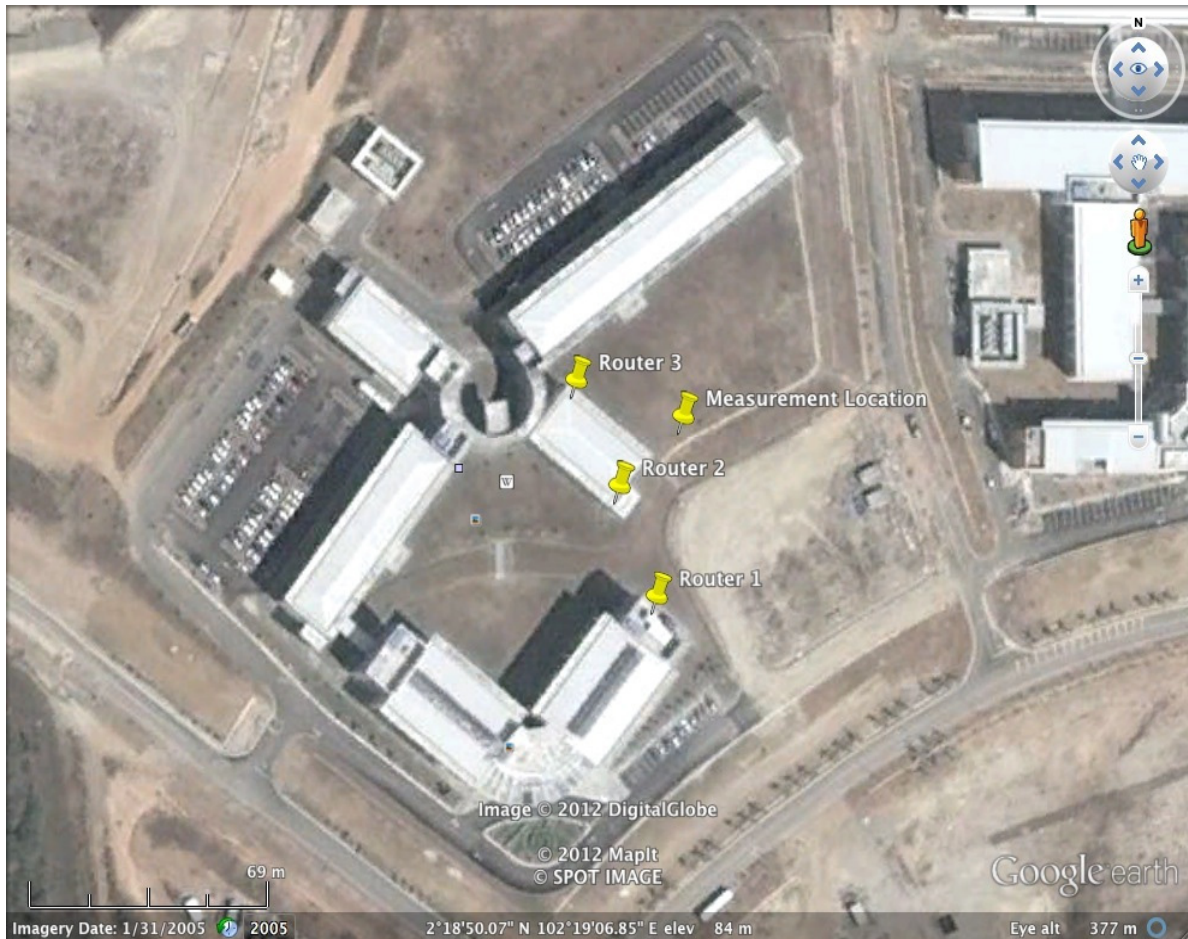
**Fig. (3).** Measurement site at latitude 2.313889°N, longitude 102.318333°E given by Google earth.

Seven measurements were conducted on 21<sup>st</sup> January, 25<sup>th</sup> January, 17<sup>th</sup> March, 18<sup>th</sup> March, 19<sup>th</sup> March, 20<sup>th</sup> March, and 30<sup>th</sup> March. All the measurements were done in year 2011 at Universiti Teknikal Malaysia Melaka (UTeM) (latitude 2.313889°N, longitude 102.318333°E), Malacca, Malaysia. Fig. (3) shows the measurement site together with the location of interfering transmitters labeled as Router 1, Router 2 and Router 3.

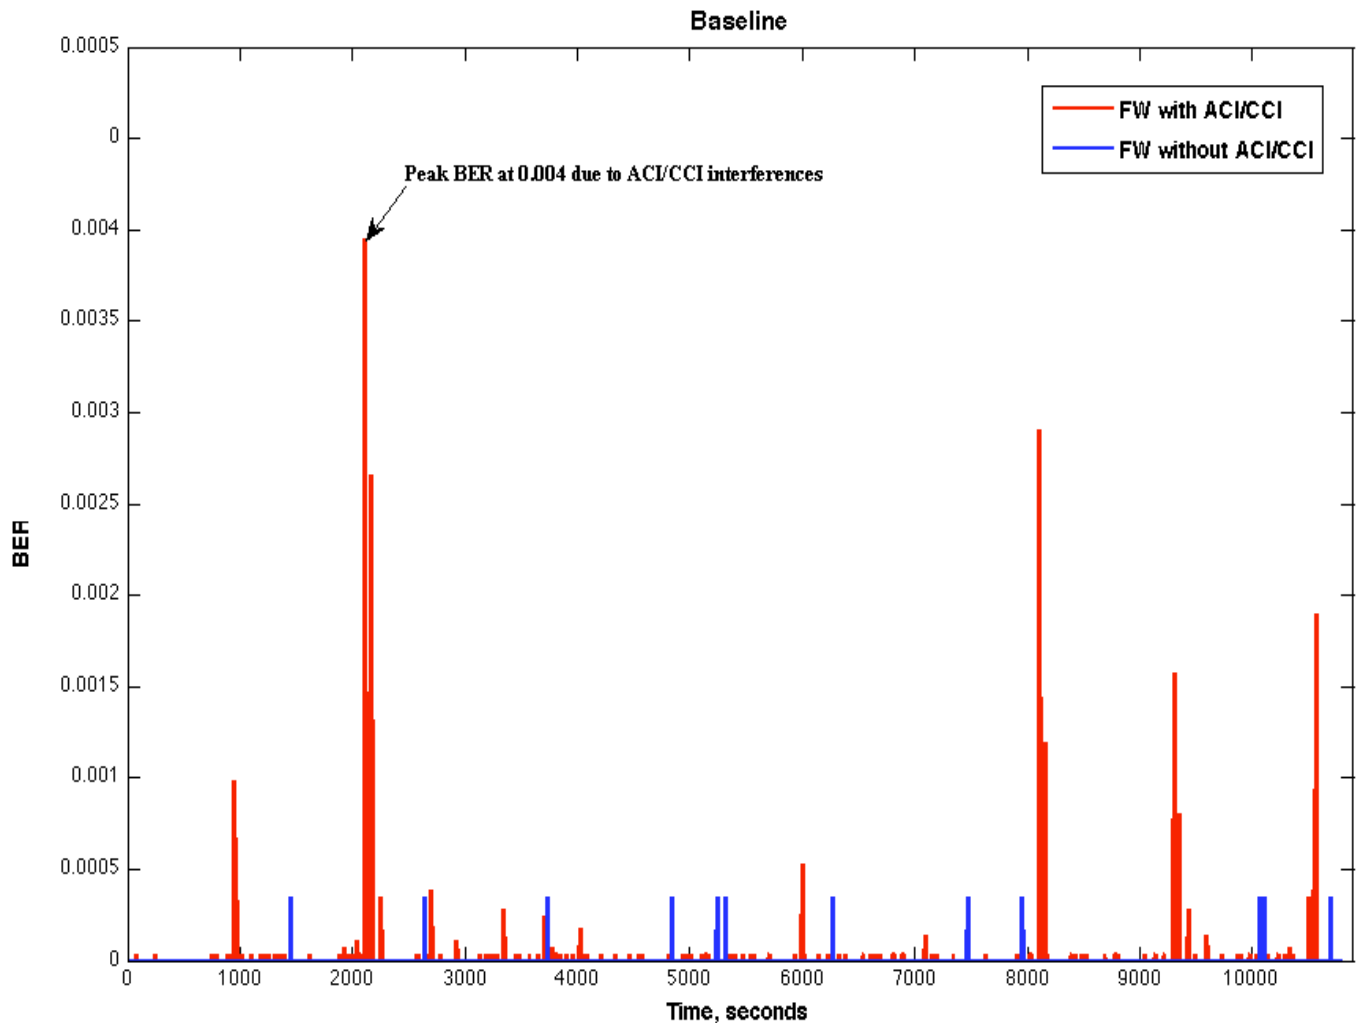
Fig. (4). Measured BER during Baseline 1 and 2 measurements at 2.4 GHz.

Fig. (4) shows the BER plots of FW measurements done on 21<sup>st</sup> January 2011 (denoted as Baseline 2) and 30<sup>th</sup> March 2011 (denoted as Baseline 1) with red and blue color codes,

respectively. The average BER values are  $1.75 \cdot 10^{-5}$  and  $1.27 \cdot 10^{-6}$  for Baseline 2 and Baseline 1 respectively. The average BER value of Baseline 2 is ten times higher than the Baseline 1 value however this value is insignificant because below than  $1 \cdot 10^{-4}$ . Moreover the PER values for both measurements were low enough to avoid audible errors. These baseline measurements demonstrated how multiple antennas technology provided reliable communication links for audio transmission even under the influence of ACI and CCI.

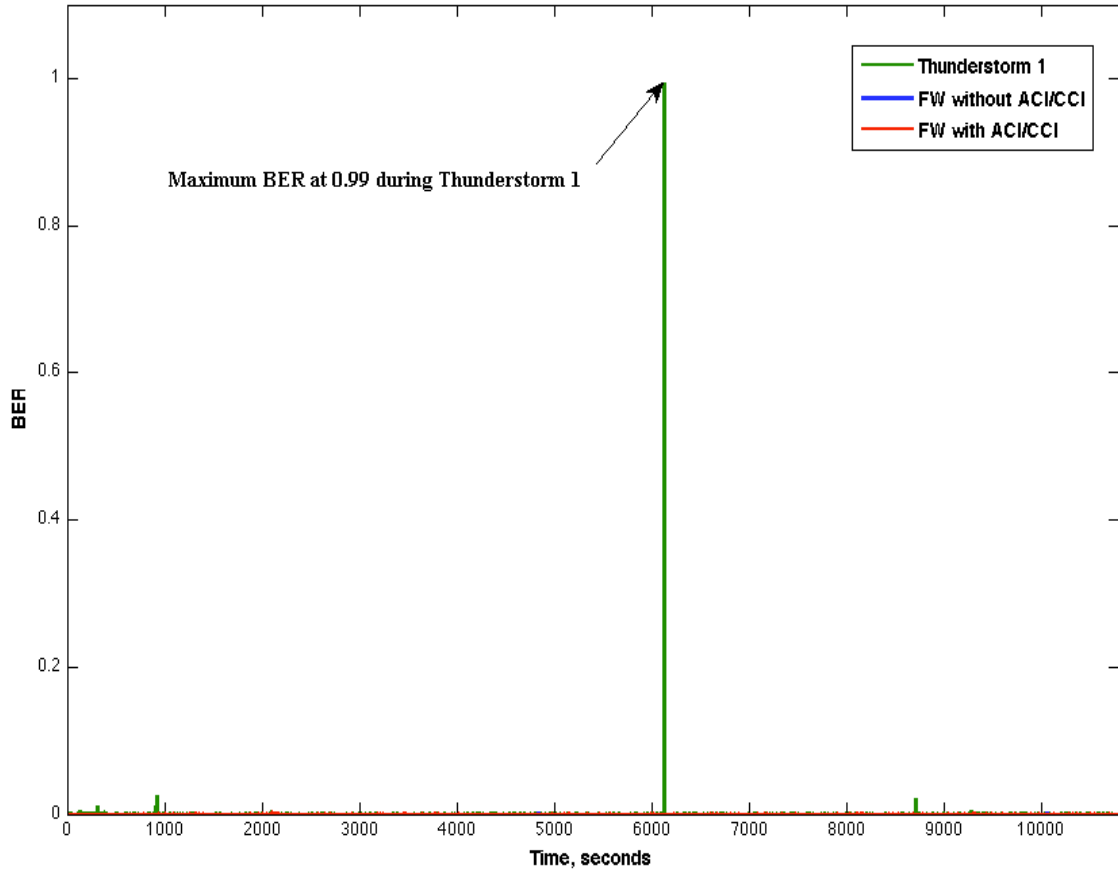
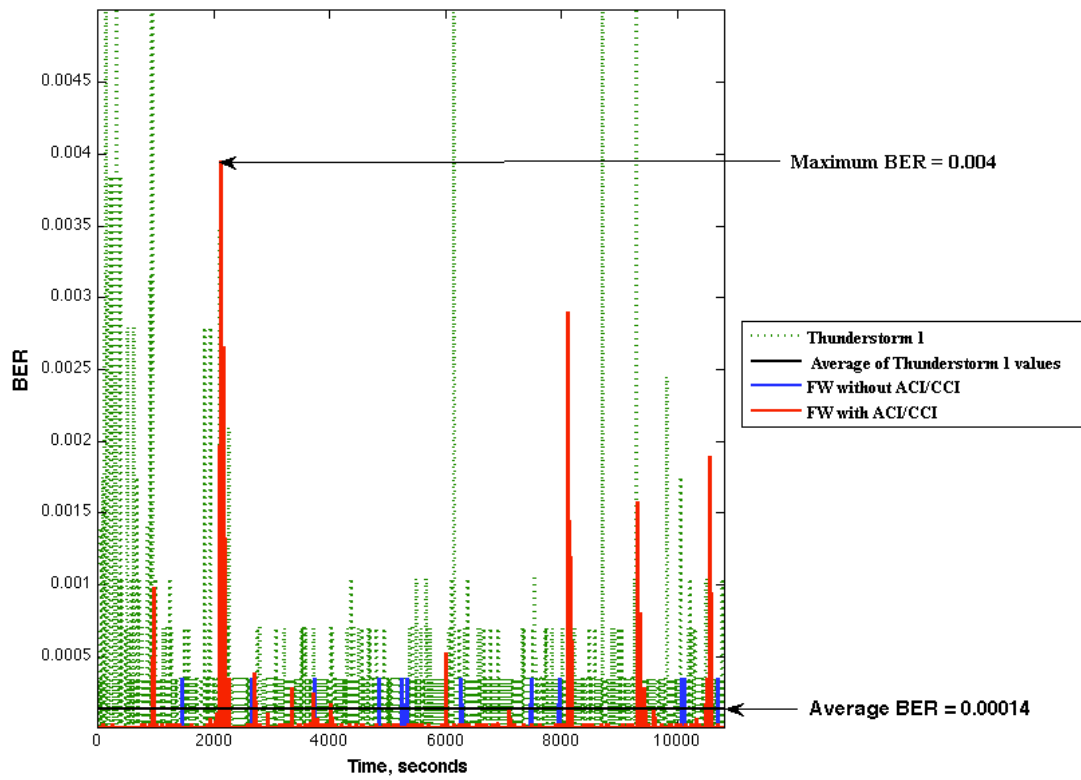
(a) Full scale BER range.

(b) BER range is scaled between 0 and 0.04.

Fig. (5). Measured BER during Thunderstorm 1 measurements on 25<sup>th</sup> January 2011 at 2.4 GHz.

Fig. (5a) shows the measured BER during 25<sup>th</sup> January 2011 thunderstorm (denoted as Thunderstorm 1) at 2.4 GHz. Most of the BER points were recorded below  $2 \cdot 10^{-4}$  as the average BER value (shown as black line, see Fig. 5b) was estimated at  $1.40 \cdot 10^{-4}$  with exception at 6135 seconds point in the second hour of measurement. At this point, almost all the transmitted bits were corrupted with  $9.9 \cdot 10^{-1}$  BER recorded. The communication link may cause audible errors for the audio transmission during Thunderstorm 1 because the average BER value was higher than  $1 \cdot 10^{-4}$  and measured PER value was higher than  $1 \cdot 10^{-2}$ . Zoomed BER values between 0 and 0.004 are shown in Fig. (5b) to provide a clear comparison of Thunderstorm 1 and baseline values.

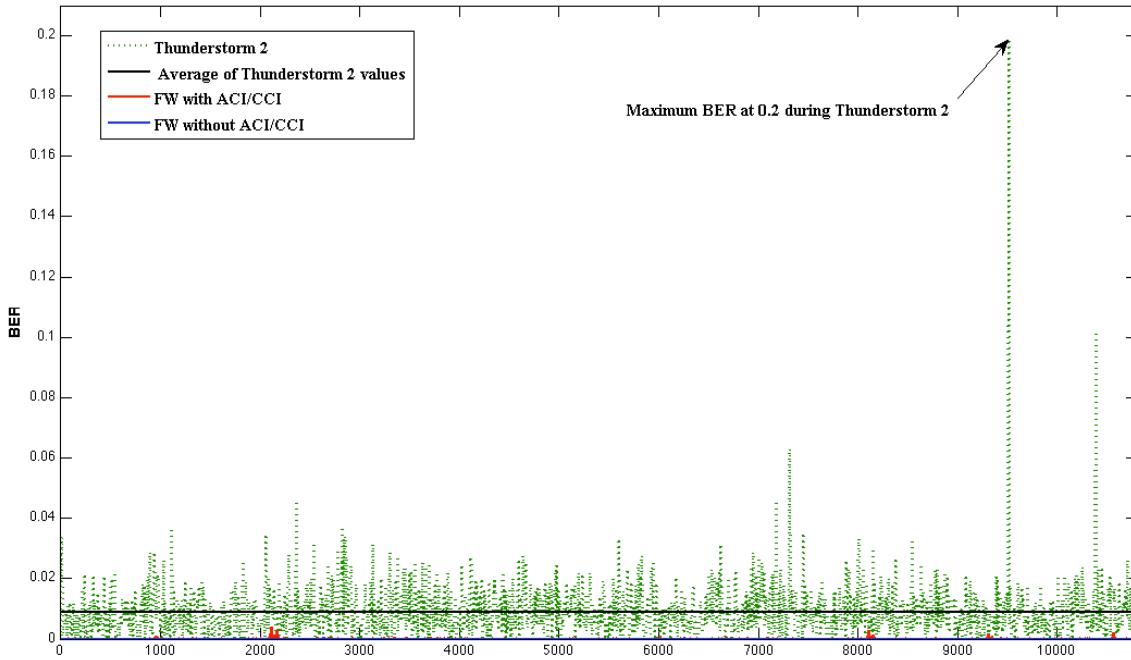
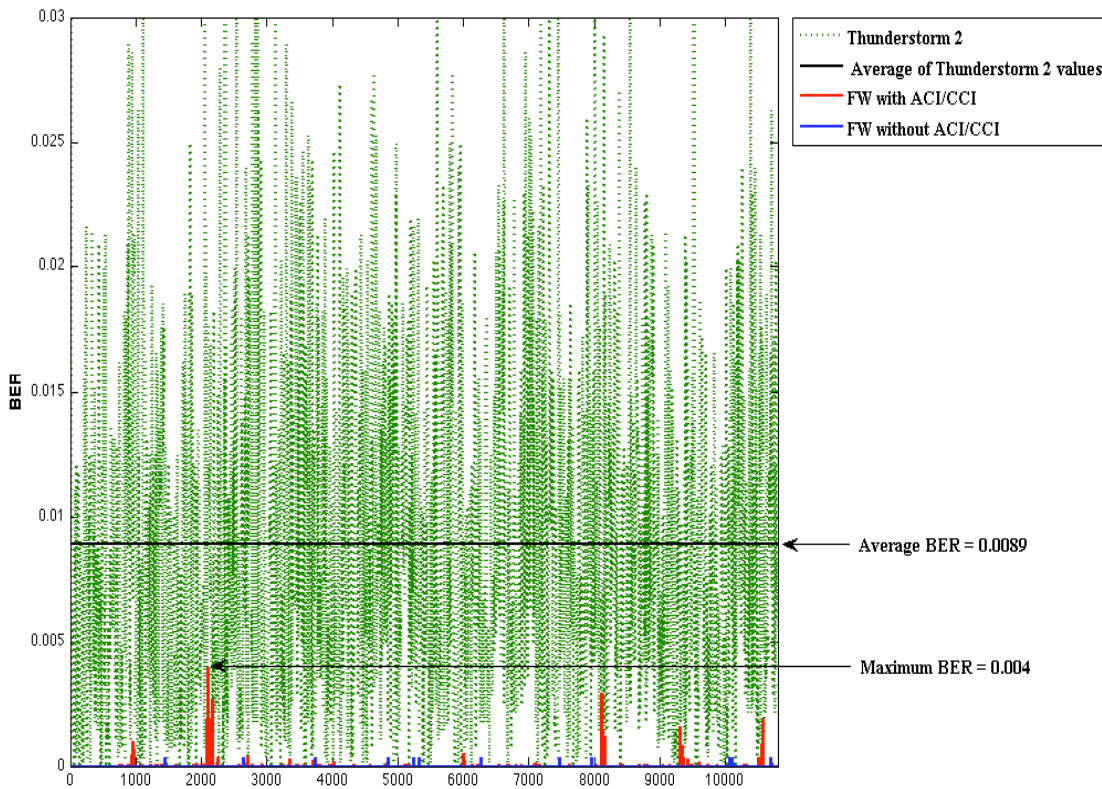
(a) BER range is scaled between 0 and 0.2.

(b) BER range is scaled between 0 and 0.03.

**Fig. (6).** Measured BER during Thunderstorms 2 measurement on 17<sup>th</sup> March 2011 at 2.4 GHz.

Fig. (6a) shows the measured BER during 17<sup>th</sup> March 2011 thunderstorm (denoted as Thunderstorm 2) at 2.4 GHz. Most of the BER points were recorded below  $1 \cdot 10^{-2}$  as the average BER value (shown as black line) was estimated at  $8.9 \cdot 10^{-3}$  with exception at 9513 and 10390 seconds in the

third hour of measurement. At these points, two maximum recorded BER values were  $1.988 \cdot 10^{-1}$  and  $1.010 \cdot 10^{-1}$  at 9513 seconds and 10390 seconds respectively. The communication link may cause audible errors for the audio transmission during Thunderstorm 2 because the average

BER value was higher than  $1 \cdot 10^{-4}$  and measured PER value was close to  $1 \cdot 10^{-2}$ . Zoomed BER values between 0 and 0.03 are presented in Fig. (7b) to provide a clear comparison of Thunderstorm 2 and baseline values.

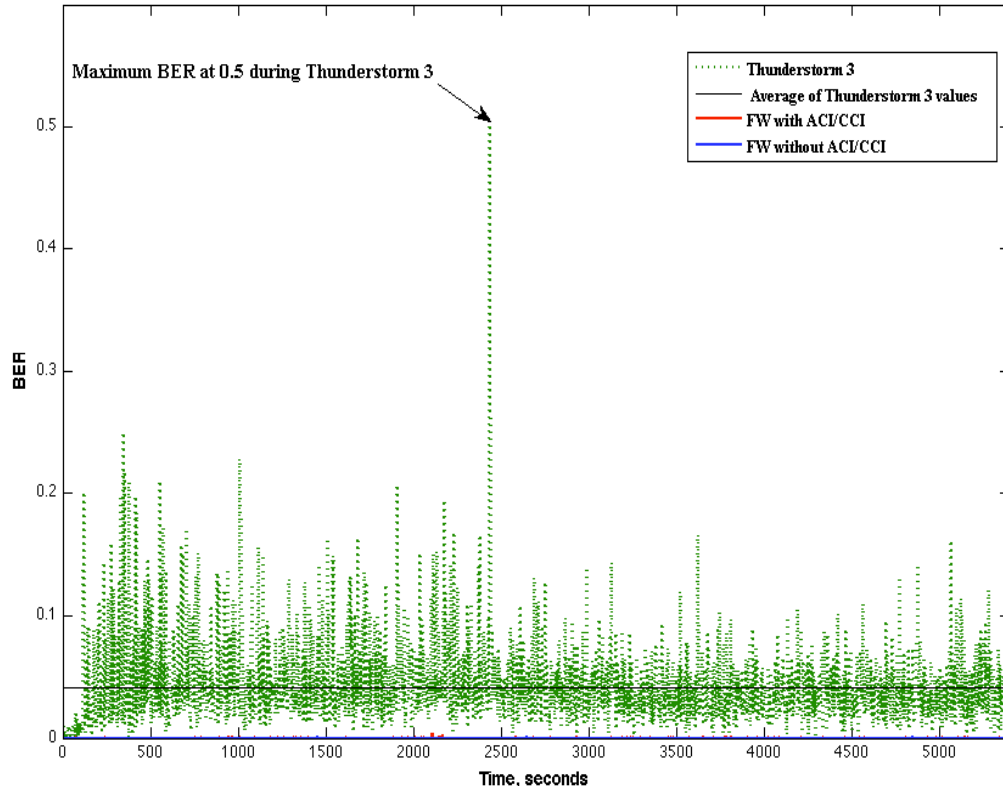
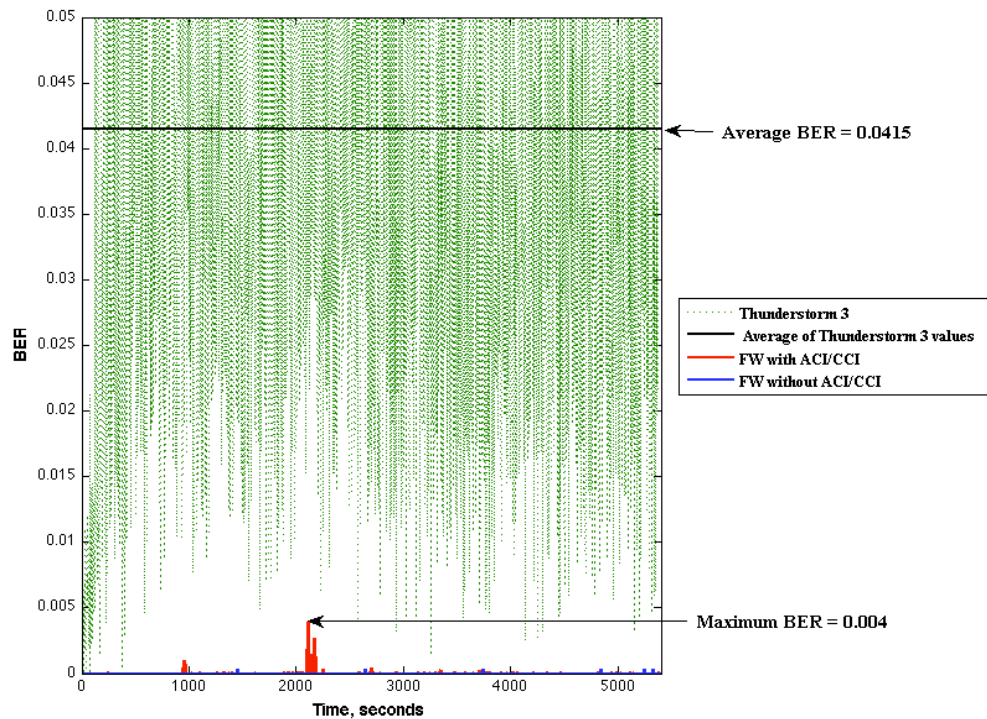
(a) Full scale BER range.

(b) BER range is scaled between 0 and 0.05.

Fig. (7). Measured BER during Thunderstorms 3 measurement on 18<sup>th</sup> March 2011 at 5.2 GHz.

Fig. (7a) shows the measured BER during 18<sup>th</sup> March 2011 thunderstorm (denoted as Thunderstorm 3) at 5.2 GHz. Most of the BER points were recorded below  $5 \cdot 10^{-2}$  as the average BER value (shown as black line) was estimated at

$4.15 \cdot 10^{-2}$  which is higher than recommended value at  $1 \cdot 10^{-4}$ . The maximum recorded BER value was  $5.024 \cdot 10^{-1}$  at 2435 seconds. Also it was observed that PER value was higher than  $1 \cdot 10^{-2}$  during this 90 minutes duration. The communication link may cause audible errors for the audio transmission during Thunderstorm 3. Zoomed BER values

between 0 and 0.05 are given in Fig. (7b) to provide a clear comparison of Thunderstorm 3 and baseline values.

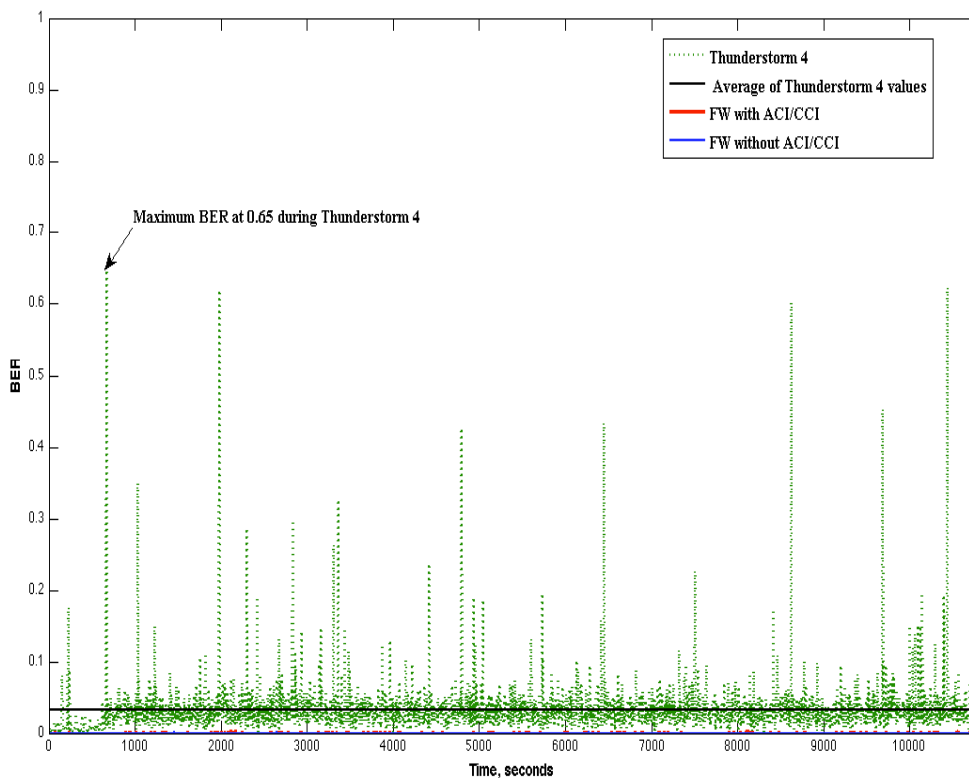
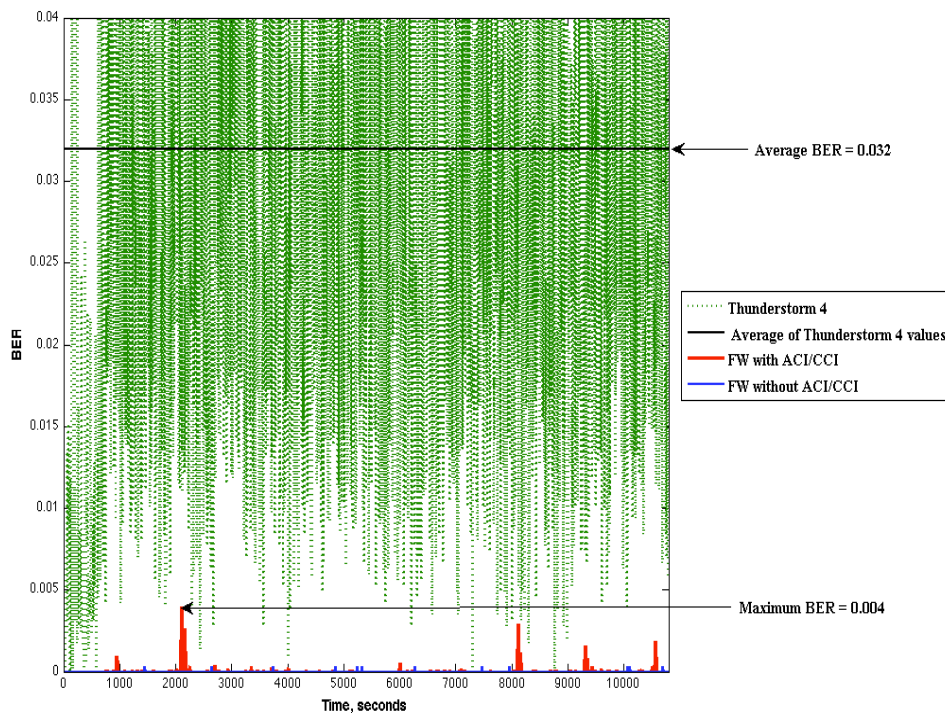
(a) Full scale BER range.

(b) BER range is scaled between 0 and 0.04.

Fig. (8). Measured BER during Thunderstorms 4 measurement on 19<sup>th</sup> March 2011 at 5.2 GHz.

Fig. (8a) shows the measured BER during 19<sup>th</sup> March 2011 thunderstorm (denoted as Thunderstorm 4) at 5.2 GHz. Most of the BER points were recorded below  $5 \cdot 10^{-2}$  as the

average BER value (shown as black line) was estimated at  $3.2 \cdot 10^{-2}$  which is higher than recommended value at  $1 \cdot 10^{-4}$ . The maximum recorded BER value was  $6.484 \cdot 10^{-1}$  at 666.2 seconds. Also it was observed that PER value was higher than  $1 \cdot 10^{-2}$ . The communication link may cause audible errors for the audio transmission during Thunderstorm 4.

Zoomed BER values between 0 and 0.04 are shown in Fig. (8b) to provide a clear comparison of Thunderstorm 4 and baseline values.

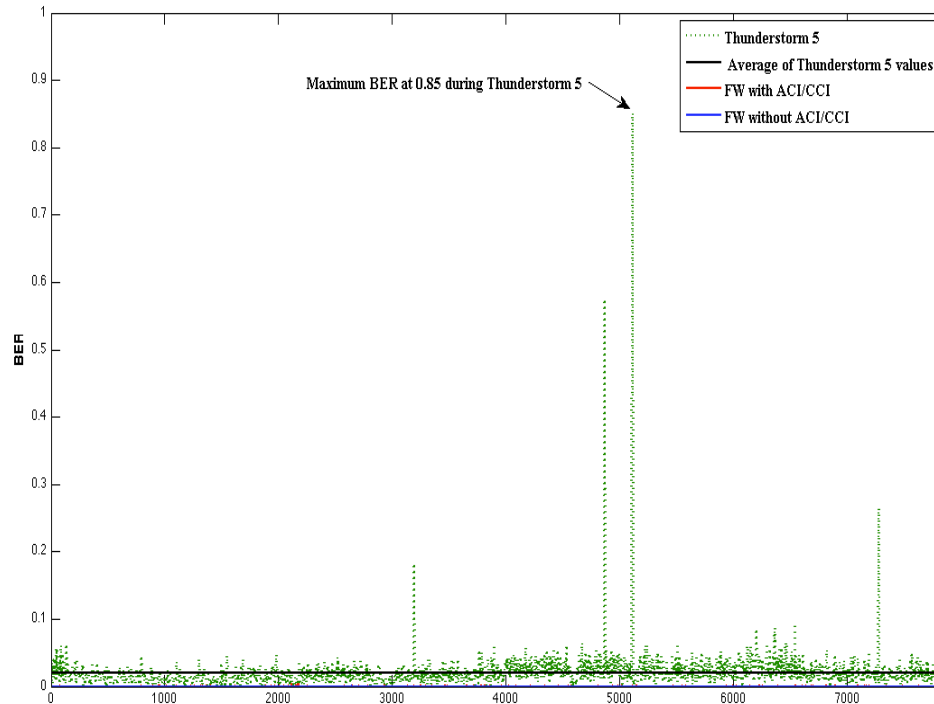
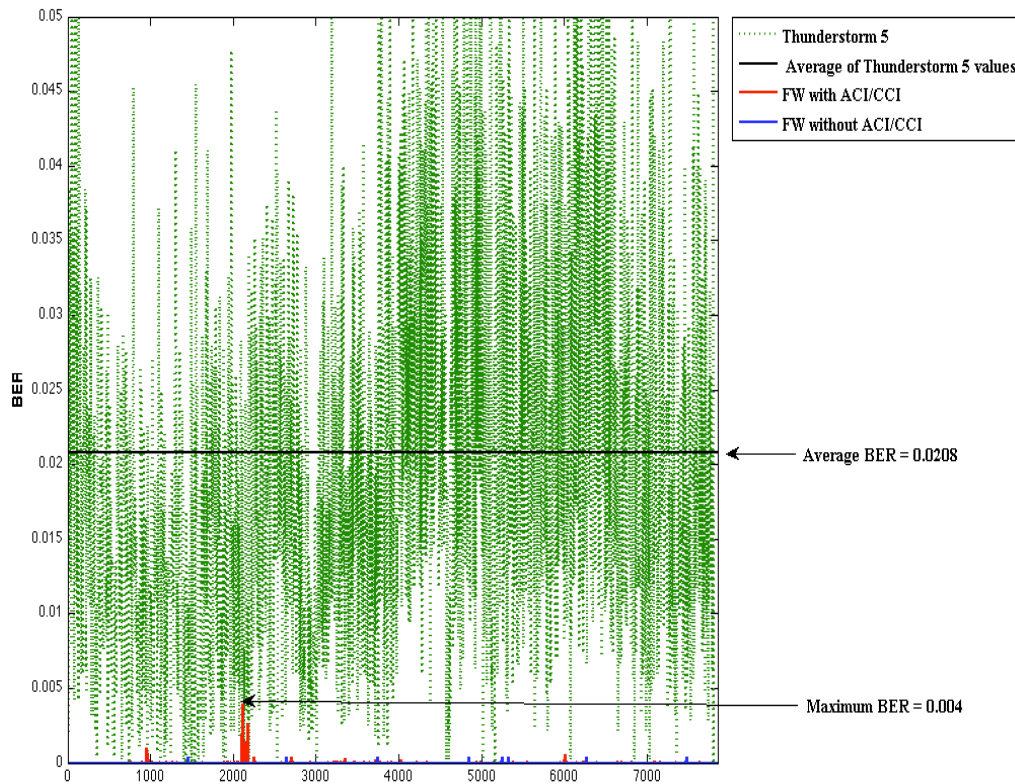
(a) Full scale BER range.

(b) BER range is scaled between 0 and 0.05.

Fig. (9). Measured BER during Thunderstorms 5 measurement on 20<sup>th</sup> March 2011 at 2.4 GHz.

Fig. (9a) shows the measured BER during 20<sup>th</sup> March 2011 thunderstorm (denoted as Thunderstorm 5) at 2.4 GHz.

Most of the BER points were recorded above  $5 \cdot 10^{-2}$  as the average BER value (shown as black line) was estimated at  $2.08 \cdot 10^{-2}$  which is higher than recommended value at  $1 \cdot 10^{-4}$ . The maximum recorded BER value was  $8.520 \cdot 10^{-1}$  at 5110 seconds. Also it was observed that PER value was higher than  $1 \cdot 10^{-2}$  during this 130 minutes duration. The communication link may cause audible errors for the audio transmission during Thunderstorm 5. Zoomed BER values between 0 and 0.05 are given in Fig. (9b) to provide a clear comparison of Thunderstorm 5 and baseline values.
