### The Study Of Wear Process On Uncoated Carbide Cutting Tool In Machining Titanium Alloy

#### ABSTRACT

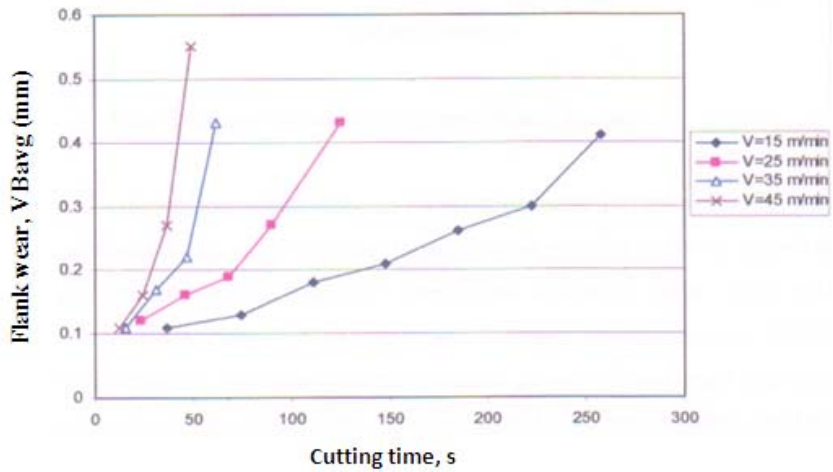
Fig. 2: Flank wear on various cutting speed when feed rate = 0.02 mm/rev

Figure 2 and 3 shows the progression of the typical average flank wear at the speeds of 15, 25, 35 and 45 m/min when machining titanium alloy Ti6Al4V with inserts CNMG 120408-M5 TP1000 at feed rates 0.02 and 0.04 mm/rev respectively. From the figures, it can be seen that the flank wear curves were generally in three stages; at initial stage, followed by gradual stage and finally the abrupt stage of wear. This behaviour was also reported by previous researched (J.P. Chubb, J. Billingham, 1980, 6].

The flank wear rate was rapid at higher cutting speeds and feed rates, additionally cutting under dry conditions. Increased flank wear rate was observed with increase in the cutting speed. A shorter contact area at the chip-tool interface was observed at high cutting speeds. This caused a concentration of high temperature very close to the cutting edge. It has been shown in Figure 2 and 3 where cutting speed at 45 m/min produced the highest value of  $VB_{avg}$  for flank wear. On the other hand, increased the feed rate contributes to shortened the cutting time or tool life and this had shown on Figure 4 and 5. This significant decrease in the tool life for inserts at higher feed rate can be attributed to the increase of temperature and plastic deformation. These factors weaken the cutting tool material.

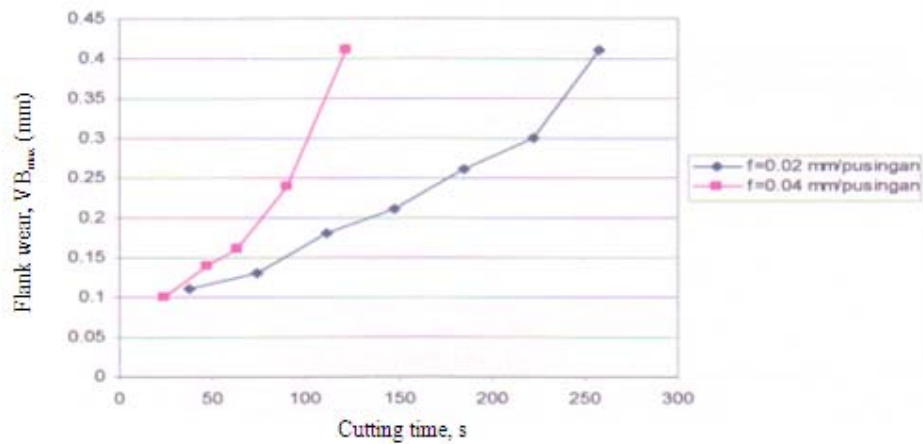
Fig. 4: Flank wear on different feed rate when cutting speed = 15 m/min

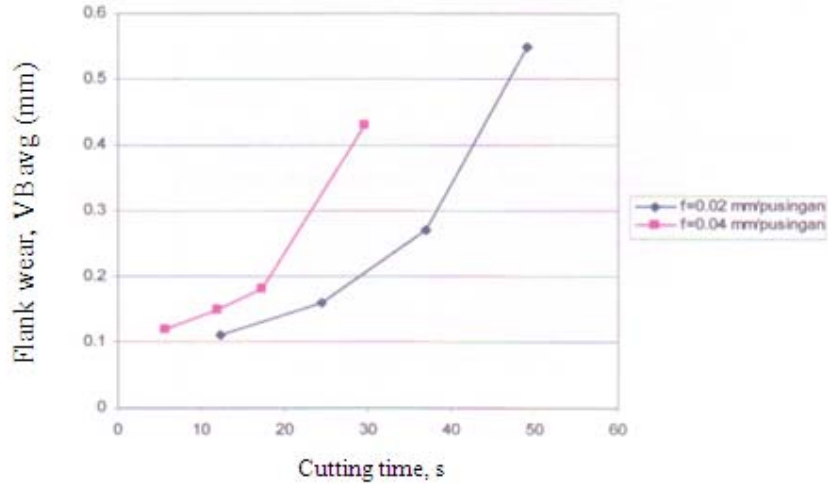
**Fig. 5:** Flank wear on different feed rate when cutting speed = 45 m/min

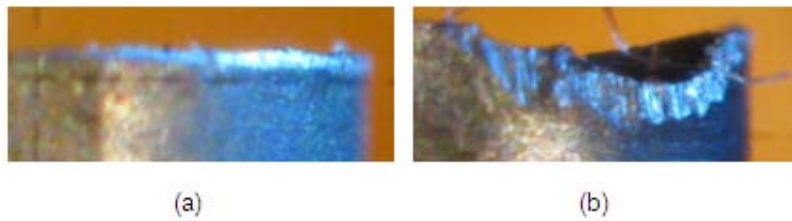
**Fig. 6:** Tool wear at early cutting (a) and final cutting (b) when  $V = 15$  m/min and  $f = 0.02$  mm/rev.

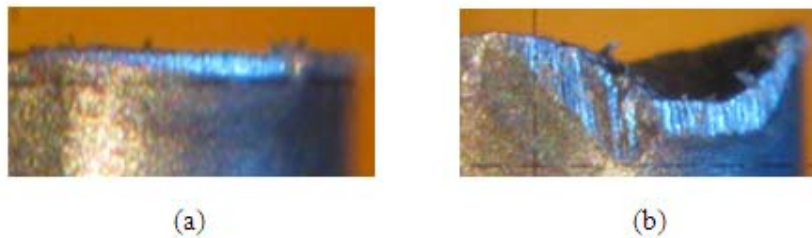
**Fig. 7:** Tool wear at early cutting (a) and final cutting (b) when  $V = 45$  m/min and  $f = 0.04$  mm/rev

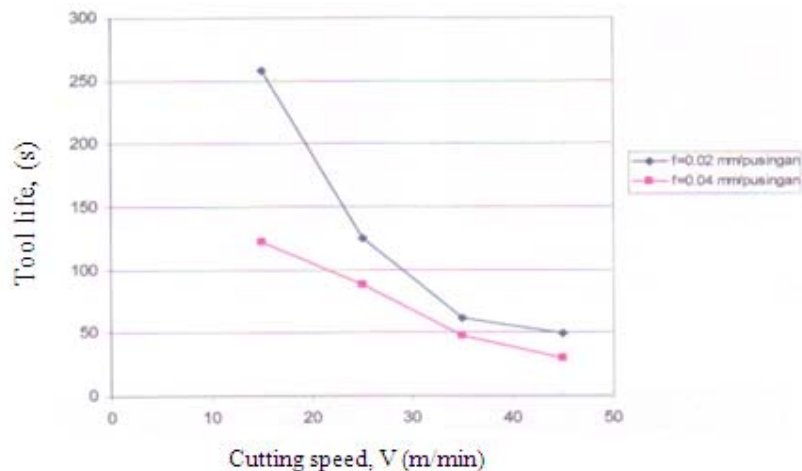
**Fig. 8:** Tool life for different feed rates

Traditionally, tool life is defined by flank wear due to the significant influence this parameter has on the surface finish and dimensional accuracy of the machined part. The tool life was influenced significantly by the temperature generated and the forces exerted at or near the cutting edge of the tools. Therefore, changes in cutting speeds and feed rates will directly influence the cutting forces and temperature generated, especially during dry cutting, and hence the tool life. This had shown in Figure 8 where the highest value for feed rate and cutting speed produced the lowest tool life. Meanwhile in Table 5 show the values of tool life among two types of feed rate on particular cutting speed. In general, the most important point in machining processes is the productivity, achieved by cutting the highest amount of material in the shortest period of time using tools with the longest lifetime (Ahmad Yasir *et al.* 2009).
