The Malaysian International Tribology Conference 2013, MITC2013

Comparison between up-milling and down-milling operations on tool wear in milling Inconel 718

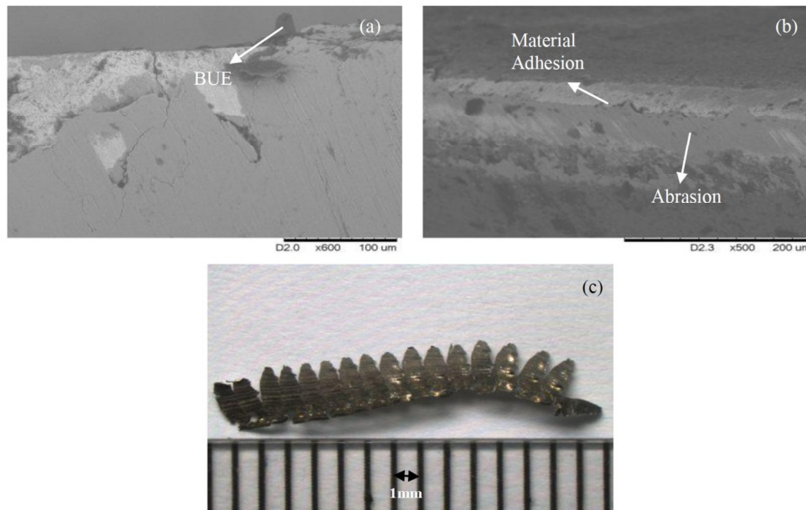
Fig. 2 (a) BUE (b) Abrasive and adhesive wear (c) Segmented chip with typical saw-tooth shape.

Fig. 1(b) indicates the effect of feed rate on the tool wear by keeping the DOC and speed constant. From the result obtained, feed rate also give a direct proportional relation to the tool wear, where increasing the feed rate will accelerate the tool wear. For feed rate of 0.2 mm/tooth, tool is already worn-out in a single cutting pass with the wear reading of 0.53 mm. This phenomenon is due to BUE formed on flank face that changes the geometry of the tool [14]. The result as in Fig. 2(a) was obtained from the experiment and it shows BUE occurred near the DOC line because of higher stress acting on the cutting edge.

From Fig. 1(c), the effect of cutting speed is clearly shown that the flank wear is increased with increase of cutting speed. The experiment was done with a constant DOC; 0.5 mm and feed rate; 0.1 mm/tooth. The result also concluded that as the cutting speed is increased, abrasive and adherence of workpiece on the flank face can be clearly seen as illustrated in Fig. 2(b). In general, this phenomenon is mainly due to the generation of high contact pressure and temperature between workpiece and tool, where most of the wear mechanism of carbide tool is abrasive and adhesive wear [14]. In term of chip morphology, up-milling operation tends to generate a segmented chip with a typical saw-tooth shape as shown in Fig. 2(c). This phenomenon showed that the local rate of heat build-up in the material is large enough that thermal softening overwhelms the effect of strain hardening. The segmented chip will result an increase in tool wear and degradation of workpiece surface finish [15].

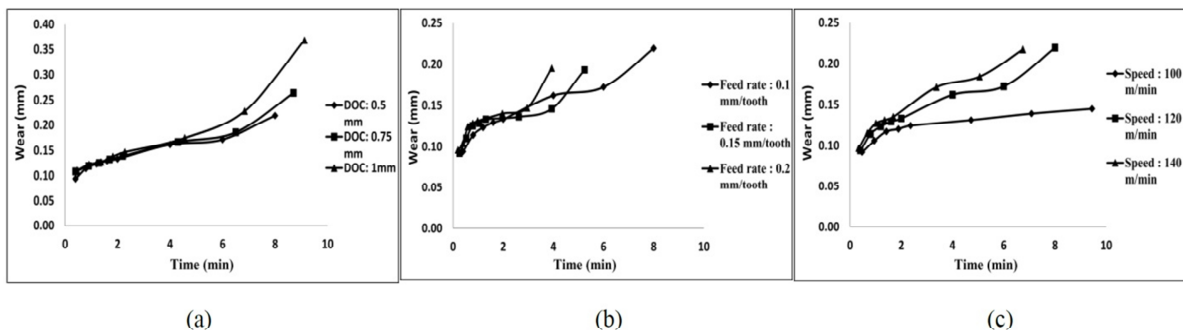
The difference in cutting results during down-milling that due to change of DOC, feed rate and speed over cutting time can be seen in Fig. 4(a), (b) and (c). Overall, all the parameters show the improvements in tool wear when the same parameters used in up-milling are applied in down-milling operation. From the results in Fig. 4(a), the progress of flank wear increases steadily at the initial stage before unevenly progressed after around four minutes of cutting times. This is due to chipping and further more will lead to notch wear that caused by the repetitive load [5].

The effect of feed rate during down-milling is observed in Fig. 4(b). In general, the progress of the wear has three stages: initial, steady-state and worn-out regions. All the feed rate values started with the increasing of flank wear until they reached almost 1 minute before they gone through steady state region for a certain period of time. For $f_z=0.2$ mm/tooth, it takes 3 minutes, while for $f_z=0.15$ mm/tooth and $f_z=0.1$ mm/tooth both respectively take 4 minutes and 8 minutes before the wear drastically increase, leaving the steady state region. As in up-milling, flank wear increases when the feed rate is increased due to BUE formed at flank face and increase the normal contact stress at the tool-chip interface and in the tool-chip contact area. The chipping of the cutting edge will take place and leads to tool breakage when the level of normal contact stress reaches the breaking feed of the tool [16].

Fig. 4(c) shows the influence of different cutting speed on tool wear under down-milling operation. It can be observed that tool wear is very sensitive to cutting speed. When the speed is low (100 m/min), the tool wear on the flank face is slowly increasing compared to the progress of wear during high speed (140 m/min). This was most likely due to increase of the cutting temperature which resulted in a loss of material strength and increase of its plasticity [17]. In other words, tool tips become easier to get wear where abrasive wear marks and workpiece material adhesion were still prevalent in all test performed.
