An overview of the defects on tested orchard sprayers in Belgium

Declercq, J.¹; Huyghebaert, B.²; Nuyttens, D.¹

DOI 10.5073/jka.2012.439.036

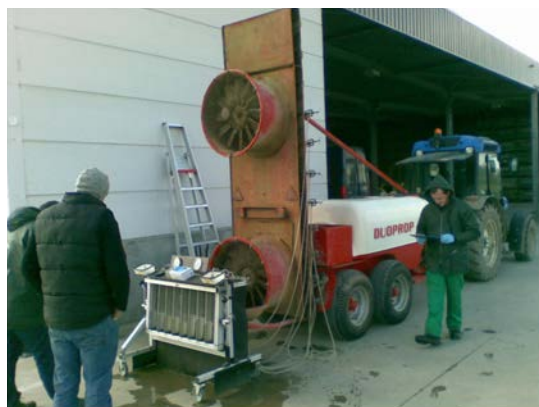
Fig. 1. Measuring nozzle flow rate and spray pressures.

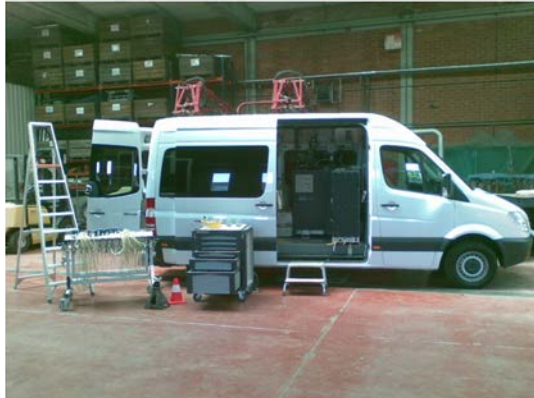
Fig. 2. Inspection van with test equipment.

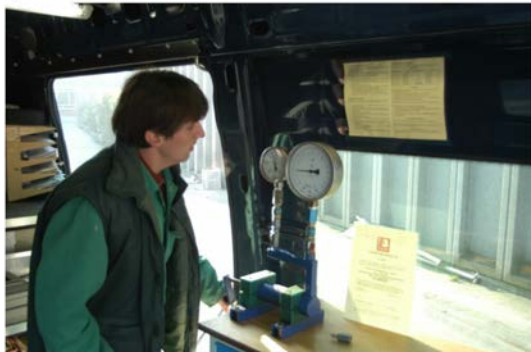
Fig. 5. Testing the sprayer manometer.

Malfunctioning pressure gauges cause the second highest number of rejections (26%). The sprayer pressure gauge is checked by comparison with a reference manometer placed on a nozzle holder. The whole measuring range is tested, generally from 2 to 15 bar depending on the type of orchard sprayer. When the deviation exceeds 10% the pressure gauge is dismantled from the sprayer and tested on a pressure test bench. When the deviation is also higher than 10% on the test bench, the pressure gauge and the sprayer are rejected.

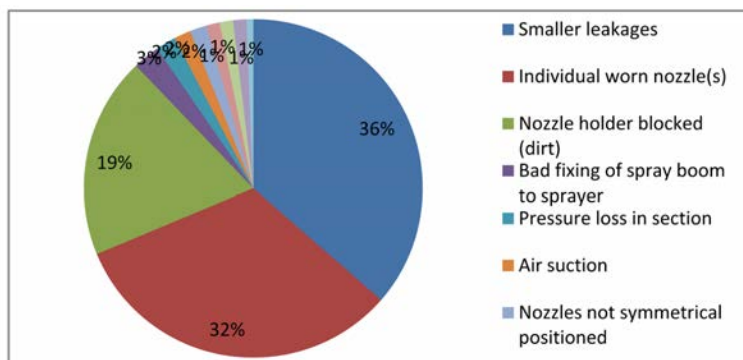
Fig. 6. An overview of category II defects during 2008-2009-2010 (Orchards sprayers).

Three major items are responsible for 87% of the Category II defects i.e. small leakages (36%), worn or blocked nozzles (32%) and partly blocked nozzle holders (19%). Small leakages mainly occur at hoses and nozzle holders but also a number of other sprayer components can show smaller leakages such as the pump, the filter housing and the shut off valves.

Second item are individual worn or blocked nozzles. It happens that only some individual nozzles of the set are worn or dirty (32% of the Category II defects). Those nozzles are clearly marked in the inspection certificate but don't need to be replaced in case the average nozzle flow doesn't exceed the limits. In most cases, it concerns nozzles that are partly blocked due to dirt because fruit growers have the habit to replace their nozzles by new ones every time they are called for an inspection.

Third important item is pressure loss caused by dirty or partly blocked nozzle holders (19%). Partly blocked nozzle holders can cause a significant pressure drop with lower flow rate as a consequence. These nozzle holders are also clearly marked in the inspection certificate so the owner can solve the problem by replacing or deblocking the nozzle holder(s).

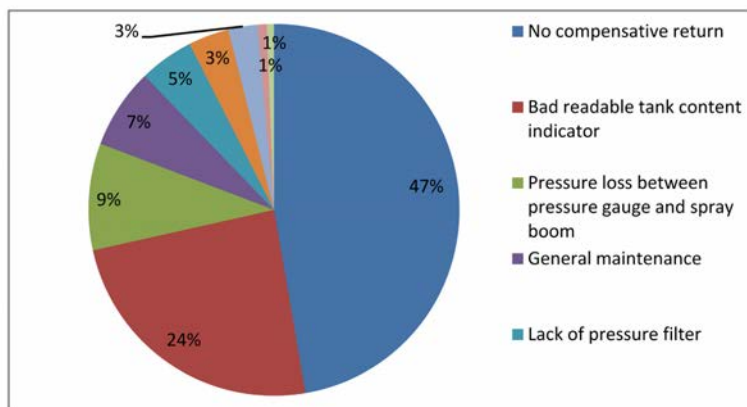
Fig. 7. An overview of category III defects during 2008-2009-2010 (Orchards sprayers).

Many old sprayers don't have the pressure compensation (47%). The user has to adjust the working pressure when he closes a section in order to obtain the same rate. Also a large number of problems concern the readability of the tank content indicator (unreadable or defect: 24%). Further on, 9% of the sprayers show a pressure drop between the working pressure gauge and the spray boom (9%). The pressure drop value is registered on the inspection certificate. This gives the owner the possibility to adjust the pressure at the working gauge to obtain the desired pressure at the spray boom. Furthermore some smaller items are noted, such as bad general maintenance (7%), lack of a pressure filter (3%) and wrong air bell pressure (3%).
