## The inspection of soil-disinfection equipment in Belgium.

DOI 10.5073/jka.2015.449.0010

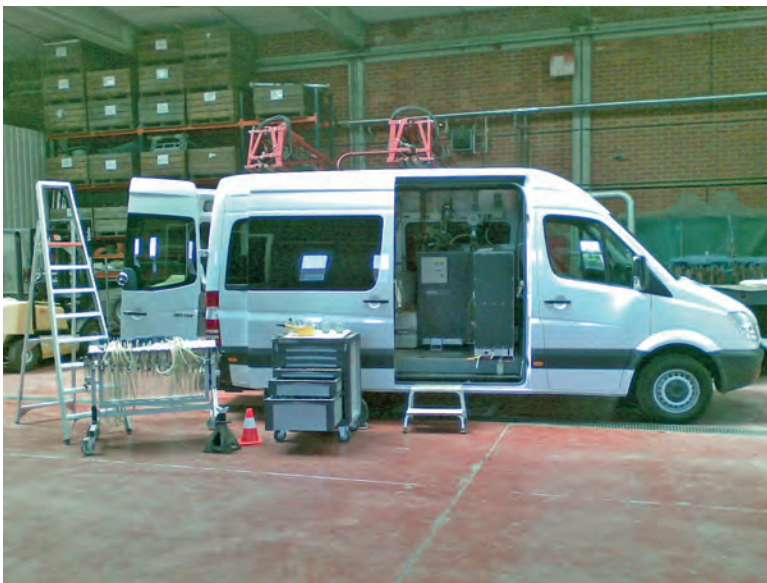
Fig. 1. Inspection van with test equipment.

credited according to ISO 17020 which guarantees a maximum quality of the performed inspections. The inspection teams (3 in the Flemish region and 2 in the Walloon part) are equipped with a test van that contains all necessary equipment to perform the inspections according to the Belgian federal legislation (Fig. 1). The inspections are carried out at a neutral location where farmers/contractors are invited at an exact date and time, to present their sprayer for testing at this place. All over the country test locations are hired in a way that farmers/contractors don't need to travel distances > 15 km with their sprayers. On demand inspection teams also perform inspections at the farmyard, but therefore an extra fee is charged. The inspection procedure is based on the analytical principle which means that all parts of the machine are tested separately. After the inspection the farmer/contractor receives a certificate confirming the approval of the sprayer for the next three years or specifying all the items that need to be repaired in case of a rejection. No repairs are made to the sprayer during the inspection, so the farmer/contractor needs to repair the defects himself or leave the repairs up to a workshop. Consequently, the repaired sprayer has to be represented for a second passage.

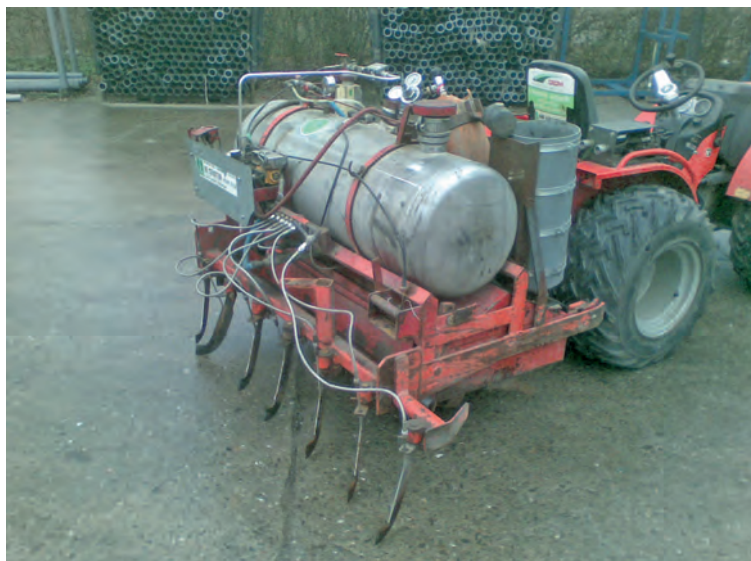
Fig. 2. Typical soil-disinfection machine.

In order to clarify the inspection protocol, one first needs to know how this type of machines work (Fig. 2). Therefore a hydraulic scheme is useful and a simple scheme is shown in Fig. 3 containing all elementary parts of a common used soil-disinfection machine.

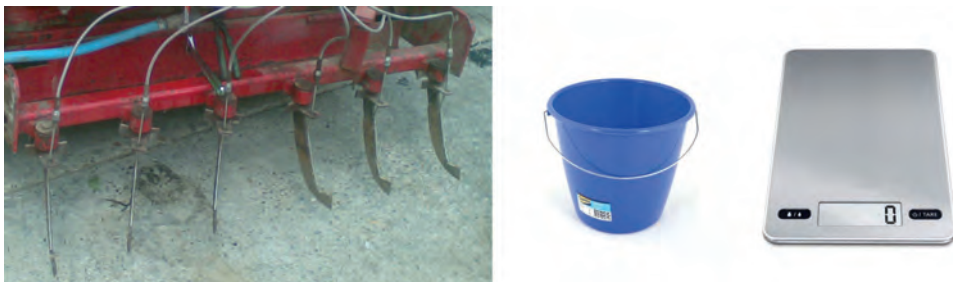
At first, pattern testing was performed with graduated measuring cups and a stopwatch as sometimes performed on normal field crop sprayers. Disadvantage of this method is that some of the injectors are very difficult to reach and with two inspectors only 3 injectors at a time can be measured. Furthermore while inspecting, the inspectors are close to the outflow of the injectors, and in some cases need to position arms underneath the machine what makes this an unhealthy and unsafe situation.

Fig. 4. Soil-disinfection machine injectors, pattern measurement.

Finally a number of identical buckets and a digital balance were bought. Before testing the pressure and/or flow is regulated to the desired values while spraying. Then the main valve is shut off and underneath each injector an empty bucket is placed. The start value of the flow meter (if present and when the flow meter is a counter) and also the test pressure is written down. Then the main valve is opened and at the same time a stopwatch is activated. While measuring, the test pressure is written down, and for real time flow meters the real time flow is registered. After minimum 2 minutes of measuring the main valve is shut off and the stopwatch is deactivated. By weighing the buckets combined with the measured time, the individual flow/flow rate (pattern) and total flow/flow rate can be de-

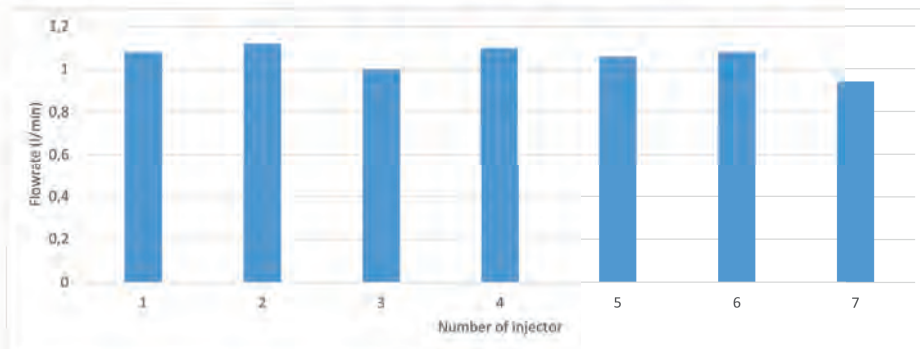
1	2	3	4	5	6	7
<b>A13300003</b>							
Opgevangen (liter)	1,08	1,12	1	1,1	1,06	1,08	0,94
Gemiddeld debiet (l/min)	1,05						
Individuele afwijking	2,44%	6,23%	-5,15%	4,34%	0,54%	2,44%	-10,84%

Fig. 5. Pattern of soil-disinfection machine nr. A13300003.

terminated. The flow meter value can be compared with the captured flow. A maximum difference of 10% is accepted. The inaccuracy following out of different supply pipe lengths is compensated by the long measuring period. The mean value of the flows is calculated and the difference with this mean value per individual injector may not be above 10%. As injected soil-disinfectant gets its good working from evaporating into the soil, this 10% is a satisfying limit for this type of applications.
