Practical experience in running Field Sprayers Inspection Station, and measuring tools design and their implementation

J. Zubek

Owner and Inspector for Field Sprayers Inspection Station DOI 10.5073/jka.2015.449.0034

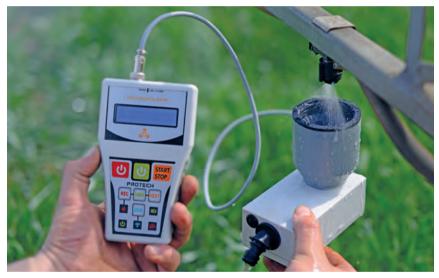
Fig. 1. MicroFLOW in use.

The aim of the research was to find alternative, faster, cheaper and more accurate methods of measuring the flow of liquid from field sprayers nozzles with free flow, and the development of devices for doing so. I believe that the prevalence of use our tools will significantly speed up the inspection process, while increasing its reliability and precision. Developed devices MicroFLOW (Fig. 1) and SprayerTEST (Fig. 2) use well known principle of measuring the intensity of the free flow of liquid from any source actually. They use also best technical solutions presented by other companies, but our invaluable advantage is the possibility of any technical adaptation and modification of software. Microflow and Sprayer Test has been developed after several months of testing, training and research.

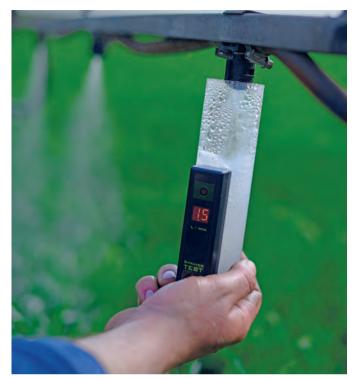
Fig. 2. SprayerTEST in use.

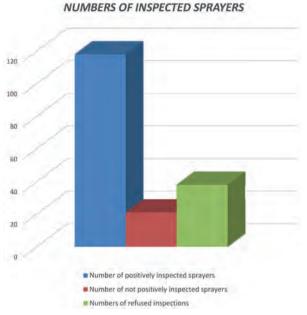
Fig. 3. Number of inspected sprayers.

Data collected during our activity (fig. 3 and 4) – can show what are the main technical problems, and inquiry were result of most problems for farmers why farmers are not well prepared:
