Bio-sorption Activated Media for Nitrogen Removal

In a Rapid Infiltration Basin – Monitoring Project

Project Agreement No. NS 003

May 1, 2018

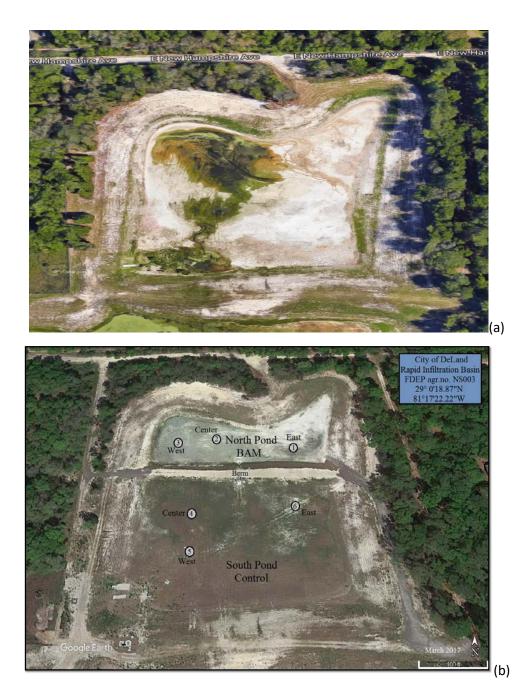
Figure 4 Aerial Photographs of (a) North (pre-study) RIB without separation berm and (b) BAM RIB (North) and Control RIB (South) with Lysimeter Locations Source: Google Maps (reference time is May 2016 and March 2017)

The RIB to be modified with BAM is part of a larger RIB site. The larger and smaller part of the RIB can be loaded independent of each other. Thus, minimal modification of the RIB plumbing was necessary. All the RIB areas are used by the City of DeLand for reclaimed and excess stormwater disposal when the water is not used for irrigation. Reclaimed water, river water and excess stormwater are pumped to the RIBs. The existing northern RIB is approximately 3 Acres and is shown in Figure 4. The location of the berm separating the BAM RIB from the Control RIB and the lysimeters is shown in Figure 4 (b).

The existing RIB was modified with a dividing berm. The dividing berm separates the RIB with BAM from the Control RIB (see Figure 4). The BAM RIB was constructed on the north side of the RIB and has 2 feet of BAM under an area of about 1 acre (43,600 SF). The Control RIB remained with the existing soil condition and is about 1.68 acres (73,200 SF). Figure 5 is the "as-built" plan. Reclaimed water

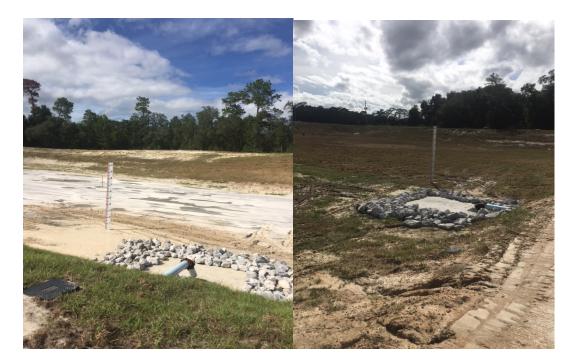
(a) BAM RIB looking northeast (b) Control RIB looking southwest Figure 6 Inlet Pipes and Staff Gages for Depth Measures

Staff gages were used to directly measure the water levels in both RIBs. Shown in Figure 6 are the staff gages for the BAM RIB and the Control RIB. Also shown are the inlet pipes that discharge water into the RIBS. The inlet pipes include vales and meters to distribute equally (on a RIB area basis) the same input flow rate from the reclaimed water reservoir of the Deland WRF.

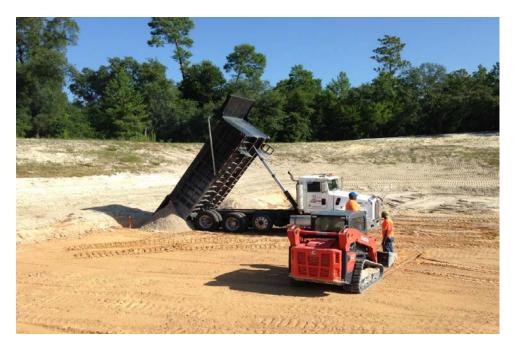
Figure 10 Installation of the BAM in the one-acre RIB

1. **The installation time for BAM:** The installation was completed in one week. City staff placed 3227 CY of BAM. The BAM was delivered in dump trucks (see Figure 10).

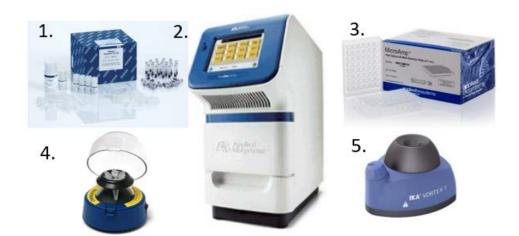
Figure 22 qPCR instrument and Accessories used in UCF Lab (1. DNeasy PowerSoil kit, 2. Applied Biosystem StepOne Real-Time PCR System, 3. PCR 48-well plate, 4. Centrifuge, 5. Vortex mixer)

Figure 22 is shown to validate the DNA method of analysis as other lesser accurate instruments can be used. These are the highest-grade instrumentation.

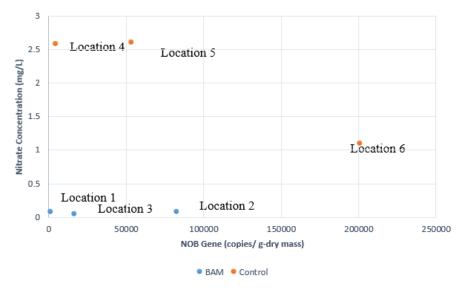
Results from second sampling event for the NOB show that the optimum depth for nutrient removal was at the surface layer for BAM RIB, and only at locations 5, and 6 for Control RIB (Fig. 23 (a)). The increase presence of NOB, 1 foot below the surface at location 4 can be attributed to ponding effect. The ponding of reclaimed water at this location could have affected adsorption of nutrients in the soil consequently affecting the NOB activity by reducing oxygen in the top layer. The accumulation of nutrient at the surface on the RIB provided the required environment for microbial growth. Ashe quantity of NOB is associated with nutrient availability in the soil and nitrogen removal. The increase in NOB population in the BAM RIB from the first and second sampling event demonstrate the relationship between microbial population and nitrate removal. The more NOB available at the BAM RIB the more microbiological activity present by NOB to convert nitrite to nitrate.

The difference in NOB and denitrifier population in the distinct depths (0, 1, 2 ft) for both the BAM and Control RIBS for first sample data is due to the initial state of the project. Initially the organisms require time to stabilize before a consistent trend is observed. The inlet water nitrogen concentration varied adding to the required microbial adjustment. A trend of decreasing NOB population with depth is observed at the final stage for all the locations apart from location 4, which has an increase in NOB population at depth of 1 foot before decreasing (Fig. 23(a)). Further, NOB increased
