*Proceedings of International Conference : Problem, Solution and Development of Coastal and Delta Areas
Semarang, Indonesia – September 26th, 2017
Paper No. C-35*

The Influence of Seismic Load to Deformation of Dam

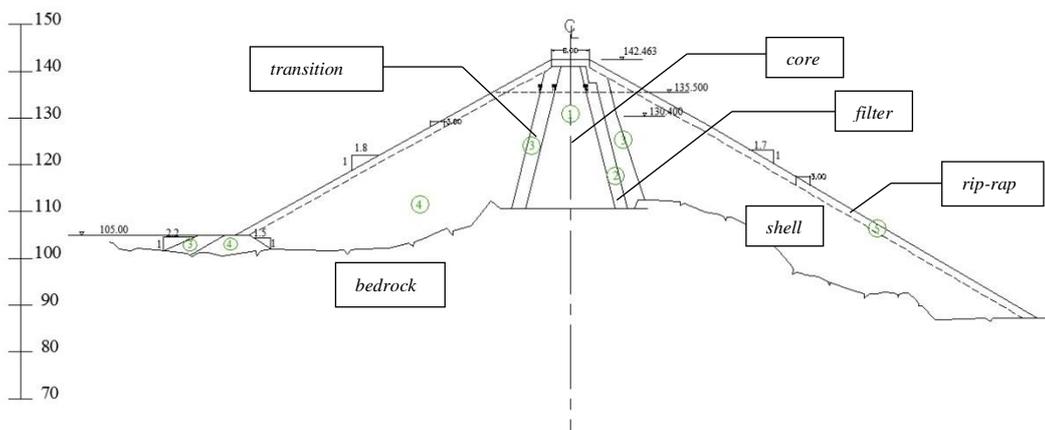
Fig. 2. Cross Section of Sermo Dam
(Department of Public Works, 1994)

This study took on Sermo Dam which is located in Ngrancah River, a child of Serang River in Hargowilis village, Kulon Progo Regency, Yogyakarta. The location of this study can be seen in Fig. 1. In addition, in this study focused on sta 12 of Sermo Dam, which can be seen in Fig. 2. Sermo Dam is a rockfill dam which comprises of several zones, core, filter, transition, shell, and bedrock making up the body dams from upstream to downstream.

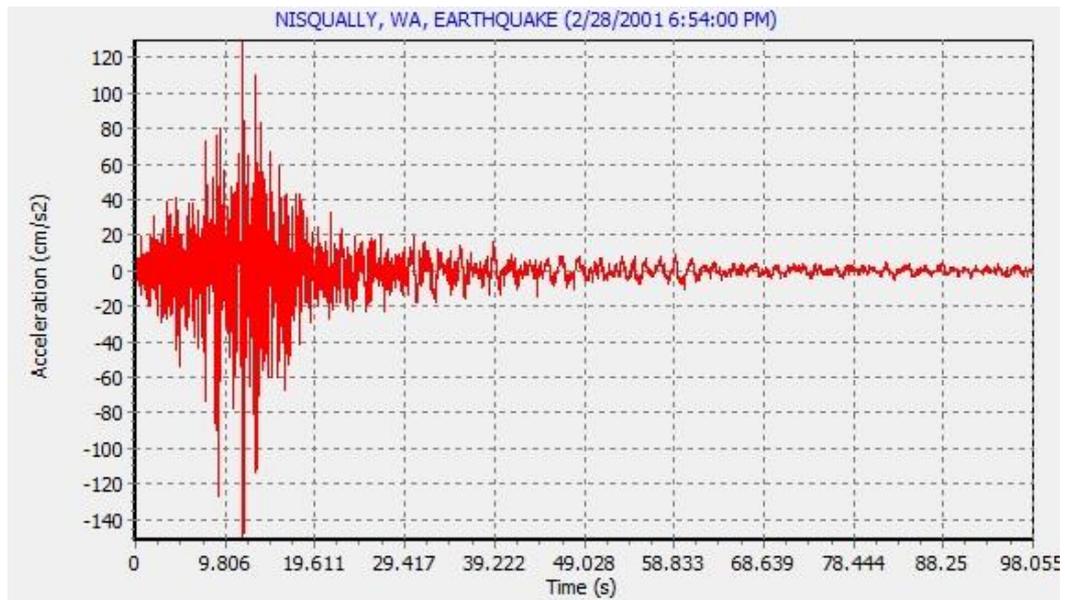
Fig. 3. Time History of Nisqually, Washington
(Stong Motion Data Center)

The result of the soil response due to the earthquake waves that propagate will be a vibration, which is called the time history data. Data on earthquake recording, particularly the magnitude and Peak Ground Acceleration (PGA) values, which is the highest point in the time history data graph. Example of time history data can be seen in Fig. 3 which was the earthquake recording data in Nisqually, Washington, with magnitude moment, 6.8 Mw Peak Ground Acceleration value of 151.70 cm/ sec² or 0.15 g, and 15.6 of epicentrum distance (CESMD).

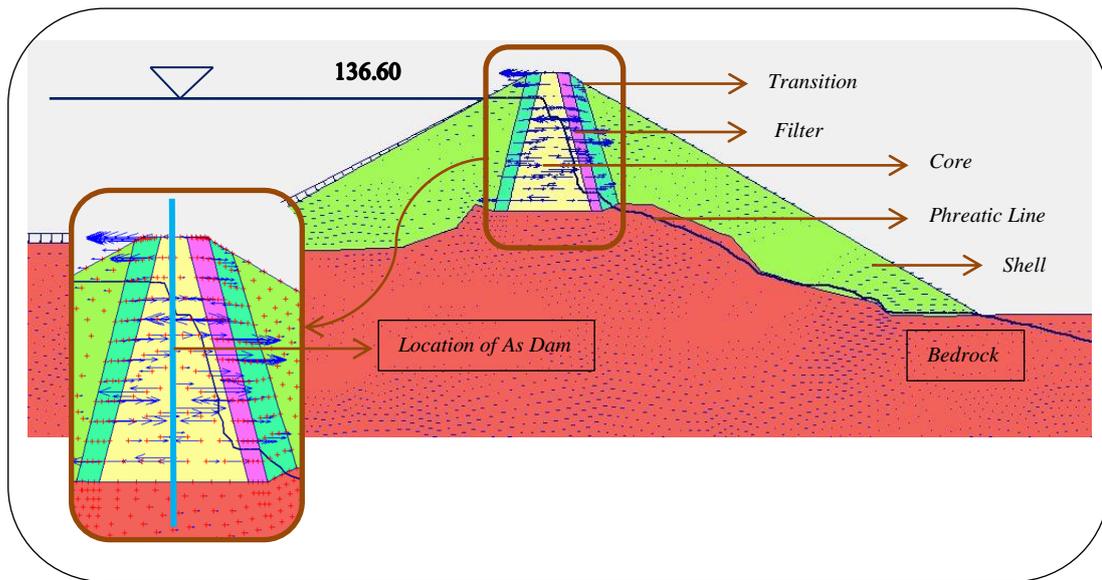
Fig. 4. Stress Direction Dam Simulation Caused by Seismic Load

The simulation results of the dam model with a water level of 136.60 meters and the phreatic line which was occurred can be seen in Fig. 4. Also, its includes the stresses due to seismic load which is given on the dam structure.

Fig. 4 shows that due to horizontal seismic force, afterwards there are turn up stresses to the right and left that occurs at the core zone of dam. On the other hand, the result of the dam's maximum horizontal deformation in the as dam after the horizontal seismic load can be seen in Table 3.

This study observes the deformation of the dam. The zone position of dam to be reviewed is located in the core zone. Specifically, on the as dam or center of dam which can be seen in Fig. 4. Therefore, the deformation result that was taken according to the maximum horizontal deformation that occurred in this location of as dam. The selection of this core zone position is based on the consideration that in the core zone is a zone in soft soil forming and potentially influences the deformation occurs due to water storage and seismic load.
