Bond-shear Behavior of FRP Rods as a Function of Attachment Configuration

Keywords: *bond-shear, FRP rods, embedment depth, mode of failure*

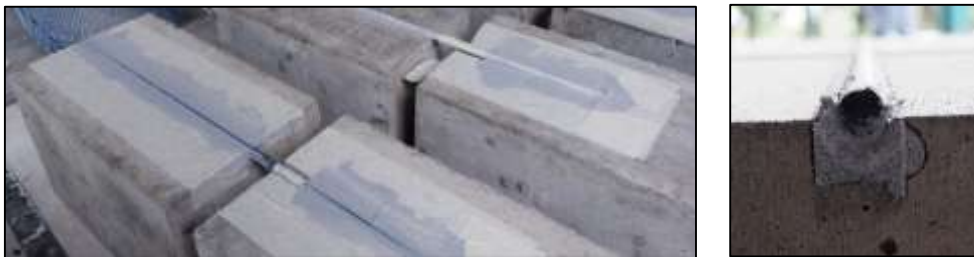
The RTH specimen was only filled on both sides of the rod. The attachment of the epoxy to the rod was prevented by covering the half rod with a duct tape (Fig. 5).

Fig. 5. RTH assemblage

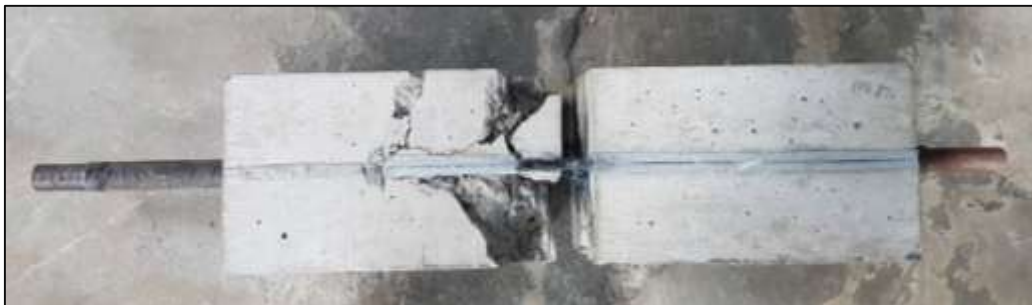
The shifting from the edge position of the rod to the center of the groove didn't significantly increase the shear strength. Fig. 8 represents the failure pattern of both RTE and RTF.

Fig 8. Concrete failure pattern of RTE and RTF
