# SURFACE AND SUBSURFACE CHARACTERISTICS RELATED TO ABRASIVE-PLANING CONDITIONS

*Lidija Murmanis and Bryan H. River*

## ABSTRACT

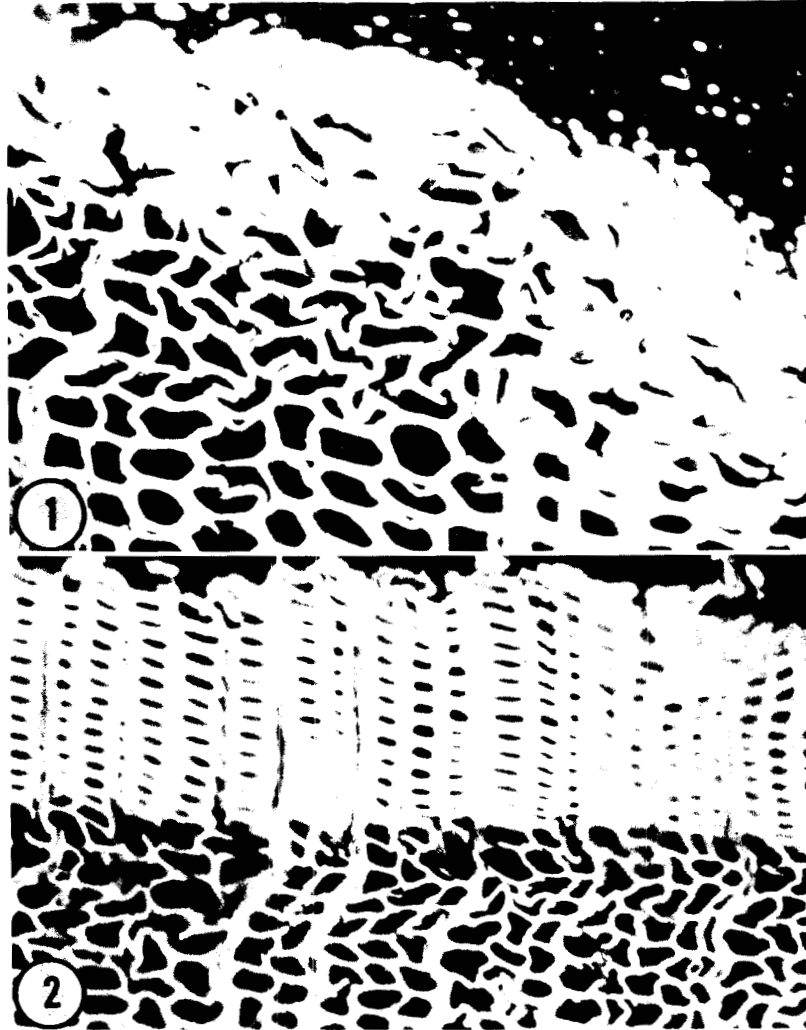
FIG. 1. Douglas-fir (36 grit, 35 ft/min, 0.003 in.). Earlywood compacted to a depth of about six cells, crumpled and broken to an additional depth of five to six cells.  $\times 162$ .

FIG. 2. Douglas-fir (36 grit, 35 ft/min, 0.003 in.). Latewood surface with damage one to two cells deep but underlying earlywood cells crumpled and some broken.  $\times 125$ .

Surface and subsurface damage is found at every set of planing conditions. In severe cases earlywood cells are crushed to a depth of 10 to 12 cells with the upper layers forming a compact mat (as shown in Fig. 1, when 36 grit was used). In the latewood the damage is less severe—only two to three cells deep. However, the compressive forces crumple earlywood cells below the surface (Fig. 2).

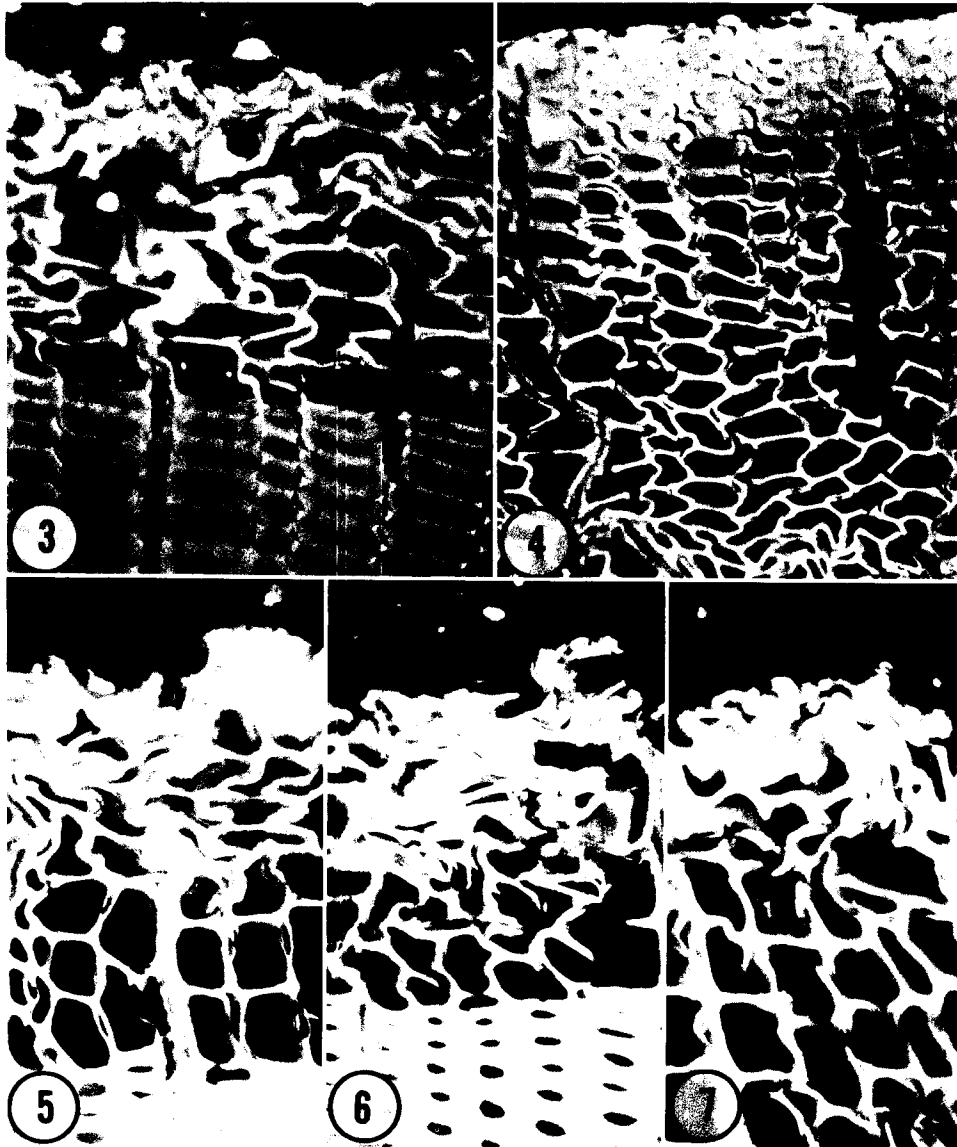
FIG. 3. Douglas-fir (120 grit, 55 ft/min, 0.010 in.). Earlywood compacted to a depth of three to six cells and crumpled an additional four to five cells deep; latewood with some cracking between rows of cells.  $\times 170$ .

FIG. 4. Douglas-fir (120 grit, 35 ft/min, 0.003 in.). Latewood surface relatively sound except for cracking between rows of cells; underlying earlywood crumpled to a depth of 14 to 15 cells, with some cracking evident.  $\times 98$ .

FIGS. 5-7. 5.—Douglas-fir (80 grit, 35 ft/min, 0.003 in.). 6.—Douglas-fir (80 grit, 55 ft/min, 0.010 in.). 7.—Douglas-fir (80 grit, 65 ft/min, 0.020 in.). All samples show similar damage when the same grit but different feed speeds and cuts of depth were used.  $\times 170$ .

The finer grit sizes appear to cause less damage, as complete crushing of earlywood cells extends only three to six cells deep (Fig. 3). In latewood the surface damage is minimal, but the earlywood cells beneath the surface still are crumpled (Fig. 4).

Feed speed and depth of cut make no appreciable difference in the damage caused at any one grit size. For example, compare Fig. 5 (stock removal rate 1.26 in.<sup>3</sup>/in./min) with Fig. 6 (6.6 in.<sup>3</sup>/in./min) and Fig. 7 (16 in.<sup>3</sup>/in./min) in which all three samples are machined with 80 grit.

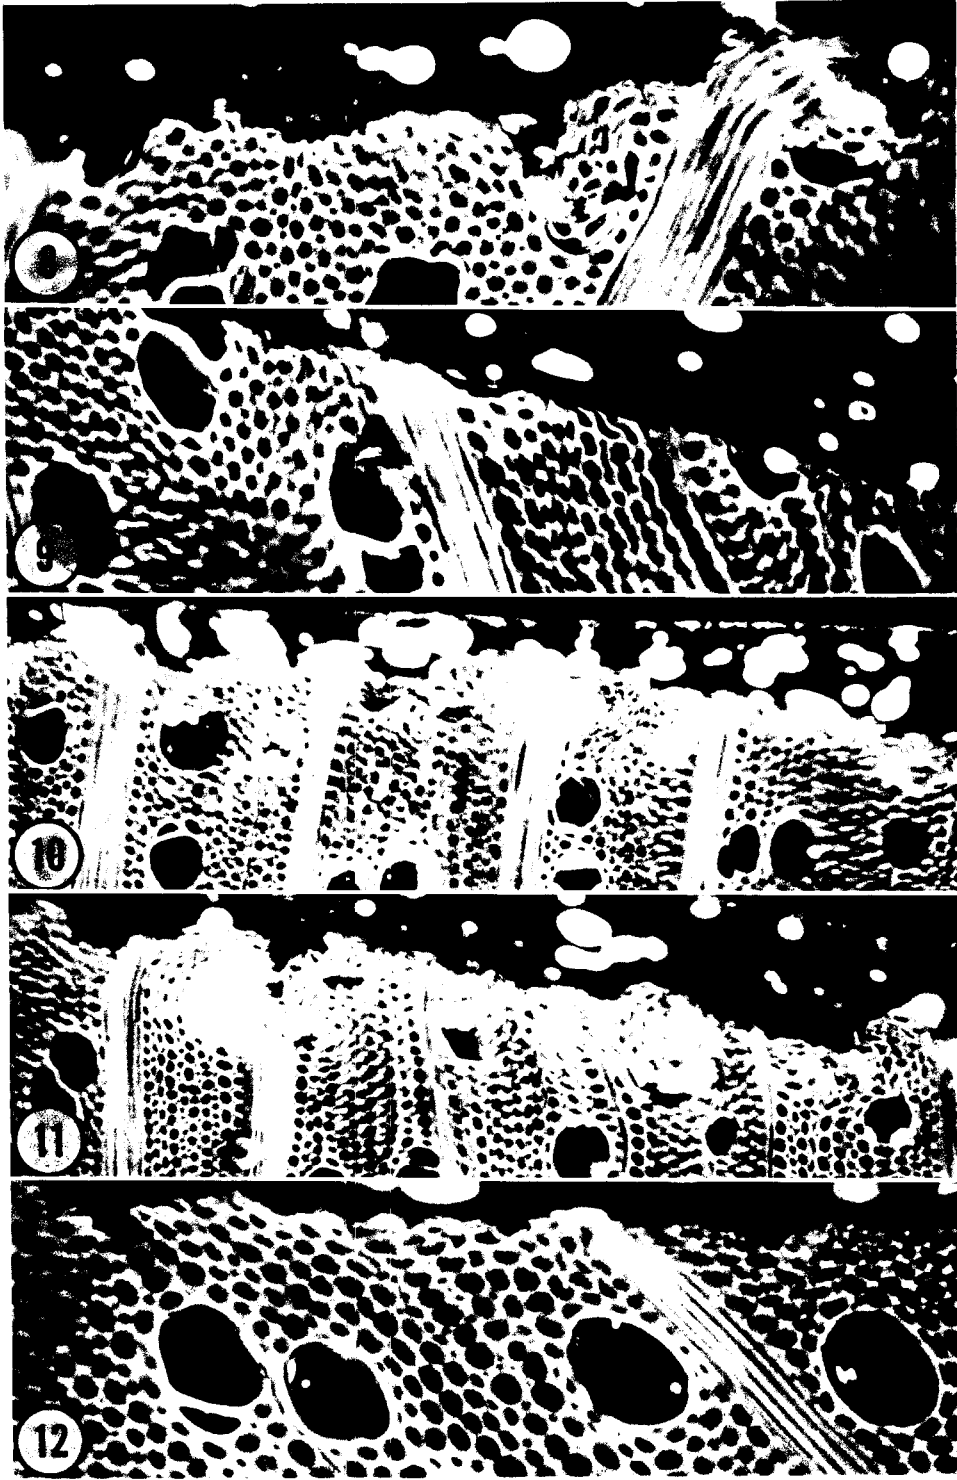
FIG. 8. Hard maple (36 grit, 35 ft/min, 0.010 in.). Surface severely damaged; fibers in some regions flattened to a depth of two to three cells or pressed into vessel lumina; ray protrudes above the surface and pressed into vessel lumen.  $\times 170$ .

FIG. 9. Hard maple (36 grit, 45 ft/min, 0.020 in.). Almost no surface damage present.  $\times 170$ .

FIGS. 10, 11. Hard maple. 10.—(80 grit, 35 ft/min, 0.010 in.). 11.—(80 grit, 45 ft/min, 0.020 in.). Both samples show severe surface damage.  $\times 98$ .

FIG. 12. Hard maple (120 grit, 35 ft/min, 0.003 in.). Fairly sound surface; fibers flattened or slightly crumbled only to a depth of one to three cells.  $\times 170$ .

Surface and subsurface damage is not as severe as in Douglas-fir but is still found at every set of planing conditions. In maple the fibers are more likely to be torn away or compressed into vessel lumina than to be crushed flat. Ray cells are often left protruding above the surface when the fibers are torn away. When crushing occurs, it extends only five or six cells deep. The severity of damage is variable but cannot be positively linked either to feed speed or depth of cut. For example, a piece machined with 36 grit at 35 ft/min and 0.010-inch depth of cut shows severe damage (Fig. 8), but a piece machined with a higher stock removal rate (36 grit at 45 ft/min and 0.020-in. depth of cut) shows virtually no damage (Fig. 9). This observation supports our hypothesis that at some rate of stock removal (not necessarily the lowest) the compression force on the wood may be reduced to a level minimizing the damage. Similar types of, and variability in, the amount of damage occur with 80 and smaller grits, but the patterns of variability at these grit sizes do not support our hypothesis. For example, pieces of wood machined with 80 grit at 45 ft/min, 0.020-in. depth of cut or at 35 ft/min and 0.010-in. depth of cut show equal damage (compare Figs. 10 and 11 with Figs. 8 and 9). Although the severity of damage is not linked to feed speed or depth of cut, at machining levels within the range of stock removal rates applied, the damage seems less when 120 and 150 grit are used (Fig. 12).

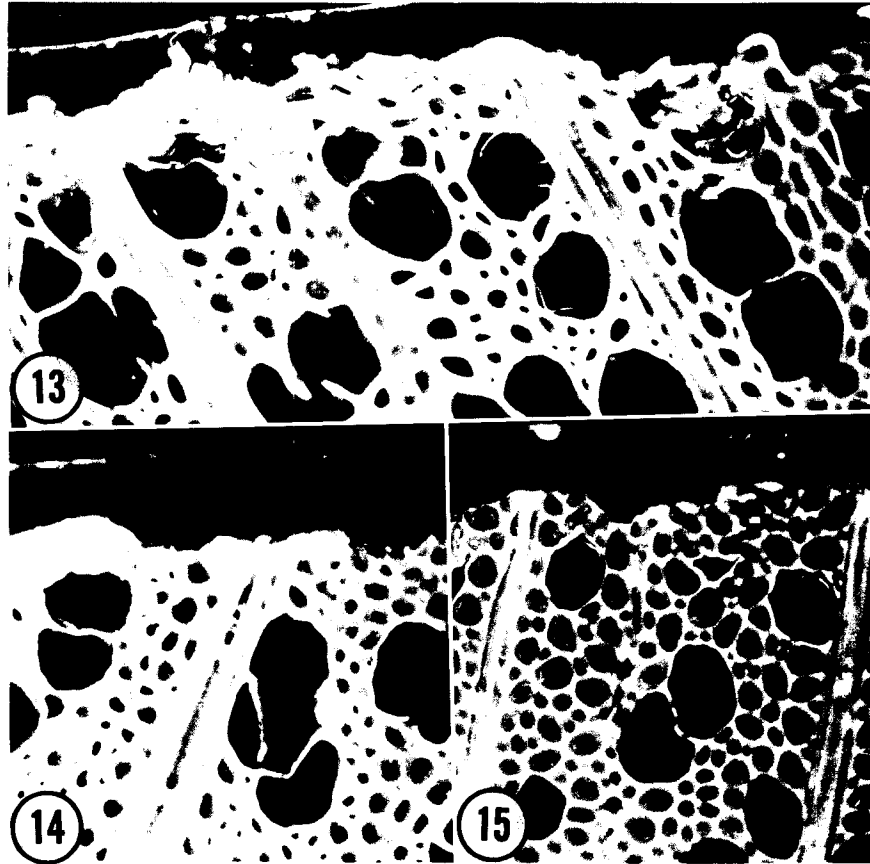
FIG. 13. Yellow-poplar (36 grit, 55 ft/min, 0.020 in.). Some fibers flattened or pressed into vessel lumina.  $\times 162$ .

FIGS. 14, 15. Yellow-poplar. 14.—(80 grit, 55 ft/min, 0.010 in.). 15.—(80 grit, 65 ft/min, 0.003 in.). Both surfaces show minimal damage.  $\times 162$ .

las-fir and hard maple. Fibers are crushed to a depth of five or six cells as in maple, but they are more likely to be pressed into vessel lumina since there are a greater number of vessels than in maple (Fig. 13). As in Douglas-fir latewood, and in maple, there are areas of the yellow-poplar pieces where damage is minimal (Figs. 14 and 15). In contrast to maple, yellow-poplar ray cells do not protrude above the surface after abrasion probably because the rays are narrower and weaker. In yellow-poplar there also seems to be some trend toward lesser damage with finer grit sizes, and as with the other two species examined, the effects of feed speed and depth of cut are negligible.
