SHEARING BEHAVIOR OF STRUCTURAL INSULATED PANEL WALL SHELLED WITH BAMBOO SCRIMBER

Abstract. In this study, shearing behavior of a structural insulated panel (SIP) wall, which consisted of a Styrofoam core board, shell panel of bamboo scrimber, and frame of Spruce–Pine–Fir dimension lumber, was tested under monotonic and cyclic loads. Results showed that the SIP wall failed at similar positions under two loading modes, although more serious destruction occurred under cyclic than monotonic load. There was a linear relationship between load and displacement at the initial loading stage, which indicated that the wall worked under the elastic state. At a later loading stage, bearing capacity and rigidity decreased as a result of wall slip. Shearing strength under monotonic and cyclic loads was 20.0 and 15.8 kN·m⁻¹, respectively, which met the requirement of the standard code for design of timber structures. Energy consumption of the SIP wall covered with bamboo scrimber was 11,556.6 J·m⁻¹.

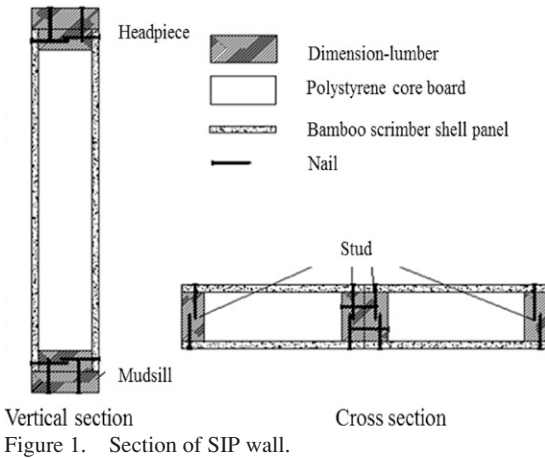
Bamboo scrimber used for SIP shells was made of *Neosinocalamus affinis*. The SIP panel contained two shell panels and one core board. The bamboo scrimber shell panel was $2440 \times 1220 \times 6$ mm (length \times width \times thickness). The polystyrene core board was $2364 \times 1144 \times 89$ mm (length \times width \times thickness). PUR adhesive was used to bond the shell panel and core board according to ASTM (2004). The distance from shell edge to core edge was 38 mm. The groove

formed by the shell panel and core board was filled with dimension lumber (Fig 1).

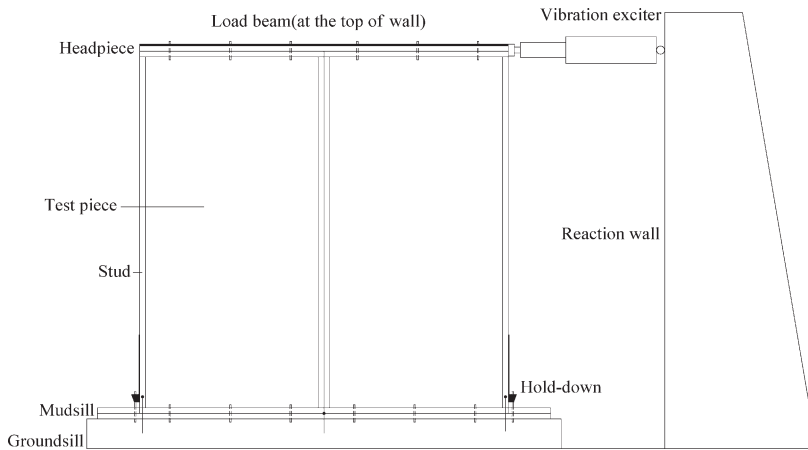
Figure 2. Sketch for SIP wall installation and loading position.

The SIP wall sample consisted of two SIP panels and eight dimension lumbars, which were composed of headpiece, mudsill, and studs. Headpiece and mudsill consisted of two pieces of dimension lumber, respectively. Midstuds between two SIP panels consisted of two pieces of dimension lumber, and the right and left stud consisted of one piece of dimension lumber, respectively. The sizes of dimension lumbars are listed in Table 1. Dimension lumbars and shell panels were connected by nails. The wall and load beam and the wall and groundsill were connected by screw bolts. Hold-downs were fixed between the left and right stud and mudsill (Fig 2). Connectors between the hold-down and left and right stud were tapping screws, and those between the hold-down and mudsill were screw bolts.

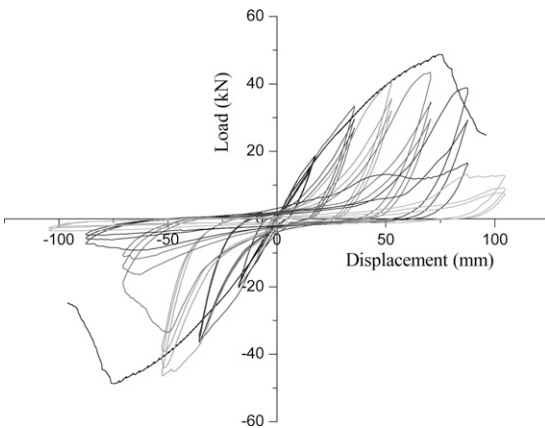
Figure 3. Skeleton curve under cyclic load and displacement-load curve under monotonic load.

A skeleton curve under cyclic load gained according to the first cycle of different target displacements is shown in Fig 3 (the curve with the black box). A displacement-load curve under monotonic load and its symmetrical curve around the base point were also figured.

Failure phenomenon was similar under both monotonic and cyclic loads. There were three stages: elastic, plastic, and failure (as Fig 3 showed). At the initial stage, the load-displacement curve was nearly linear. As load increased, wall displacement and mode slight noise increased. As increasing maximum load occurred, displacement increased rapidly, cracks occurred between the hold-down and wall and the bamboo scrimber

The displacement-load curve of the SIP panel under monotonic and cyclic loads is shown in Fig 3. Skeleton curve (the line with black box in Fig 6) under cyclic load was got according to Fig 3. The black line is the displacement-load curve under monotonic load (in the first quadrant); its symmetrical curve around the base point is given (the black line in the third quadrant). The colored line is the displacement-load curve under cyclic load, and the different colors mean different cycles with different control displacements.

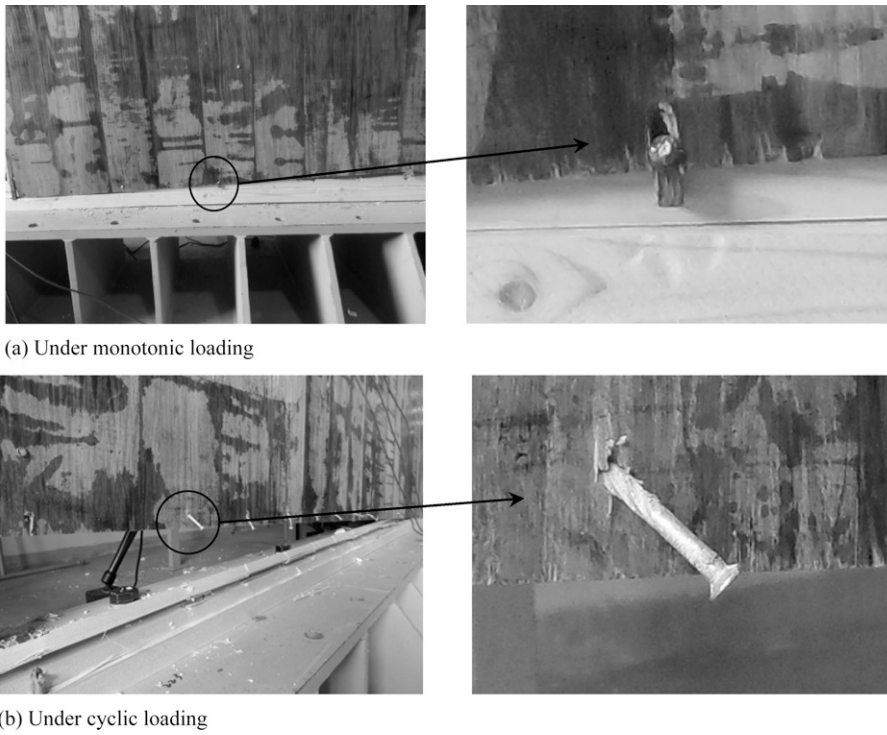
Figure 4. Damage situation at bottom of SIP wall.

Cracks were mainly distributed at the bottom of the SIP wall. Damage at the mudsill is shown in Fig 4. The shell panel where it contacted the mudsill and tacked nails was destroyed under both monotonic and cyclic loads. Under monotonic load, nails connecting the mudsill and bamboo scrimber panel stayed in the mudsill and looked undamaged from the part exposed on the panel surface (Fig 4a). Under cyclic load, nails connecting the mudsill and bamboo scrimber panel were pulled out and bent from the pulling out part. They stayed in the bamboo scrimber panel. The mudsill was destroyed (Fig 4b).

Failures mainly occurred at the bottom of the wall. Under monotonic load, nails stayed in the mudsill and looked undamaged from the part exposed on the panel surface. The shell panel and mudsill were slightly damaged. The hold-down lower vibration exciter bent under the action of loading. Under cyclic load, nails were forced out and bent at the pulling out part and stayed in the bamboo scrimber panel. The mudsill was destroyed. Hold-downs at the left and right were both deformed.

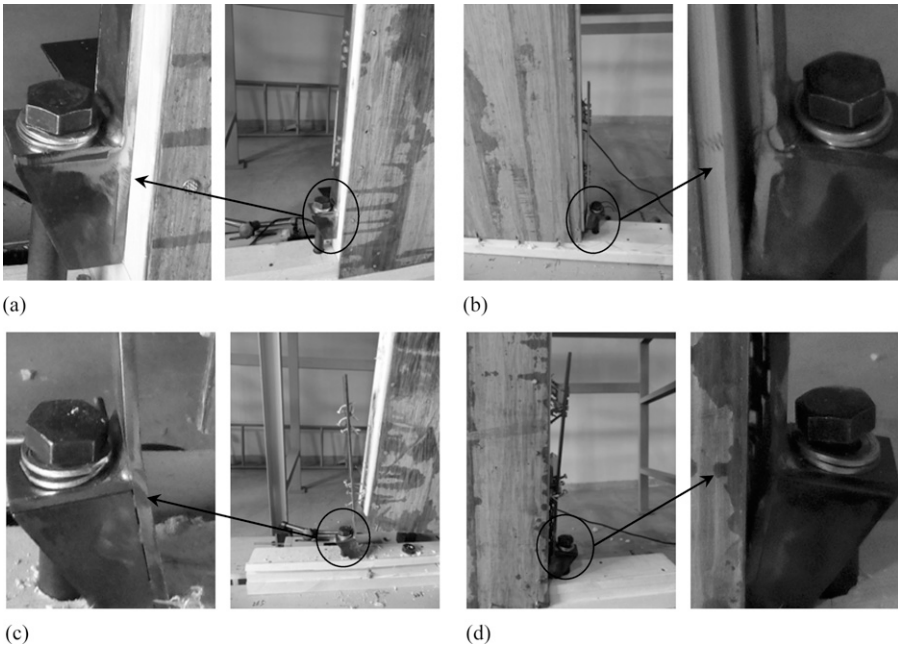
Figure 5. Damage at hold-downs. (a) Diagonal of vibration exciter under monotonic load; (b) lower of vibration exciter under monotonic load; (c) diagonal of vibration exciter under cyclic load; (d) lower of vibration exciter under cyclic load.

Damage of hold-downs at the left (located diagonal to the vibration exciter) and right (located lower than the vibration exciter) side stud was different under monotonic load. The left one did not appear to be damaged (Fig 5a), whereas the right one was pulled out from the side stud and bent (Fig 5b). Under cyclic load, hold-downs at the left and right were both pulled out (Fig 5c,d) and obviously bent.

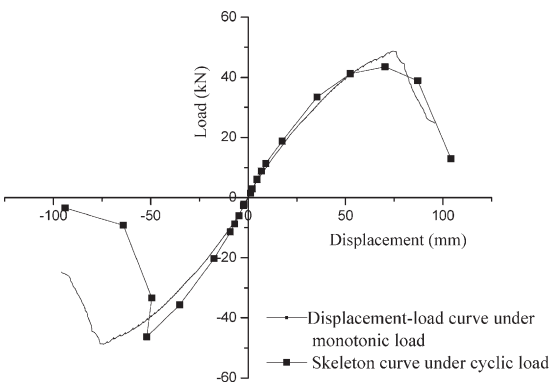
Figure 6. Displacement-load curve under monotonic and cyclic load.

At initial loading, the displacement-load curve was almost linear. The wall worked in an elastic situation. The testing result was similar with a steel plate shear wall under cyclic loading (Guo et al 2011). The area enclosed by a hysteresis loop was small. Rheostriction phenomenon was obvious. During the middle loading, the area enclosed by the hysteresis loop increased. Among the three cycles at one grade controlled by the same target displacement, the latter two had higher contact ratios and lower loads at the same displacement compared with the first one. The phenomenon showed that wall components were damaged with repeated loading, which further lessened wall strength, load capacity, and stiffness. As target displacement increased, the hysteresis loop turned from S shaped to Z shaped at different target-displacement grades and wall slip effect appeared.

Displacement-load curve was almost linear at the initial loading stage both under monotonic and cyclic loads. The area enclosed by a hysteresis loop was small. Rheostriction phenomenon was obvious from the displacement-load curve. Wall members were damaged with repeated loading and experienced further lessened strength, load capacity, and stiffness. At different target-displacement grades, hysteresis loop turned from S shaped to Z shaped as the displacement increased and wall slip effect appeared.
