Gully prevention and rehabilitation: a review

Amaury Frankl^{1,2}, Matthias Vanmaercke³, Jan Nyssen², Jean Poesen⁴

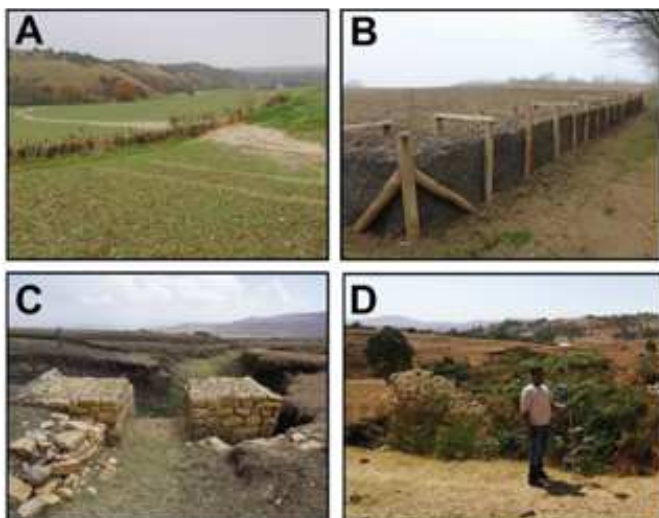
Figure 1: Examples of gully prevention and rehabilitation measures discussed. A: fascine (willow) (N France), B: woodchips barrier (W Belgium), C: in-channel check dams (bypassed) (N Ethiopia), D: revegetation (NW Ethiopia).

Drainage lines are the most dynamic places in the landscape and even minor anthropogenic (road construction) or environmental disturbances (fire) can trigger gully erosion. An increasing number of studies have, therefore, been devoted to understand processes and factors of gully erosion in various human-environmental settings, which has recently resulted in a number of review papers. Concomitantly, the number of studies on gully rehabilitation has also seen a sharp increase in recent years, but a comprehensive review on the effectiveness of gully prevention and rehabilitation methods (Fig. 1) is lacking.
