Capezzuto, F, Ciampa, F, Carotenuto, G, Meo, M, Milella, E & Nicolais, F 2010, 'A smart multifunctional polymer nanocomposites layer for the estimation of low-velocity impact damage in composite structures', *Composite Structures*, vol. 92, no. 8, pp. 1913-1919. <https://doi.org/10.1016/j.compstruct.2010.01.003>

# **A smart multifunctional polymer nanocomposites layer for the estimation of low velocity impact damage in composite structures**

## **Abstract**

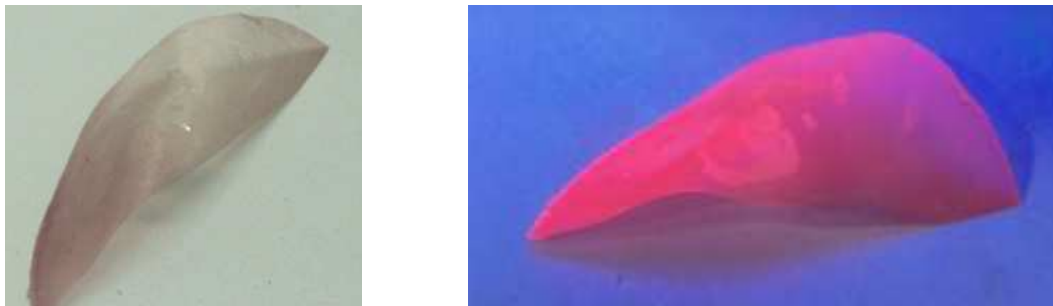
**Figure 1** (a) (b) Fluorescent nanocomposite film observed under visible light (a) and under ultraviolet light at the wavelength of 365 nm (b)

These smart materials are perfectly transparent and colorless and are able to show light at different wavelength by simply changing the excitation frequency (Fig. 1). In addition, nanoscopic semiconductors embedded into optical plastics (PS, PMMA, PC, etc.) may exhibit a combination of electric and magnetic properties not available in any of the individual constituents (Nicolais and Carotenuto, 2004; Kreibig and Vollmer, 1995). This characteristic of “*multi-functionality*” makes this material potentially employable in a wide range of technological applications for SHM, as it could provide quick information on damage location.

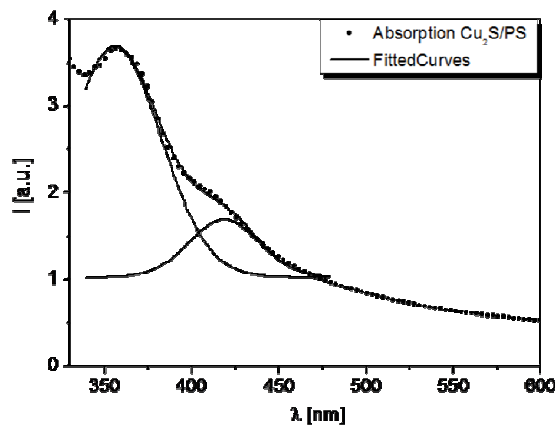
**Figure 5** UV-Vis spectrum of the  $\text{Cu}_2\text{S}$ /polystyrene nanocomposite film

As visible, the spectrum seems to contain two peaks: one strong at a wavelength of 357nm and another broad and of low intensity at 420nm. The last peak caused the nanocomposite film yellow coloration.
