MORPHOMETRIC, GEOMORPHOLOGIC AND FLOOD HAZARD ANALYSIS OF AN ARID MOUNTAIN RIVER BASIN, CENTRAL PRE-ANDES OF ARGENTINA. SOUTHWESTERN SOUTH AMERICA

ABSTRACT: LARA G., PERUCCA L. & ROTHIS M., *Morphometric, geomorphologic and flood hazard analysis of an arid mountain river basin, central pre-Andes of Argentina. southwestern South America.* (IT ISSN 0391-9838, 2018).

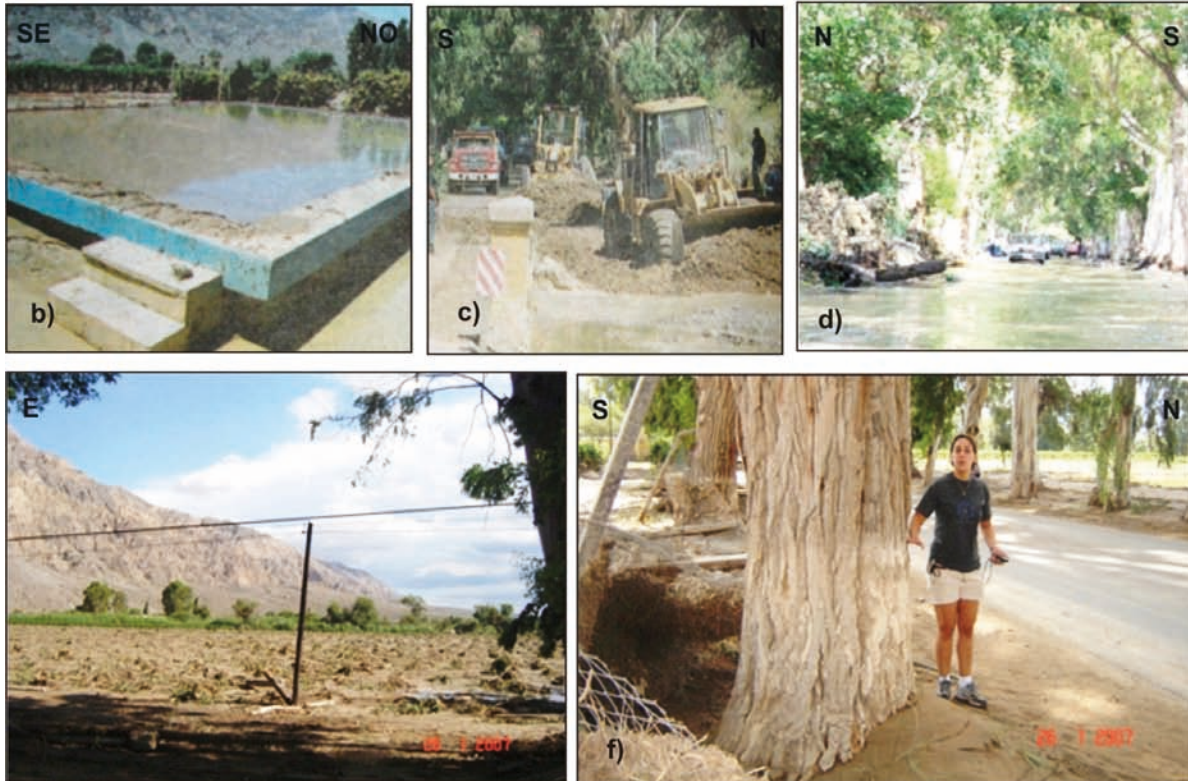
FIG. 2 - a) Google Earth DEM of De La Ciénaga River Basin with the location of photographs showing damages occurred during the flash flood event, b) swimming pool filled by mud, c) Damages in provincial route N° 12, next to Blanco bridge, d) The route N° 12 was completely filled with mud, interrupting traffic for a few hours, e) View to the south, cultures of grapevine destroyed by the flash flood. f) High water mark of the 2007 flood on a tree (Photos obtained on January 26, 2007 by Perucca).

The latest destructive event took place on January 25, 2007 (fig. 2a) when as a result of heavy rainfall (100 mm/h), a sizeable flash flood affected the Zonda valley, damaging the road that connects the farming communities and several farming and buildings (fig. 2b,c,d,e,f). Besides, many people were evacuated and a total of 30 ha were flooded (Source: Hydraulic Department).

Melton's ruggedness number (MRN) suggests high susceptibility to flash flooding, with low amounts of sediment transported. Torrential rains in summer like the 2007 January storm, cause severe damage to the locality of Zonda due to its geomorphologic and infrastructure conditions (figure 2a, b, c, d, e, f).

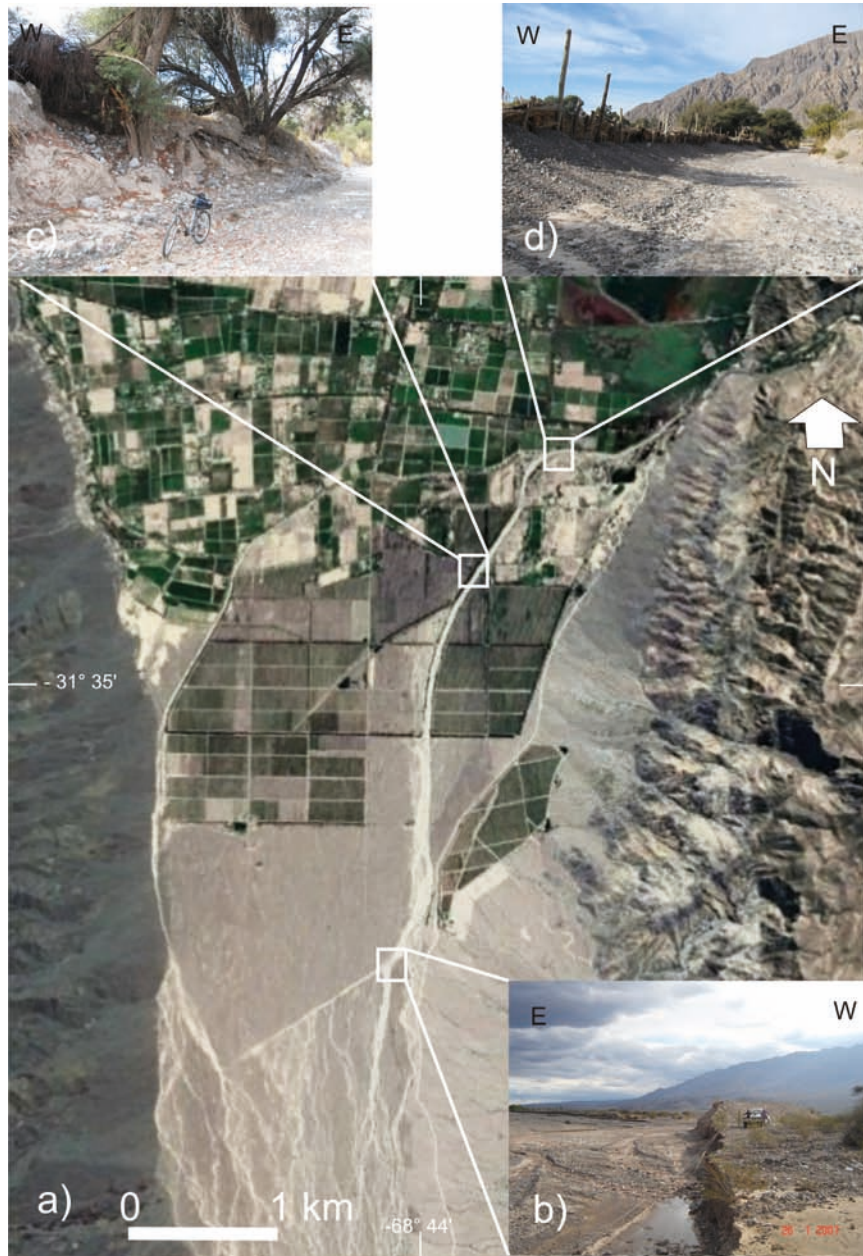
FIG. 8 - a) Google Earth image showing the lower portion of the La Cienaga River basin with b) the retaining dam, c) and d) several precarious defenses location.

Besides, one of the main causes of the destructive impact of flash floods in this mountainous basin area is produced by strong reduction of the main river channel downstream, close to the populated areas. Channel reduction to < 20m is the result of an artificial dam and precarious canalizations of the lower section of the river to prevent flooding of crops located further downstream (fig. 8a-d).

This decrease in the channel section leads to accelerated flow velocities, greater erosive power and increase of flow heights and subsequent flooding along its route (fig. 8a, b).
