International study on the long-term efficiency of stormwater infiltration by permeable pavements

Abstract: Although permeable pavements have been used all over the world in recent years to infiltrate and treat stormwater, only limited research has been undertaken to investigate and compare the long-term performance of these sustainable urban drainage system devices. This paper presents the results of an extensive international review of research on the reduction of infiltration capacity of permeable pavements over time. The results of these studies, coupled with specific knowledge of the key environmental factors on the individual research locations and infiltration testing methods used, enables the maintenance of these SUDS to be strategically planned in order to meet specific European and international infiltration capacity guidelines.

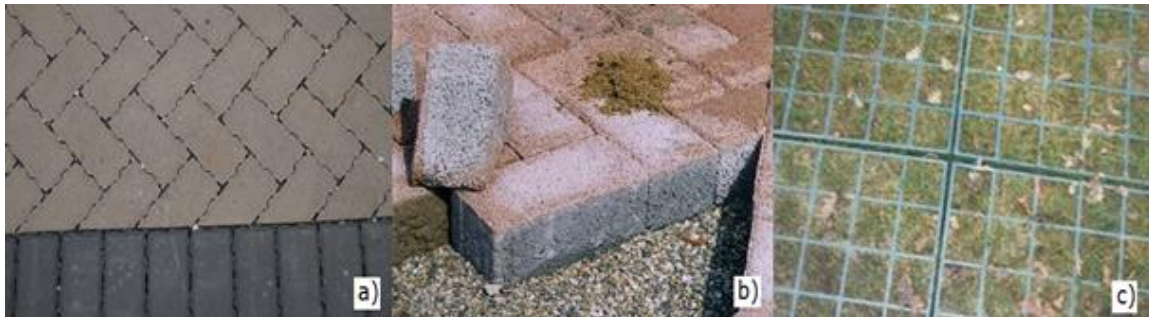
There are several types of permeable pavements typically used in Europe including concrete pavers with wide joints or apertures (Figure 1a), and porous concrete pavers, either with or without wide joints (Figure 1b). These are usually manufactured as blocks and are generally referred to as permeable concrete interlocking pavers (PCIP). Concrete and plastic grid pavers (CGP and PGP) have more open void spaces to promote infiltration. Stormwater is able to infiltrate through the large gaps in these pavers which are usually filled with gravel, or topsoil planted with grass (Figure 1c).

Figure 1 (a) Impermeable Concrete PICP; (b) Porous Concrete PICPs; (c) Grass-filled PICPs.

- **Construction.** While the construction of the test pavements were generally similar to that shown in Figure 1, there were slight differences between the sites. These included the size of the paving joints, different types of bedding aggregates and different pavement laying processes.

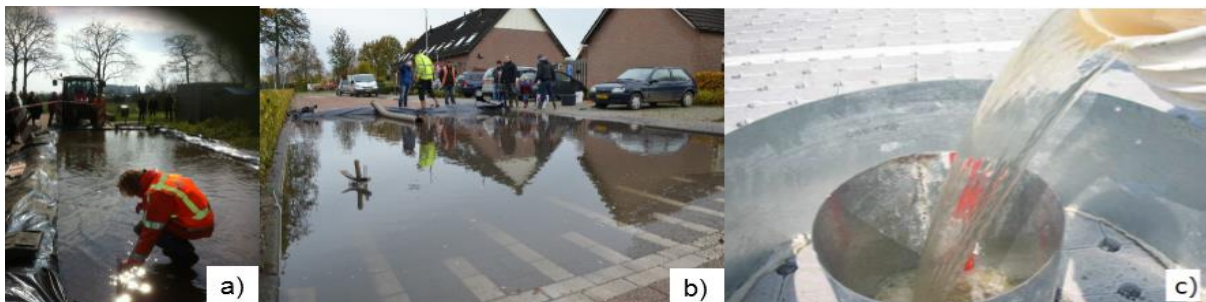
Figure 2. Full scale testing in the Netherlands (a) Impermeable barriers; (b) Plastic wrapped soil core; (c) DRIT testing

For this reason a full-scale test was developed in the Netherlands in order to get higher accuracy results (Figure 2). PICP infiltration rates from a variety of international research studies were collated and analysed in order to evaluate and predict infiltration reduction and clogging performance over time. The analysis results were then compared to international guideline requirements.

A number of previous permeable pavement infiltration studies have been based on results using a modified version of either the single or double-ring infiltrometer test (ASTM D3385-09). In these tests, rings are sealed to the pavement surface and filled with water. The time taken for the water to infiltrate through the permeable surface area is used to estimate an average infiltration rate (usually in mm/h) for the test location. Both the constant head and the falling head methods can be utilized in these testing procedures. Double-ring infiltrometer tests (DRIT) have generally been the preferred method in the past (Figure 2c).

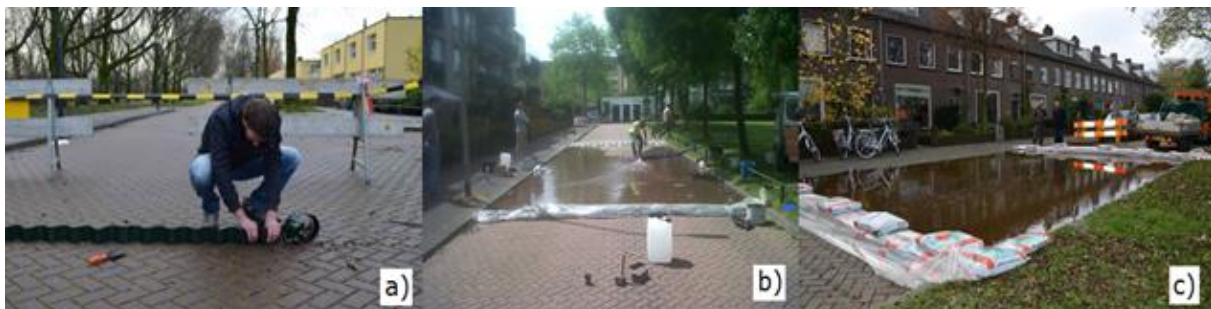
1. Soil core wrapped in plastic sheeting
2. Sand core wrapped in geotextile (figure 3b)
3. Soil- or sand-filled plastic bags (figure 3c)
4. Impermeable barriers inserted into paving gaps; and
5. Use of existing traffic calming devices (speed-humps)

Figure 3 Various Dam Variations Used at the Different Test Locations (a) Impermeable barriers; (b) Plastic wrapped soil core; (c) Soil-filled plastic bags.

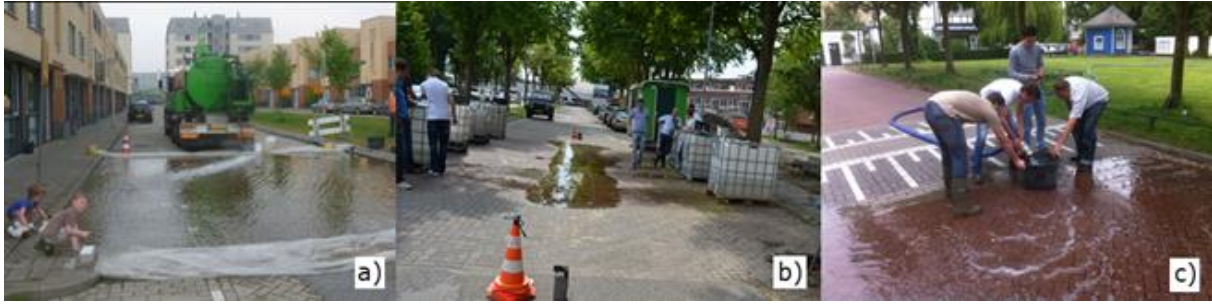
The new infiltration test requires large volumes of water to be discharged onto the test paving section in order to inundate the pavement surface. Depending on the site location, there are a number of different water supply options, including transporting water directly to site with water trucks (Figure 4-a) or water tanks (Figure 4-b), and pumping water directly from nearby canals (Figure 4-c).

Figure 4 (a) Water truck supply; (b) Water tank supply; (c) Pumping from canal.

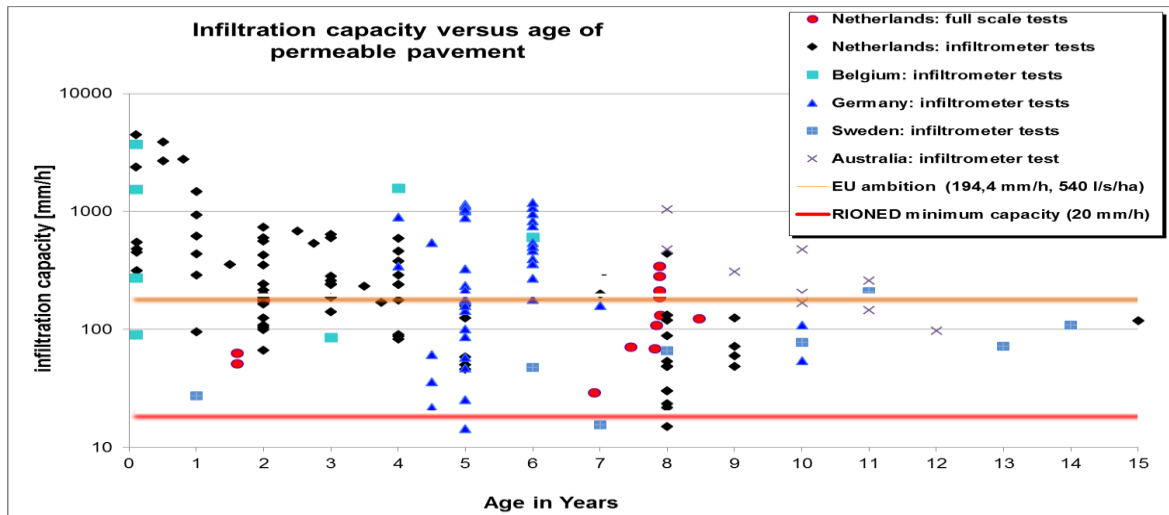
Figure 5 shows the research results of international infiltration testing studies from the Netherlands [Boogaard, 2015], Belgium [Beeldens et al., 2006], Germany [Nolting et al., 2005], Sweden [Al-Rubaei et al., 2013] and Australia [Lucke & Beecham, 2011]. It is clear from Figure 5 that there is a large variation in infiltration rates depending on the location and age of the pavement.

Figure 5 International permeable pavement infiltration capacity research results [Boogaard, 2015]

Figure 5 shows that infiltration rates of newly installed permeable pavement systems are generally very high (in the order of over 1000 mm/h), although this tends to decrease over time. Newly installed permeable pavements in many European countries must demonstrate a minimum infiltration capacity of 194 mm/h and are expected to have this capacity for years without maintenance. The results in Figure 5 demonstrate that the infiltration rates of many of the pavements tested would be sufficient for around five years.

Figure 5 shows a large variation in the calculated infiltration rates between the study pavements. There are a number of potential reasons for the observed variations in surface infiltration rates between the test pavements including:

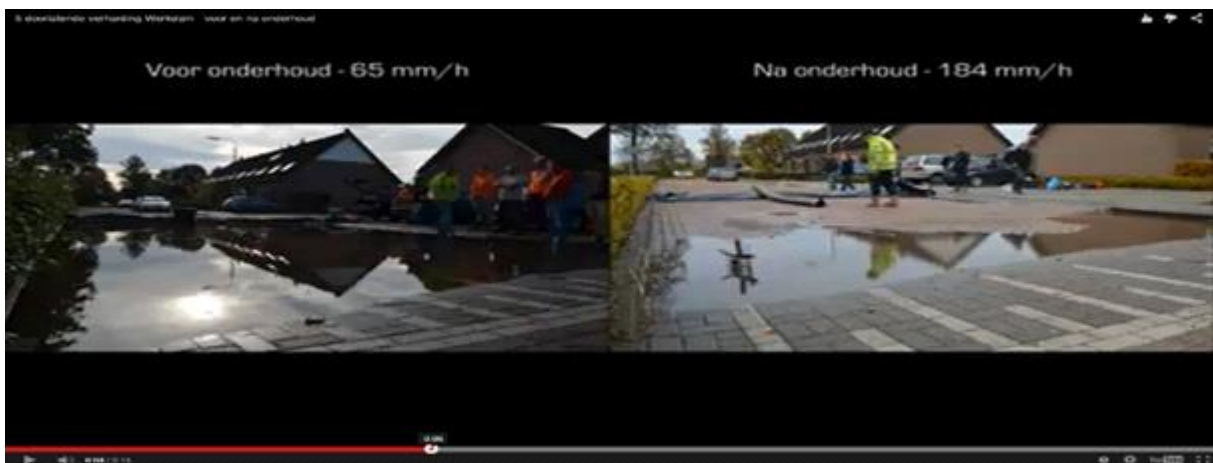
Visualisation of the hydraulic behaviour of SUDS infiltration is recommended for understanding the conducted research and it contributed for a better understanding of SUDS by many actors (e.g. urban planners from water authorities and municipalities). This visualisation (Figure 6), which allowed real-time monitoring of the entire infiltration process, was useful as a logbook for the conducted experiments and also facilitated precise verification of the pressure transducer measurements.

Figure 6 visualisation by time-lapse camera showed the infiltration capacity before and after maintenance of permeable pavement at the same time on video (<http://www.climatescan.nl/page?details=60>). (Tipping, 2015)
