Landslides density map of S. Miguel Island, Azores archipelago

Abstract. The Azores archipelago is located in the Atlantic Ocean and is composed of nine volcanic islands. S. Miguel, the largest one, is formed by three active, E-W trending, trachytic central volcanoes with caldera (Sete Cidades, Fogo and Furnas). Chains of basaltic cinder cones link those major volcanic structures. An inactive trachytic central volcano (Povoação) and an old basaltic volcanic complex (Nordeste) comprise the easternmost part of the island.

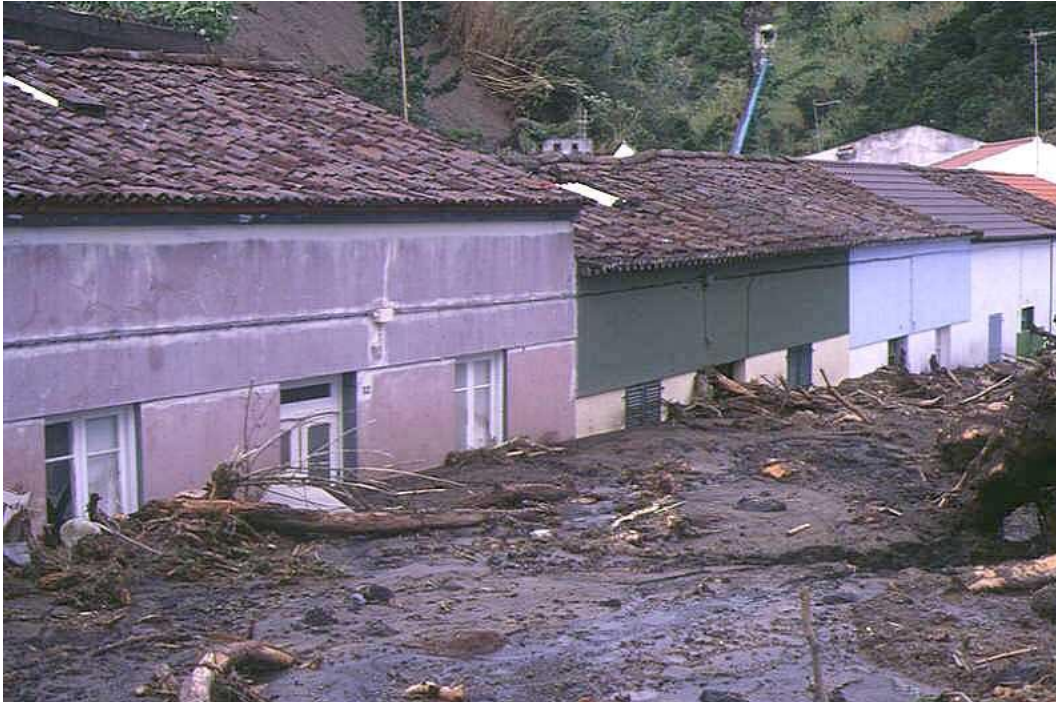
Fig. 6. Houses affected by debris flows during the 1997 Ribeira Quente event.

On 31 October 1997, nearly 1000 landslides occurred on S. Miguel Island, a few of them killing 29 people who were living in the Ribeira Quente village (Fig. 5). Povoação and Nordeste counties were particularly affected during this event (Gaspar et al., 1997; Gaspar and Guest, 1998). Several houses and bridges were partially or totally destroyed, communications, transportation and the energy supply system were disrupted and areas of fertile land became covered by mud (Fig. 6). Ribeira Quente village was isolated for more than 12 h (Fig. 7).

Most of the landslides were essentially very fluid debris flows, consisting of a mixture of water, pumice and ash. Trees with their root systems, tree trunks and branches were included in most deposits. Depending on the source, some debris flows included large blocks of lava.

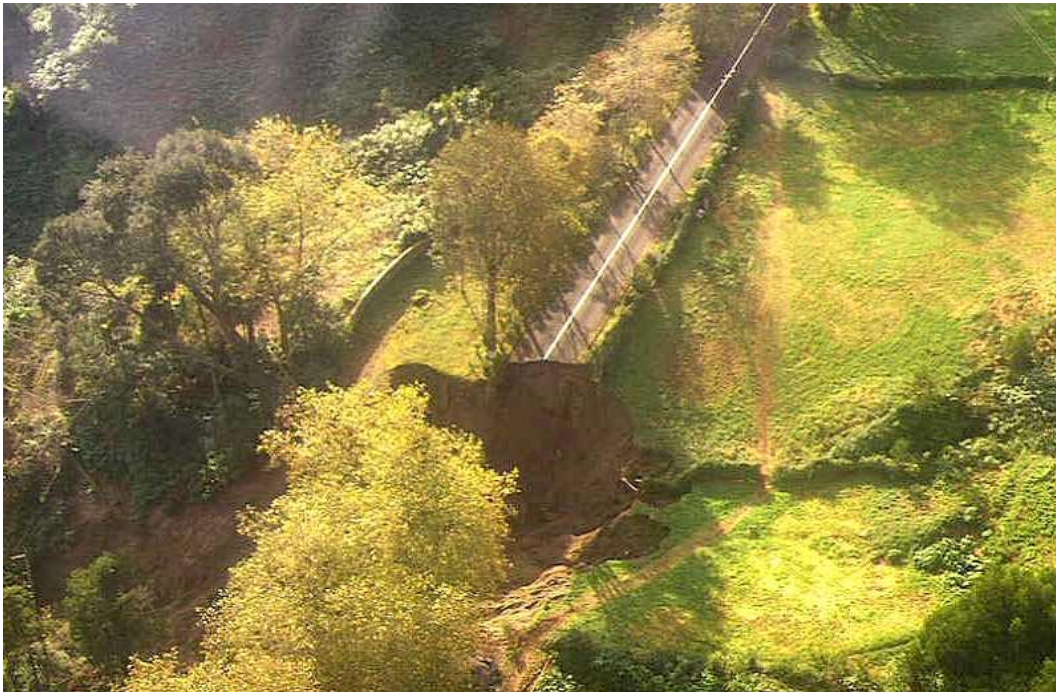
Fig. 7. Road cut by the collapse of the edge of a streamline at Furnas Volcano, during the 1997 Ribeira Quente event.
