# A Heritage Lost: The Church of the Assumption of the Blessed Virgin Mary, Portage la Prairie, Manitoba, 1927–1983

STELLA HRYNIUK

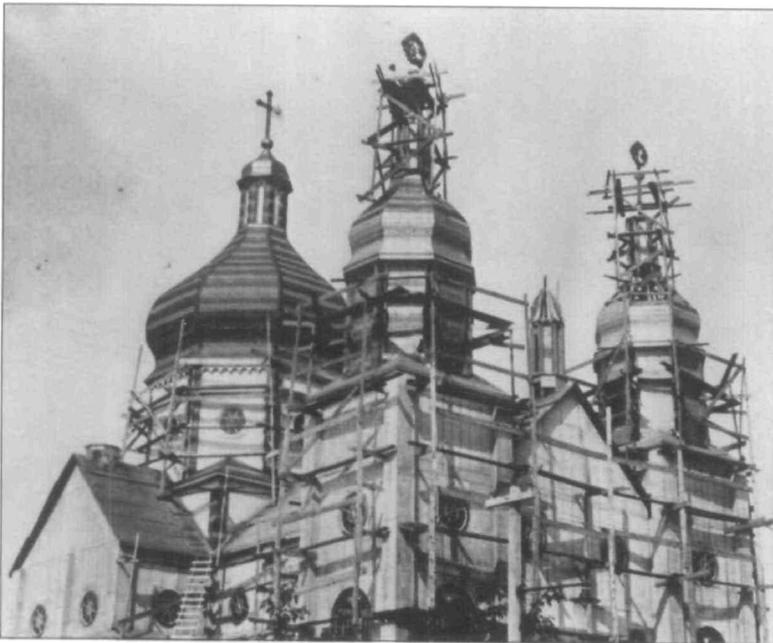
**Fig. 1**  
Putting the finishing touches on the cupolas. Note the floral wreaths on the crosses.  
(Courtesy of Mrs. K. Kuzyk, Winnipeg)

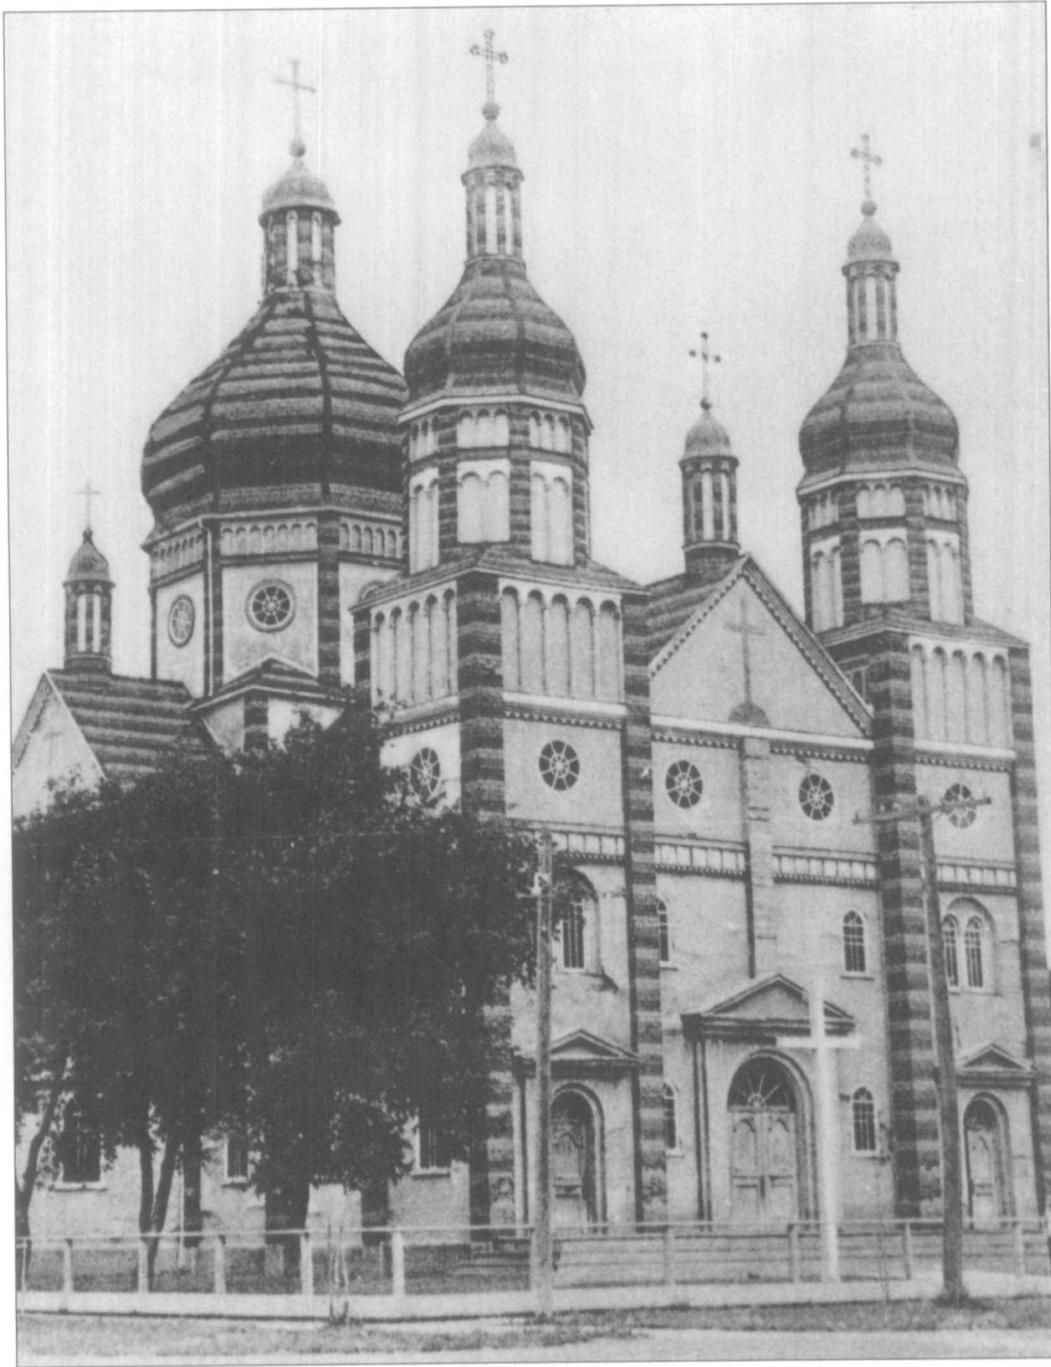
**Fig. 2**  
*The completed Church  
of the Assumption of  
the Blessed Virgin Mary,  
c. 1936. (Courtesy of  
Mrs. K. Kuzyk,  
Winnipeg)*

long and 100 feet wide (52 m by 31 m) and attained a height of 104 feet (32m).<sup>29</sup> For its general architectural form, Ruh had relied on a cruciform plan, from which the walls climbed “uninhibitedly upwards ... to blend with the skyward reach of cupola and cross.”<sup>30</sup> The wooden walls were covered with rough cast stucco,<sup>31</sup> which gave the church a pristine, glowing appearance. The roof was shingled. There was one main dome or cupola, two frontal towers, each with its own cupola,

and four subsidiary, more stylized, cupolas. At the base of each cupola, large and small, were blind arcades. The many windows punctuated the exterior appearance with their striking shape and muted colour. The cupolas were covered in steel and topped by steel filigree Byzantine-style crosses. As was common in the Ukrainian tradition, a freestanding bell tower completed the external configuration. Until the time of its demolition, the church’s “green and silver domed spires dominate[d] the town’s

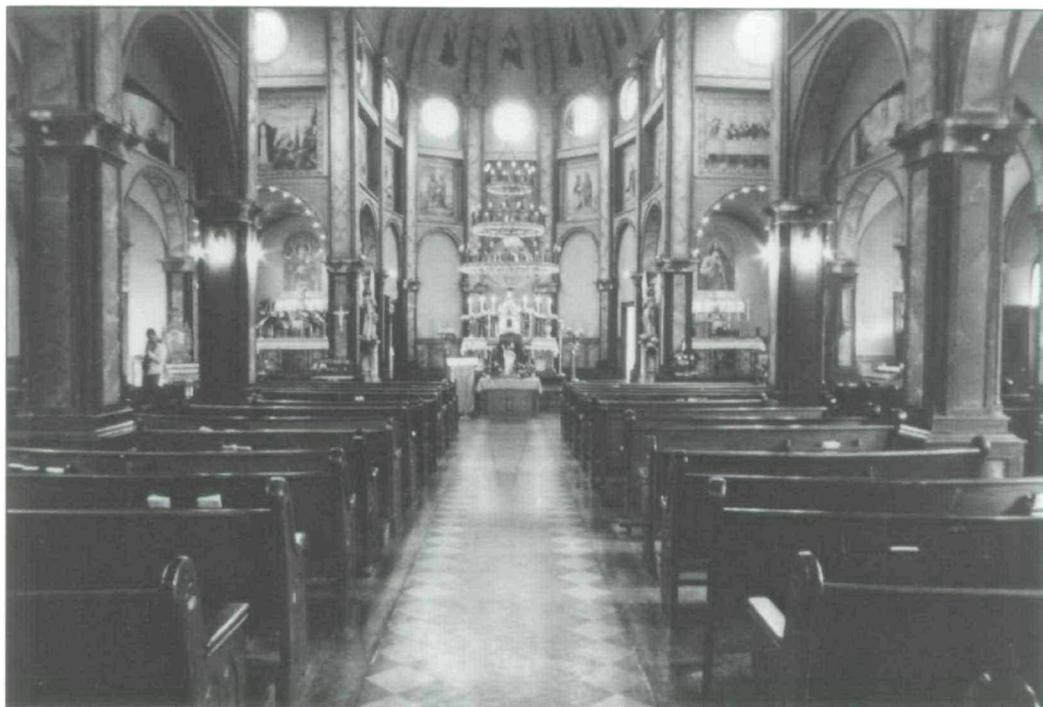
**Fig. 3**

The interior of the church, facing the altar and showing the archways and columns in the nave. (Courtesy of Historic Resources Branch, Manitoba Department of Culture, Heritage and Recreation)

and beyond it, 110 feet (34 m) away, to the altar, and also to features above eye level. Both side wings of the nave were framed in arches reaching to the ceiling. On the walls were a profusion of religious paintings,<sup>36</sup> placed at three levels and encircling the church in an orderly, harmonious pattern. At floor level there were also one-storey-high arcades or aisles along the east and west walls, which opened through colonnaded archways into the nave.<sup>37</sup> Columns supporting the upper walls extended above the arches to the vaulted ceiling and were also used at the crossing and in the sanctuary.<sup>38</sup>

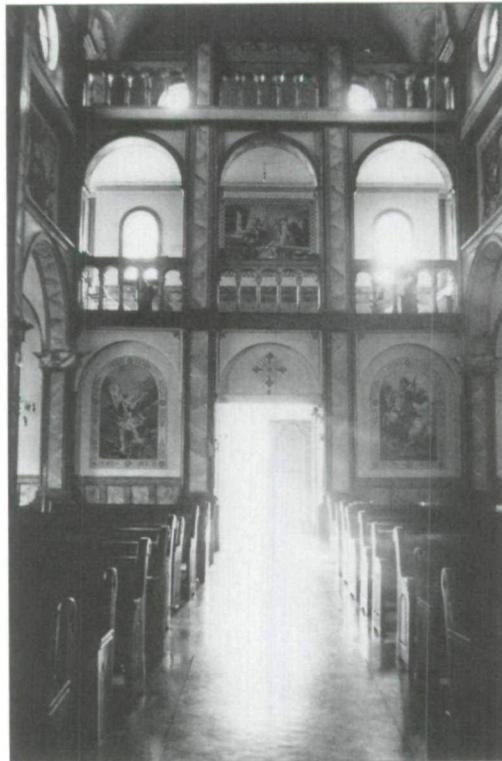
**Fig. 4**  
The interior of the church, showing the main entrance, the two choir lofts and religious paintings at two levels. (Courtesy of Historic Resources Branch, Manitoba Department of Culture, Heritage and Recreation)

Upon entering the church, one stepped into the *babynetz*, the porch, which was largely unadorned, with doors leading into the nave and steps going up to the two choir lofts, one above the other. Central double doors led into the main body of the church. The first impression given by the tall, barrel-vaulted interior was one of grandeur, balance and harmony, an effect created by the combination of light, colour, height, space and ornamentation. Although the fullness of the crowning feature of the church—the central dome over the crossing of nave and transepts—was not immediately visible, the viewers’s attention was immediately drawn to this intersection,
