# A New Double Glass-Steel Roof for an Auditorium in Cuneo

A new glass-steel roof for an auditorium of the “ex Sala Contrattazioni” in Cuneo (I) was built in 2009, with a design resulted winner of an architectural concourse. The construction, despite the small dimension, is the result of a design process that involved many interdisciplinary professionals, from architectural conception to the construction phase. The main structure has a non-conventional behavior and the steel girders support the curved glass panes with point devices. This article offers an overview of the design criteria, news on technological solutions, and unusual construction methods applied to this particular application.

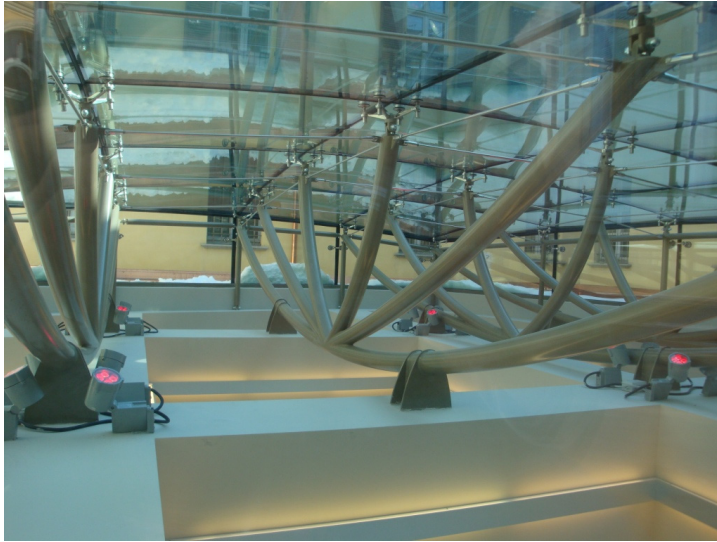
Figure 3: Internal view.

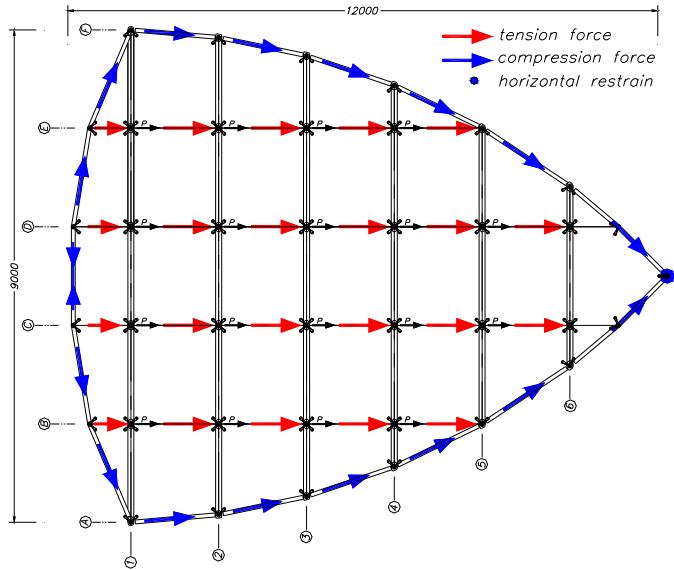
Figure 5: Horizontal load path.

The horizontal loads are induced by structural vertical imperfection and the tendency of beams to buckle out of plane, these actions are evaluated by a non-linear static analysis with a finite element model. The forces acting on the plane of the roof are transmitted by a tension rod to the outside tubular element, and then the compression force are partially discharged to foundation by torsion stiffness of main tubular elements and partially by the horizontal restraint at the lower corner (Figure 5).

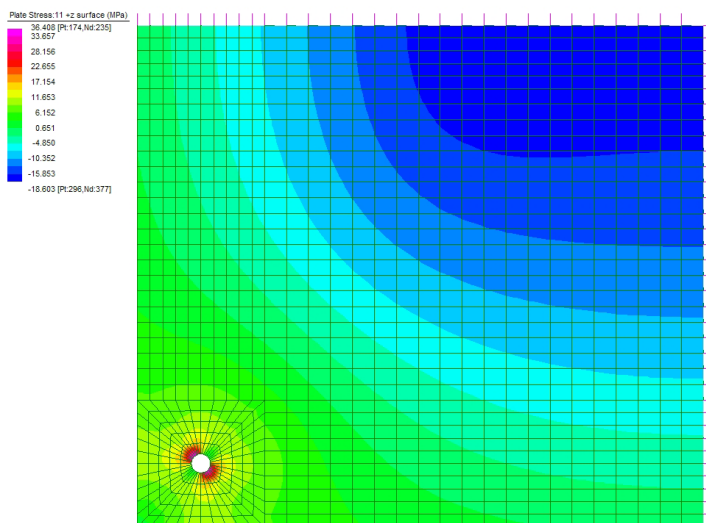
Figure 8: Principal max stress on glass pane (upper side) -  $\sigma_{\max}=36$  MPa  $< f_d=50$  MPa.

The glass panes were analyzed with a separate model conforming to the French Code 'CSTB 3574 [6]'. In this case, we have a double glaze with thickness  $h_1=10+10$  mm for the lower unit and  $h_2=12$  mm for the upper unit. The partition of external uniform load due to snow and self weight is determined according to the stiffness of lower and upper units. Additionally, the internal load, due to the isochore pressure generated by altitude difference and difference of temperature/air pressure is applied on panes. The external loads act on to the panes supported by point devices and internal loads act on panes restrained by spacer. Figure 8 and 9 shows the principal max. stress acting on surfaces, these are lower than the ultimate stress of tempered glass. The strength of glass,  $f_d$  was evaluated according to CSTB 3574 [6].

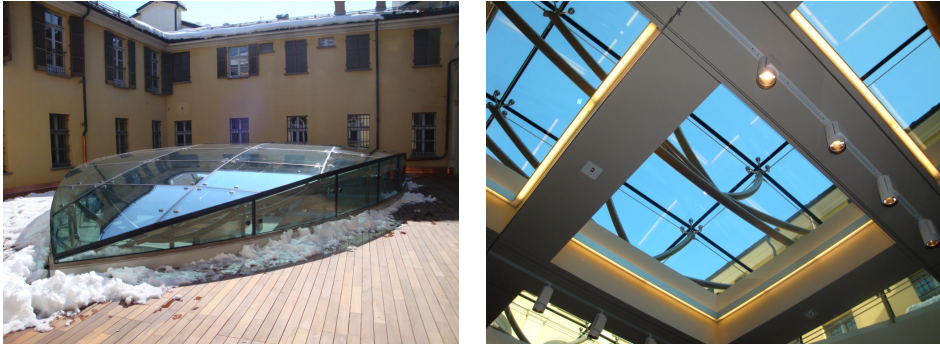
Figure 10: The cover.
