# Difficult dual stage transcutaneous lead extraction complicated by fracture of both leads

## Abstract

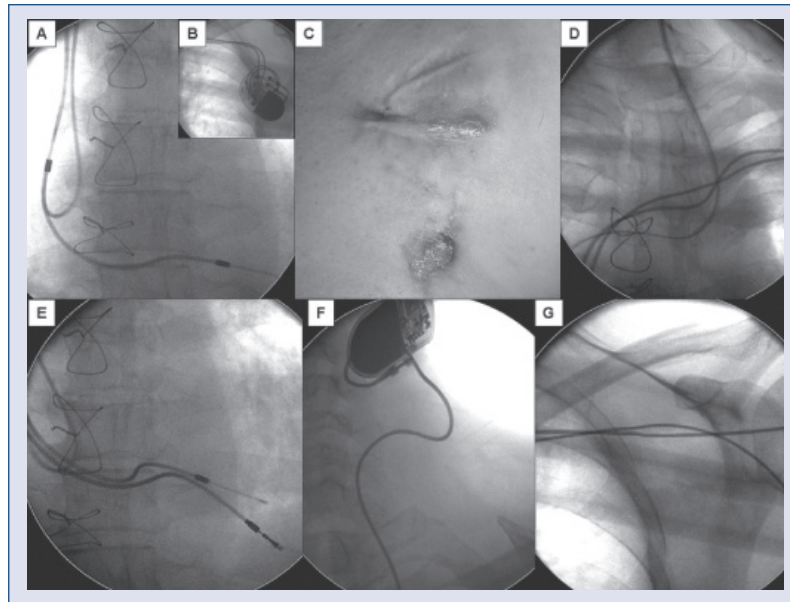
**Figure 1.** DDD pacing system (A, B) and chronic severe local infection (C). Pacemaker dependence. The screw-in lead for prolonged temporary pacing is introduced (D, E, F). Pacemaker removed, proximal endings of lead liberated (G).

followed by treatment with ciprofloxacin. Because of two old permanently implanted leads, both 11 years of age, co-existing pacemaker-dependence and a history of two episodes of infective endocarditis, he was referred to the Polish Reference Centre for extraction of the infected leads with pacemaker (Figs. 1A, B).

He did not have fever on admission, but two weeks of fever had been the reason for his admission to his regional hospital. After one week of treatment with vancomycin, his ESR was 42 mm/h, WBC 9.700, CRP 4.45 mg/L and procalcitonin 0.06 ng/mL and blood culture — negative (but on long-term antibiotic therapy). Echocardiography (TTE) showed: normal heart diameters, left ventricular ejection fraction 55%, normal function of biological aortic valve, slightly enlarged ascending aorta, no vegetations reported. There were signs of chronic pocket infection (Fig. 1B).

This began with a prolonged temporary screw-in implantation, intentionally via the internal jugular vein. It was very difficult to pass with guidewires into the superior cava vein (SCV) but finally it proved possible (Figs. 1D, E) and the new lead was connected with a VVI unit (Fig. 1F). The pacemaker was extracted, the pocket cleaned, and leads prepared for extraction with polypropylene Byrd dilators intentionally (Fig. 1G).

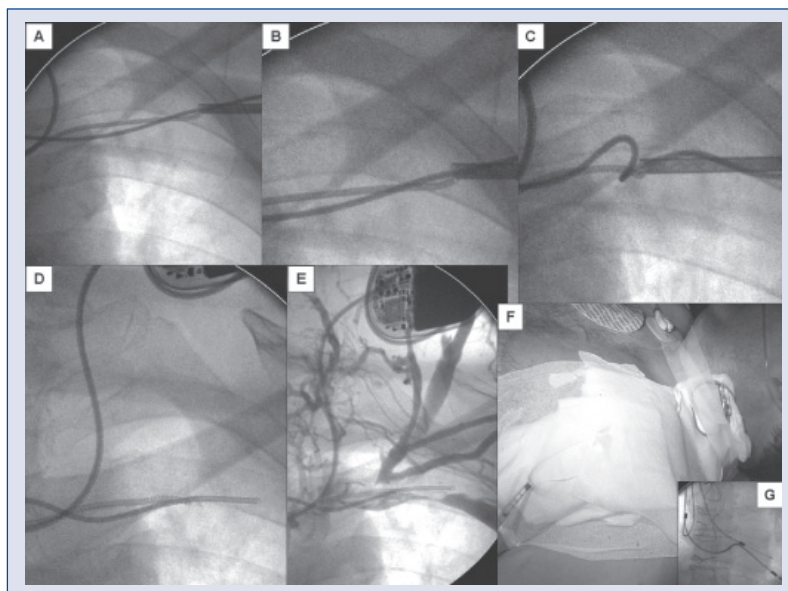
**Figure 2.** Both leads inserted very closely to sternum strongly fixed with connecting tissue scar, not sleiding. Polypropylene sheaths ineffective and metal sheaths had to be used (A, B, C). Unexpectedly, both of the leads are snapped (D, E). Impossible to use a venous approach to grasp their proximal ends (E). Patient prepared for adjourned second part of procedure (F, G).

the strong impression that both had been implanted via a single venous approach (two guidewires through a single venous puncture) which had been made extremely close to the sternum. Finally, a metal sheath (Cook) had to be used (Figs. 2A–C). Disastrously, both leads were accidentally snapped in the subclavian region (Figs. 2D, E). Venography confirmed that it was impossible to grasp their proximal ends to recapture them for a venous approach (Fig. 2E). The pacemaker pocket was closed and suction drainage was applied (Figs. 2F, G). It was decided to postpone the second part of the planned procedure until the next stage.

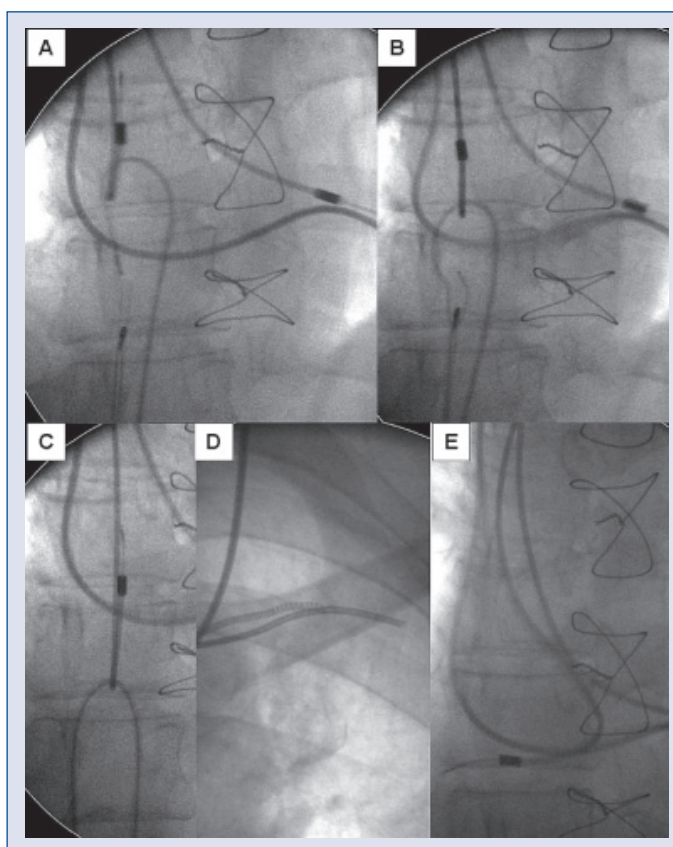
**Figure 3.** Extraction of the atrial lead — the first stage. A. A pig-tail catheter with standard guidewire is introduced to the right atrium; B. The arms of the loop are shifted over the atrial lead and the distal part of the guidewire is grabbed by a Dotter basket catheter; C. Essential element is to make the loop slide over the lead. Steady withdrawal of both extracted lead ends; D, E. Manual traction liberates unexpectedly the tip of the atrial lead, while the proximal end remains in the subclavian vein.

The femoral vein approach was used. A pig-tail catheter with standard guidewire and a basket Dotter catheter (Cook) from separate venous punctures of the same femoral vein were introduced to the right atrium (Fig. 3A). The atrial lead was planned to be extracted first, and it was looped with the guidewire/pig-tail catheter and Dotter basket catheter with retentive ending of guidewire (Fig. 3B). Shifting the pig-tail catheter over the angiographic guidewire to make the loop slide was very important. This permitted steady withdrawal of both extracted lead endings (Fig. 3C). Traction applied to both endings of the loop liberated unexpectedly the ingrown tip of the atrial lead, while the proximal end remained in the subclavian vein (Figs. 3D, E).

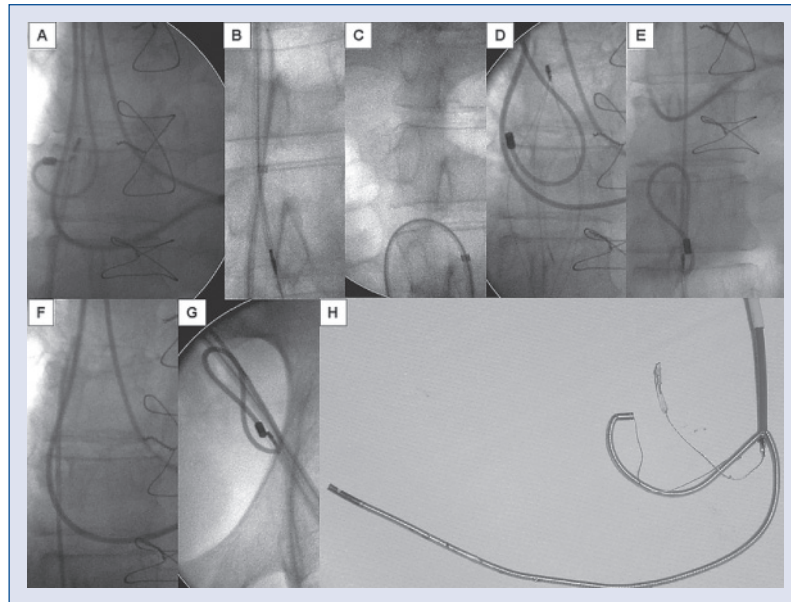
**Figure 4.** Extraction of the atrial lead — the second stage. Using basket catheter — the liberated atrial lead is grasped (A) but pulling upon the tip causes the lead to disintegrate with stretching of the internal coil (B, C). The basket catheter is used again to grasp the distal part of the atrial lead containing the ring electrode (C). This time, the grip is very steady (E) and allows removal of the proximal end from the subclavian vein (F, G). A special sheath has to be used to pass the lead via the femoral venous entry (H).

The liberated atrial lead was captured the using the previously inserted basket Dotter catheter (Fig. 4A). But pulling on the tip caused lead frag-

mentation and stretching of the internal coil (Figs. 4B, C). The basket Dotter catheter was used then to grasp the distal part of the atrial lead with its ring electrode (Fig. 4C). This time, the gripping was very steady (Fig. 4E) and made possible the removal of the proximal end from the strong connecting tissue block in the subclavian vein (Figs. 4F, G). A special larger short external sheath had to be used for passage via the femoral venous entry (Fig. 4H). The same femoral venous approaches were used for the next one — ventricular lead extraction.

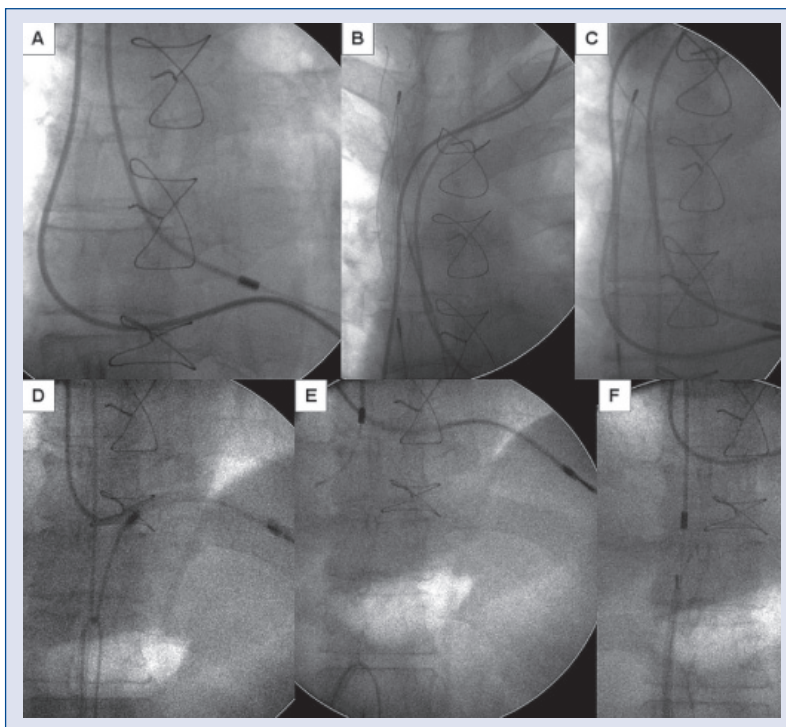
**Figure 5.** Extraction of the ventricular lead — the first stage. The multipurpose catheter is introduced to the superior cava vein with a standard guidewire (A, B) and its ending is grasped by the basket catheter (C). The loop over the ventricular lead is closed, which enables withdrawal of both extracted lead endings (D). The traction for the loop liberates the tip of the ventricular lead (E) and this tip is drawn down with the basket catheter (F).

Setting a similar loop over the ventricular lead was more difficult because of its more vertical route and the higher risk of accidental dislodgement of the temporary pacing lead. A multipurpose catheter was introduced to the SCV using the femoral vein approach with a standard guidewire (Figs. 5A, B) and the end of the guidewire was grasped with the Dotter basket catheter (Fig. 5C).

They formed the loop shifted over non-functional ventricular lead which enabled equable drawing for both extracted lead endings (Fig. 5D). Manual loop traction liberated the ingrown tip of the ventricular lead in a similar way to the atrial lead. The proximal end remained in the subclavian vein (Fig. 5E), and this tip was drawn down with the basket catheter (Fig. 5F).

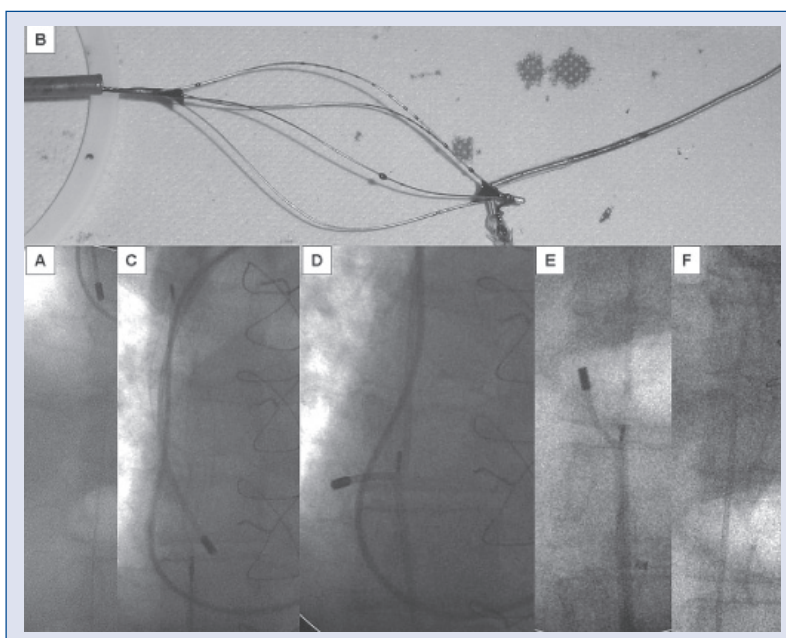
**Figure 6.** Extraction of the ventricular lead — the second stage. A. Lead fragmentation; B. Internal conductor with silicone tube and tip is removed. Basket catheter is used once again to grab the remainder of the ventricular lead (C, D) and a steady grip allows the removal of the proximal end of the lead from the subclavian vein (E, F).

Pulling upon the ventricular lead tip provoked the lead to fragment (Fig. 6A), and the whole inter-

nal conductor with its silicone tube and tip were removed from the patient's body (Fig. 6B). The basket Dotter catheter was used again to grab the remainder of the ventricular lead with its ring electrode (Figs. 6C, D). Very steady grip allowed the removal of the proximal end of the extracted lead from the scar tissue in the subclavian vein (Figs. 6E, F).

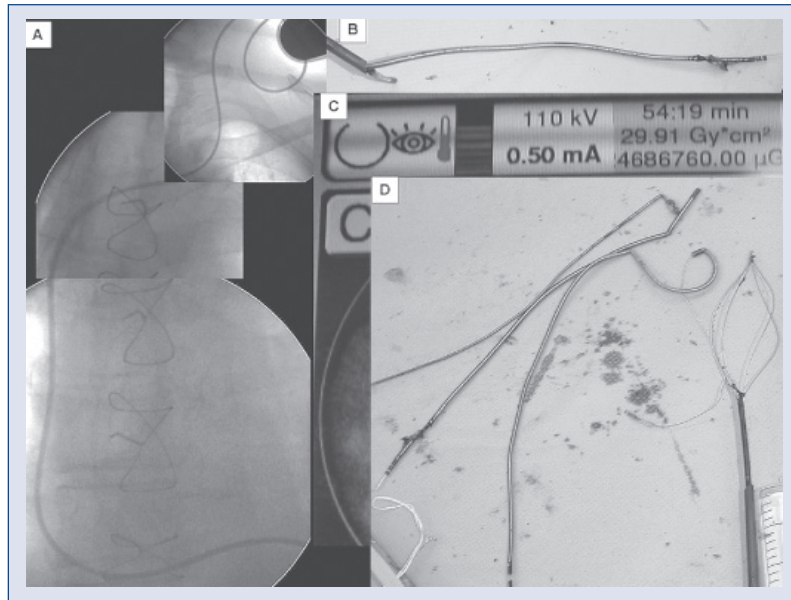
**Figure 7.** Landscape after the battle. **A.** Finally, both leads are extracted and only the lead for temporary pacing remains; **B, D.** All the extracted leads with all tools are removed; **C.** Slight overheating of X-ray machine during complicated procedure is visible.

Finally, no unnecessary lead was left behind, the functional lead for temporary pacing remained (Fig. 7A), and the extracted leads were removed via the femoral venous entry (Fig. 7B). The lengthy duration of the procedure contributed to the overheating of the X-ray machine, which explains the low quality of the X-ray images from the final part of the procedure (Fig. 7C). The Dotter basket catheter proved to be an essential tool for this very difficult lead extraction.
