An agenda for the Management of contemporary Sustainable houses

CONTEMPORARY URBAN AFFAIRS (2017) 1(2), 33-37.

1.1.4 Case Study: The Community Building

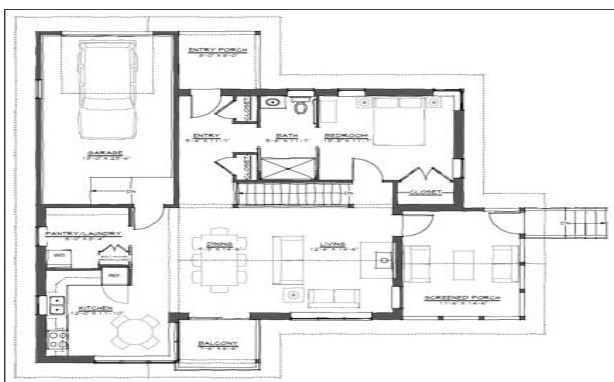
Figure 2. The Community Building, Upper Floor.

First (upper) floor: In the floor plan above, note that the north (top) wall has fewer windows than the south (bottom) wall, which overlooks Stone Mountain and the valley. Note also the differences in wall thickness: the thicker walls are a foot of blown-in, dense-packed cellulose, with an R-value of 45. Ceilings throughout are R-55. Note the ramp from the garage into the party and kitchen, the first floor of each house is designed using ADA (Americans with Disabilities

Act) standards and approved by a consultant from Independent Living Resources. The entrance is ramped; doorways are wide enough for wheelchairs, and there are no thresholds. The first-floor bathroom is handicapped accessible. Each house has one garage space, a mudroom, a screened porch, and storage space.

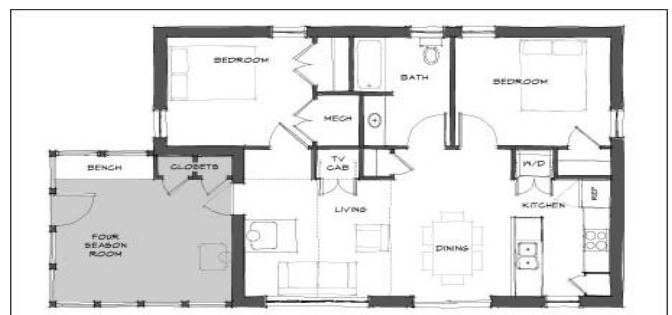
Figure 4. Mini House Floor Plan.

The Mini House echoes the design and planning of the Essential House on a smaller scale. A garage is optional.
