Identifying Osseous Cut Mark Morphology for Common Serrated Knives

Jenny Rebecca Martin
University of Tennessee, Knoxville

Martin, Jenny Rebecca, "Identifying Osseous Cut Mark Morphology for Common Serrated Knives. "
Master's Thesis, University of Tennessee, 1999.
https://trace.tennessee.edu/utk_gradthes/4193

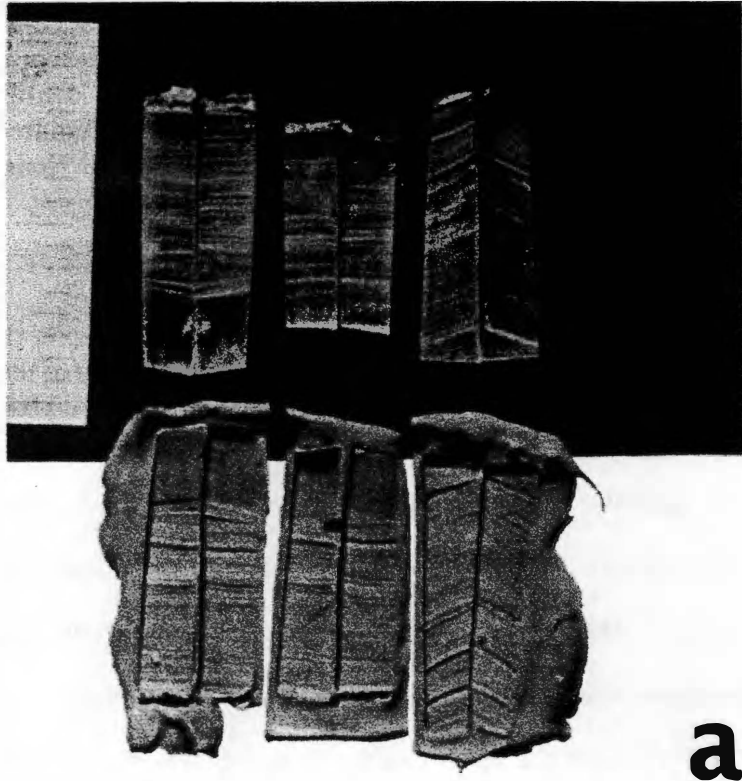
FIGURE 1.3. Striae in casts and cartilage. a, Striae created by suspected weapon in cellulose acetate butyrate and cast with dental impression material (1 inch = 25.4mm); b, comparison microscopic analysis of striae observed in blade casts and those apparent on costal cartilage of victim. Modified from Rao VJ, Hart R. Tool mark determination in cartilage of stabbing victim. *Journal of Forensic Sciences* 1983;28:798, 799.

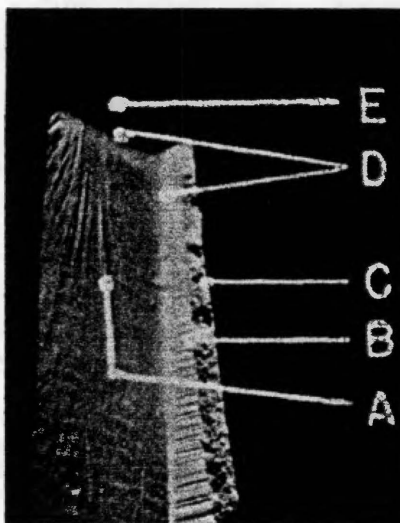
FIGURE 1.4. Class and individual characteristics of a common mass-produced screwdriver as described by Burd and Gilmore (Burd DQ and Gilmore AE. Individual and class characteristics of tools. *Journal of Forensic Sciences* 1968;13:391). Class characteristics include: a, die marks; b, edge cuts. Individual characteristics include: c, broken edge; d, wear marks; e, folded metal.

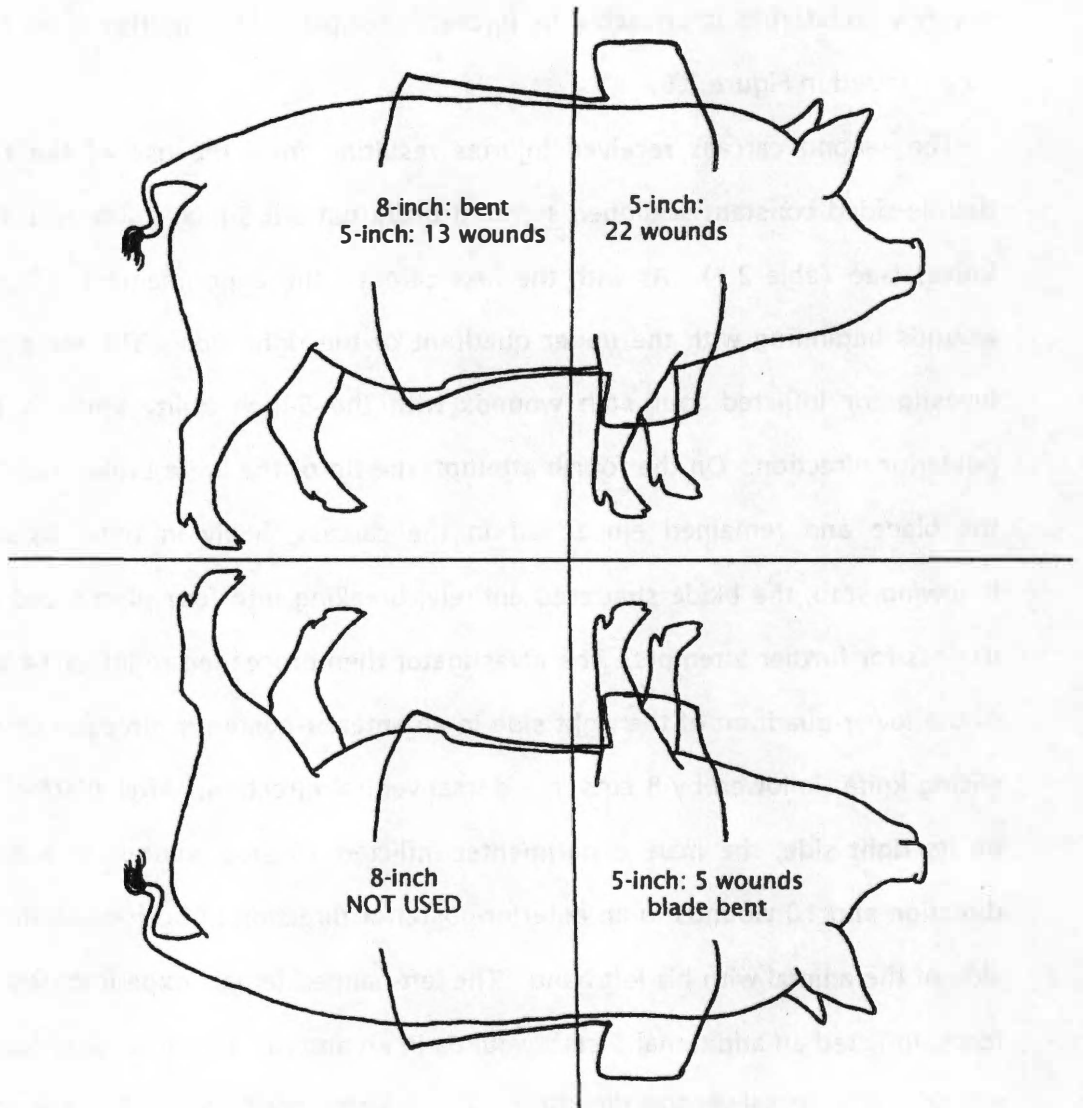
FIGURE 2.6. Visual summary of stab injuries inflicted on Pig 1. A total of 40 wounds were perpetrated by the experimenters on this individual.

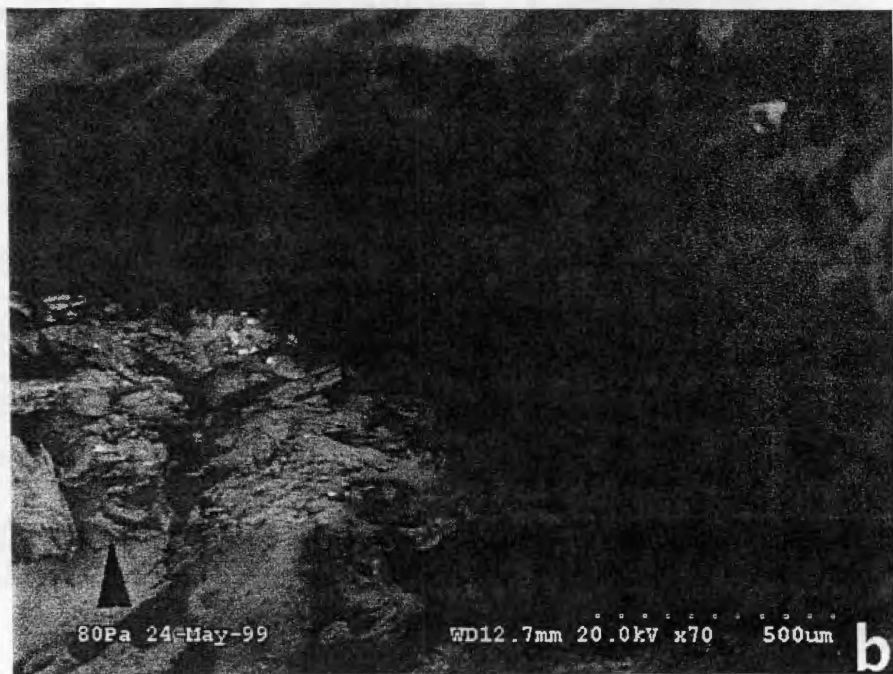
FIGURE 3.32. Scanning electron micrographs of two separate injuries showing chipping and splintering resulting from injury with the Farberware® knives, pointed up with black arrows (Fig 1). a, the lateral aspect of this deep stab wound to the fifth right rib demonstrates some surface chipping along the vertebral edge of the wound (anterior edge toward top; magnification = x80); b, chipping and splintering seen along the bony flap comprising the vertebral edge of this stab wound to the posterior edge of the ninth left rib (facing posteromedial surface, sternal end toward top; magnification = x70).

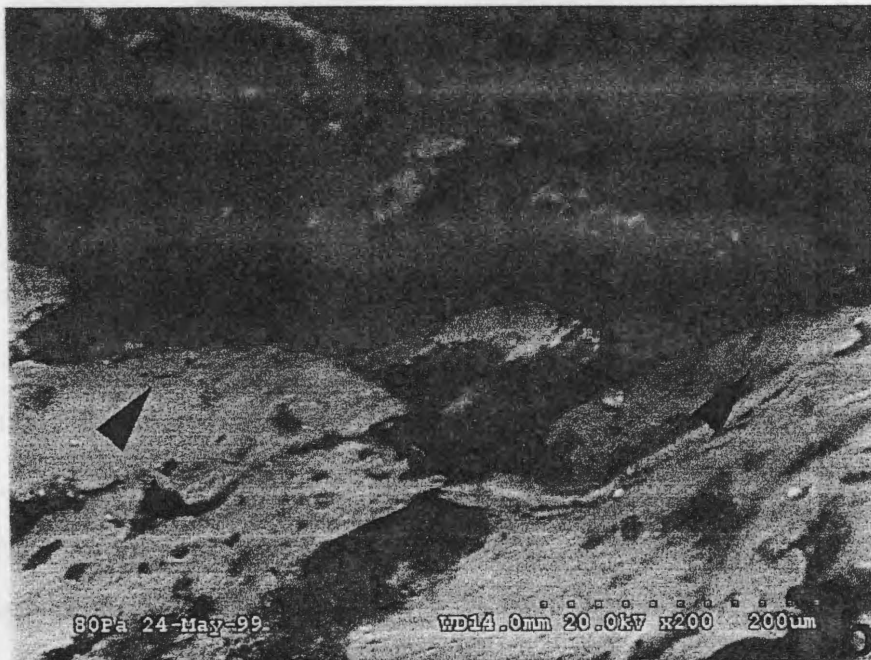
FIGURE 3.35. Scanning electron micrographs of the walls of two stab wounds to ribs in Fig 1, with wall edges pointed up with black arrows. a, further along the stab injury demonstrated in 3.38a, showing the progression of the undulating, uneven wall structure visible (anterior edge toward top; magnification = x70); b, the vertebral edge of the wall of the ninth left rib demonstrates a slightly uneven, undulating appearance (facing posteromedial surface, sternal end toward top; magnification = x200).

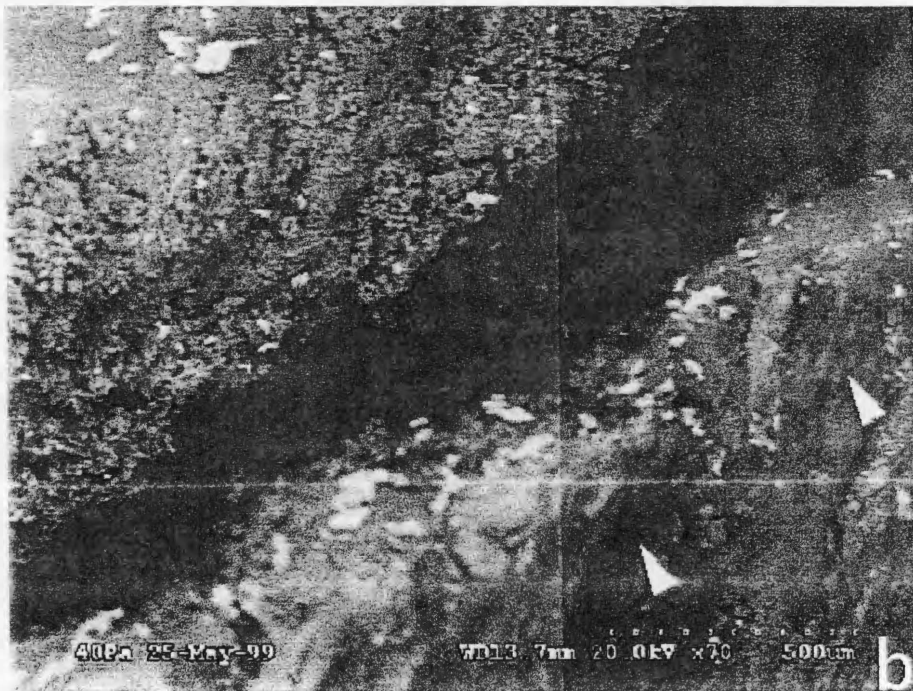
FIGURE 3.39. Scanning electron micrographs showing lipping along the edges of a wound to the eighth right rib of Pig 2 (view of medial side, sternal end toward top). a, this image of the entry point of the stab into the rib displays a slight amount of bone splintering in conjunction with lip formation, both pointed up with black arrows (magnification = x50); b, as the wound progresses into the rib, chipping is no longer visible but lipping is still apparent, pointed up with black arrows (magnification = x70).

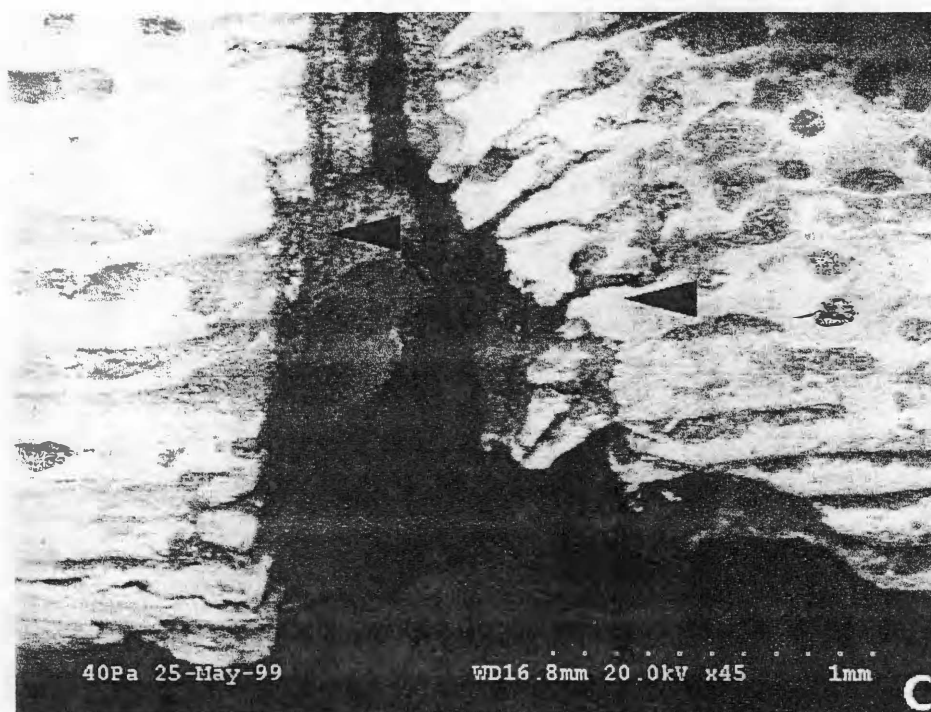
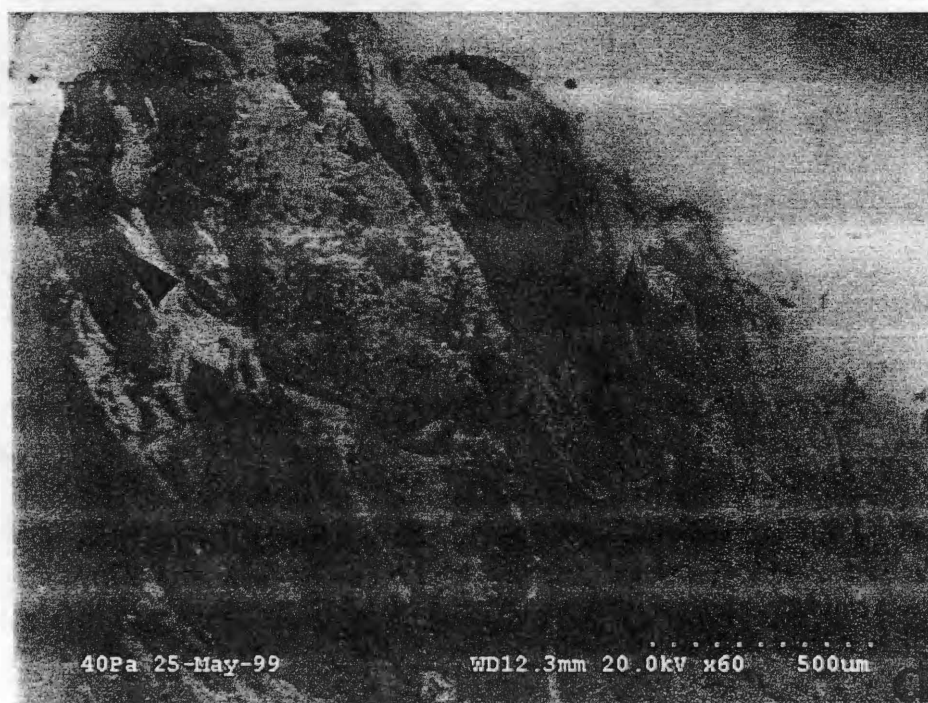
FIGURE 3.40. Scanning electron micrographs demonstrating the characteristic uneven/stepped appearance seen among the Ekco™ collection of injuries (Fig 2), pointed up with black arrows. a, the floor and walls of this stab to the sternal face of the fourth right rib show a narrow, stepped appearance (view of medial side, sternal face toward top; magnification = x70); b, the edges of this wound to the anterior surface of the eleventh right rib demonstrate an uneven, stepped appearance (view of anterior surface, sternal end toward top; magnification = x70); c, in this lateral view of an injury to the posterior edge of the fourteenth left rib, the beginnings of unevenness are visible (anterior edge toward top; magnification = x45); d, the edges of the bony flap that constitutes the sternal edge of this stab wound to the posterior edge of the fifteenth left rib show an uneven, stepped appearance (view of posterior surface, or the exterior, of the bone flap; magnification = x60).

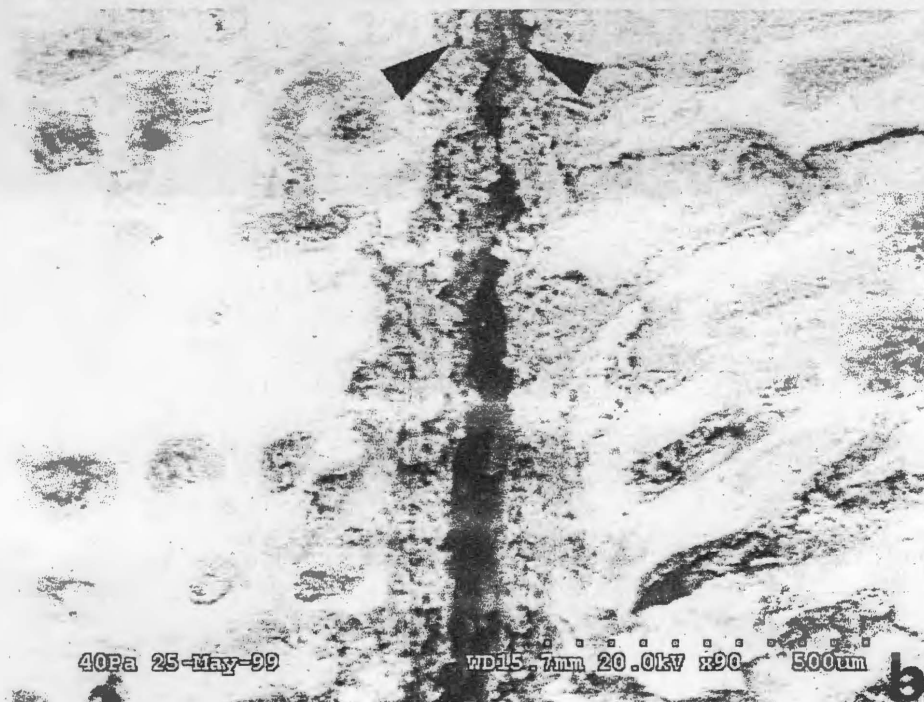
FIGURE 3.41. Scanning electron micrographs illustrating sharp tapering, pointed up with black arrows, of wound floors in rib injuries from Fig 2. a, medial view of a stab wound to the posterior edge at the midshaft region of the twelfth right rib (vertebral end is toward top; magnification = x40); b, this injury to the posterior edge of the fourteenth left rib shows significant constriction at its floor (view of lateral side, anterior edge toward top; magnification = x90).

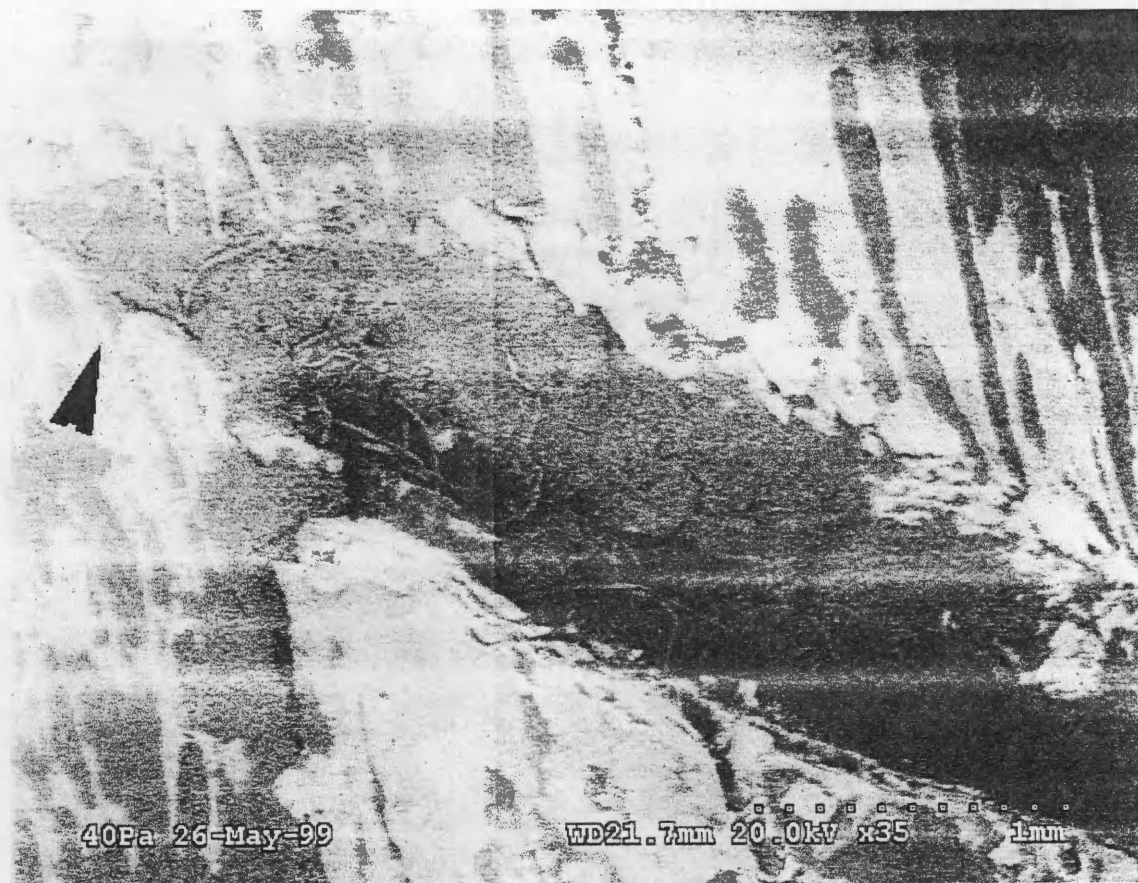
FIGURE 3.44. Scanning electron micrograph of the floor of a stab wound to the eleventh left rib of Pig 3. This demonstrates the slightly pointed, wide, shallow U shape found among the Henckels® injuries (view of lateral side, vertebral edge toward top; magnification = x35). Note also the very slight amount of lipping, "clean," uneven edges, and small fibers present within the wound, concentrated toward the floor area.
