M. Guadagnuolo et alii, *Frattura ed Integrità Strutturale*, 51 (2020) 398-409; DOI: 10.3221/IGF-ESIS.51.29

Retrofit assessment of masonry buildings through simplified structural analysis

Mariateresa Guadagnuolo, Marianna Aurilio, Giuseppe Faella

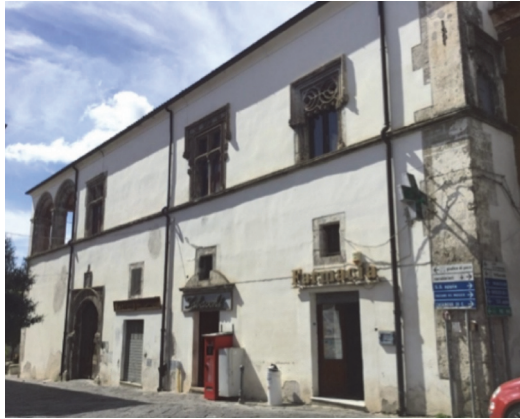
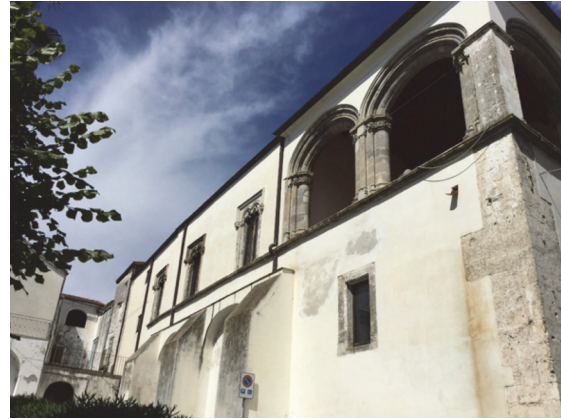
Figure 1: External front views.

The building was realized around the XIV century and it is a typical example of the construction typology of the area (Fig. 1). It is located in the historic center of Carinola (province of Caserta), a town that presents a medium-low seismic hazard.

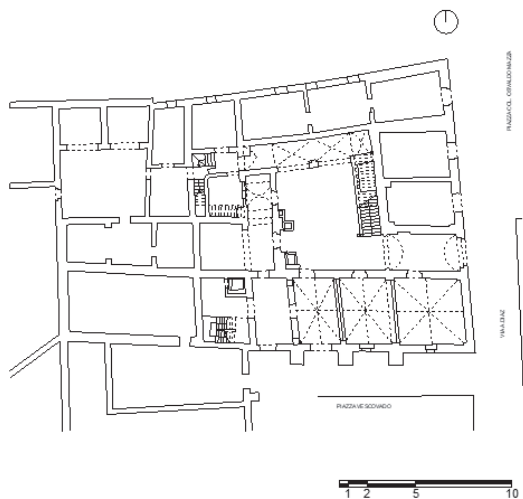
Figure 2: Ground floor plan.

The building has a compact shape and an irregular morphology both in plan and in elevation. It is on two levels around a central courtyard, where an external staircase connects the ground floor to the loggia, as shown in Fig. 2, Fig. 3 and in Fig. 4. The masonry consists of simple regular stone blocks; the walls are 60 cm thick. The floors present a large variation: cross vaults, barrel vaults and flat slab are present, while the roof is made by timber trusses.

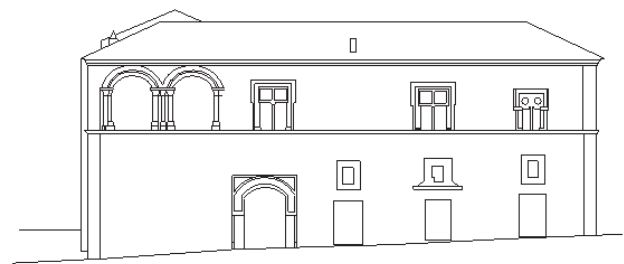
Figure 3: Elevation.

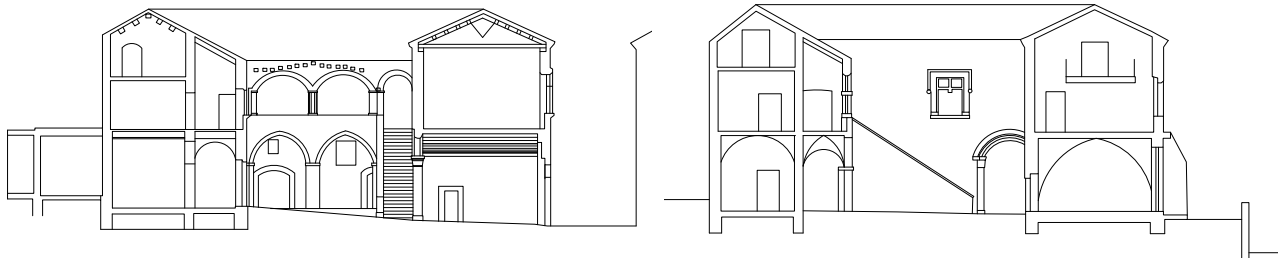
Figure 4: Sections drawings.

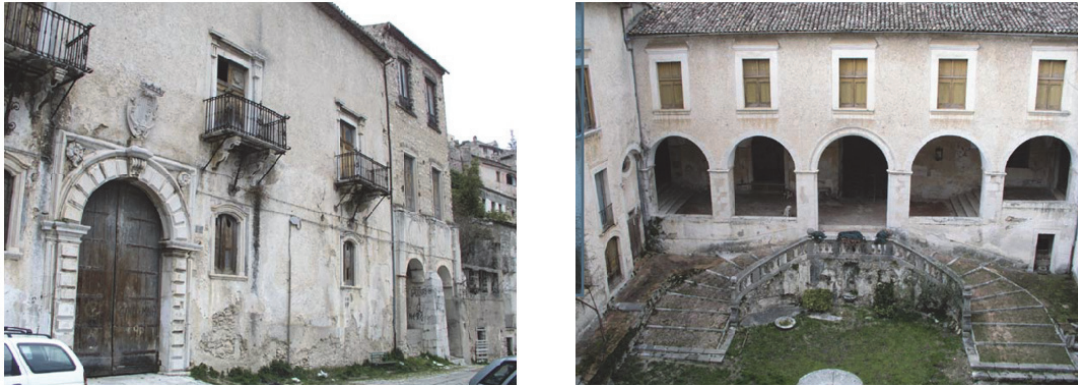
Figure 5: External front views.

The building (Fig. 5) is located in the historic center of Piedimonte Matese, in the province of Caserta. It is a prototype of the construction typology of the Middle Volturno's area, next to the Apennines; therefore, a district with high seismic hazard. The palace, built in the XVI century, consists of a massive stone masonry mixed to fieldstone and brick blocks

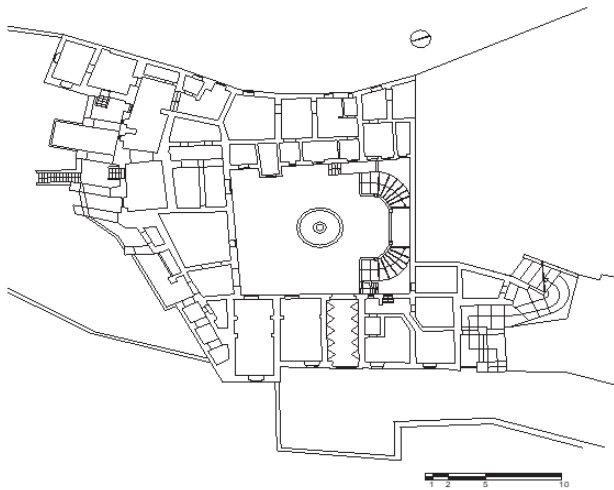
Figure 6: Ground floor plan.

with a thickness of about 80 cm. The building has four levels, arranged around a central courtyard and has a compact shape and an irregular morphology in both in plan and in elevation, as shown in Fig. 6, Fig. 7 and in Fig. 8

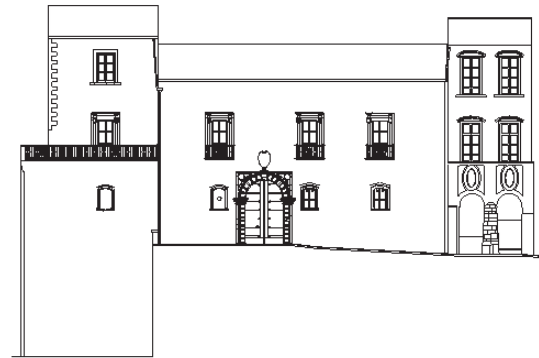
Figure 7: Elevation.

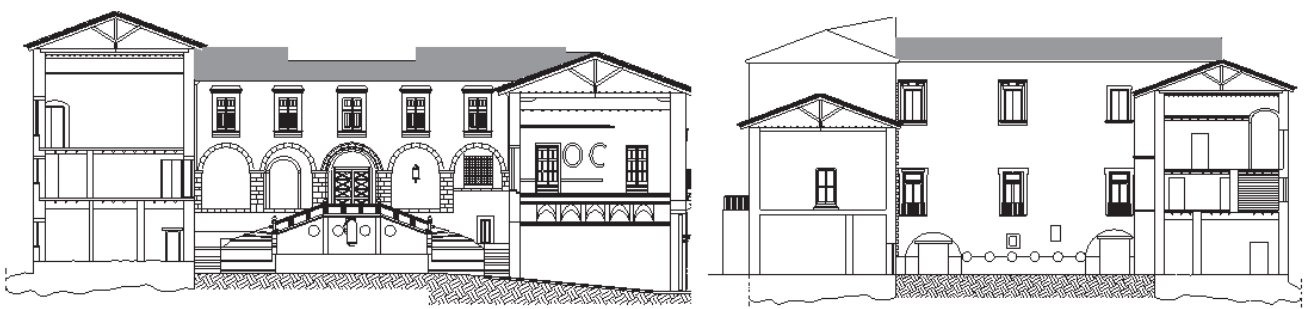
Figure 8: Sections drawings

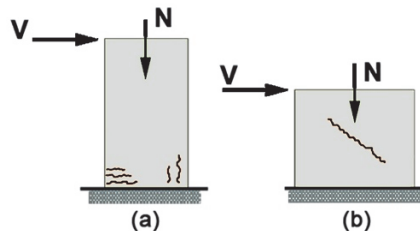
Figure 9: In-plane failure modes of masonry piers subjected to eccentric axial force: (a) flexural, (b) shear diagonal cracking.

The failure mechanisms considered are that expected in masonry walls (Fig. 9): collapse of piers due to shear or bending forces, also depending on the strength of the spandrel beams [14, 34]. In masonry piers, the coefficients of failure mechanisms ξ_{xi} and ξ_{yi} assume value of 1 in the case of shear failure and 0.8 in the case of eccentric axial force failure; the coefficients related to the spandrel beams resistance ζ_{xi} and ζ_{yi} assume values 1.0 in the case of strong spandrel beams and 0.8 and in the case of weak spandrel beams.
