## Adaptive strategies and transformation for community recovery – A case study of villages in Hinthada, Ayeyarwady Region, Myanmar

Kensuke Otsuyama<sup>a,\*</sup>, Soe Pyae Aung<sup>b</sup>, Norio Maki<sup>c</sup>

Myanmar is one of the highest meteorological hazard risk countries in the world, owing to geographical factors such as a vast delta along the Ayeyarwady River. As the Ayeyarwady Region has suffered from seasonal floods in the monsoons since historical times, long earthen dykes were constructed in the 19th century during the British colonial period. As a result, one village was divided into two by a dyke about 150 years ago. The region was severely affected by floods in 2015. Most of the unprotected villages were inundated for two to three months, while villages inside of the dyke were protected. This research aims to identify strategies for long-term recovery related to housing, livelihood, and community activities in villages divided by the dyke in Hinthada Township using household surveys. The results show that unprotected villages have adapted their elevated houses against floods and planted water-resistant crops as an income source. Protected villages have relied o

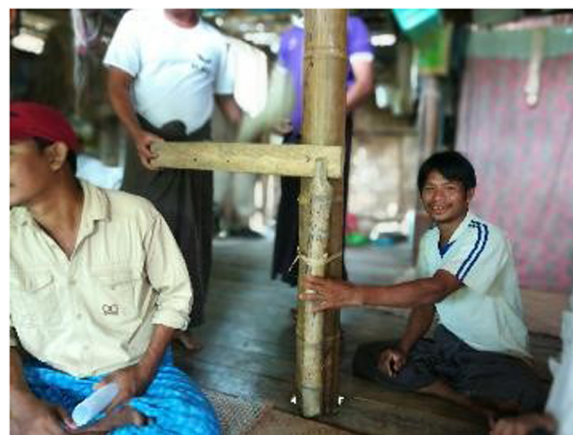
**Fig. 6.** Floor adjustment in a bamboo house.

In contrast, floor-height elevation has limitations of durability for bamboo houses on the unprotected side. According to a respondent living in village A, the house shakes because of the vibration from the motorboats used for transportation during the monsoon season. Therefore, they cannot elevate higher floor due to the shakiness of the bamboo pillars. In order to respond to the situation, villagers utilize a temporarily elevated second floor made of bamboo and reed floor sheets (Fig. 6). Bamboo house owners prepare a short corbel-receiving floor for the elevation in the house. Family members stay on the temporary second floor for two months. Since those days, they have prepared the material before the monsoon, but changing to timber houses is a better recovery strategy in this context of adaptation.

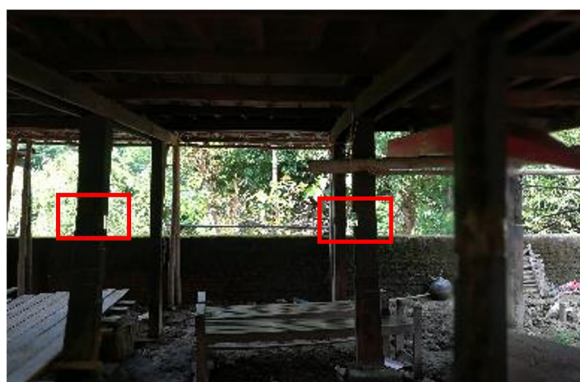
**Fig. 4.** Marks on the foot pillar for floor elevation since before 2015.

Not surprisingly, the average floor height in villages A and C is 1.92 times higher than protected villages (B and D) to cope with inundation in monsoon seasons. Specifically, most of the floor height of timber houses is elevated higher than that of bamboo houses, except in village B. After the 2015 flood, several houses were elevated one or two feet more. The foot pillars or basement foundations are elevated by the simple method (Figs. 4 and 5). As the construction work was able to repair the houses without destroying them, elevation of the houses is a reasonable approach for timber houses.

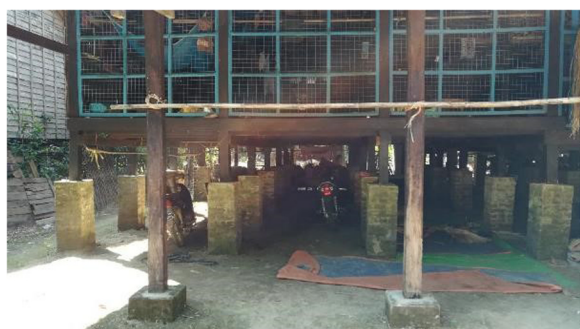
**Fig. 5.** Basement foundation elevation.

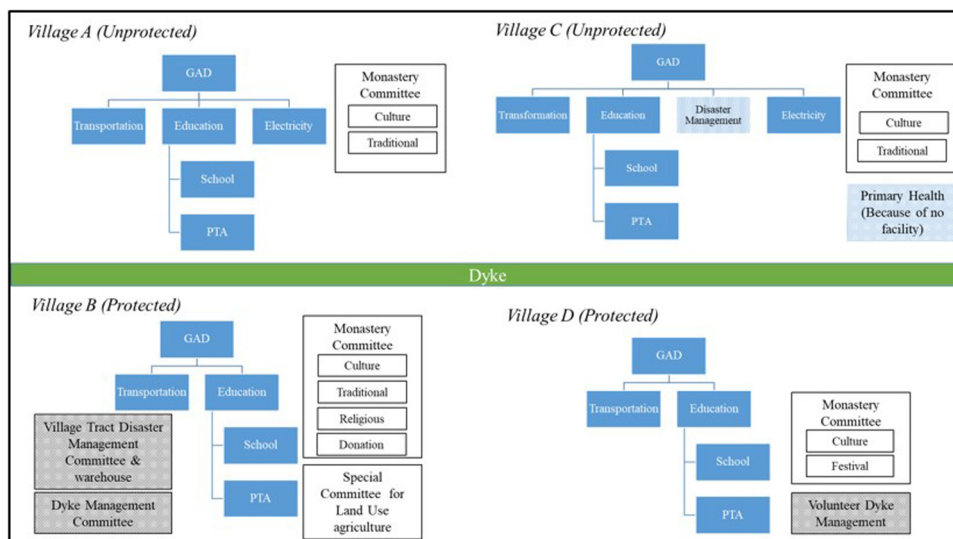
Fig. 9. Comparison of the Village Committees.

the floods. As per warnings from the Irrigation Department in the center of Hinthada Township that are issued after monitoring the water level in the Irrawaddy River, men in the villages begin voluntary observation by working 24-h shifts in the high season. The manual monitoring system requires considerable manpower as one person is required for every 1.5 miles in the dry season and for every 0.75 mile in the monsoon season. Villagers prepare sand bags, bamboo trunks, and other raw materials for making retaining walls for dyke protection. In particular, Village B is the central hub for the dyke management geologically; therefore, *Village Tract Disaster Management Committee* and *the warehouse* for emergency relief items are located at the village (Fig. 9).

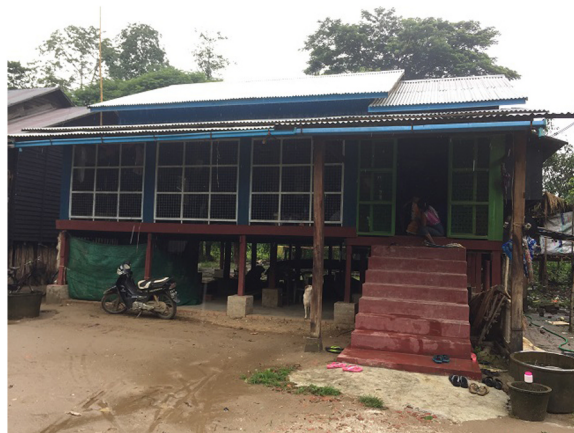
Fig. A3. Elevated timber house.

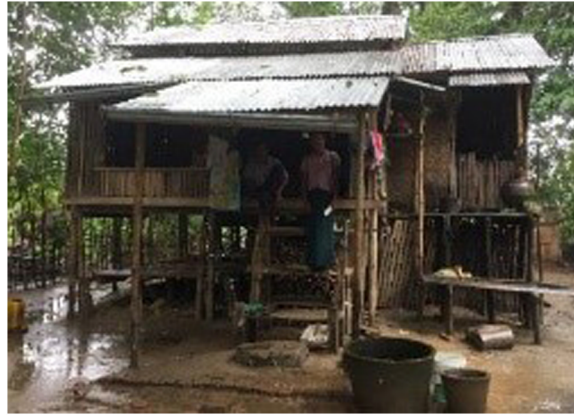
**Fig. A4.** Elevated bamboo house.

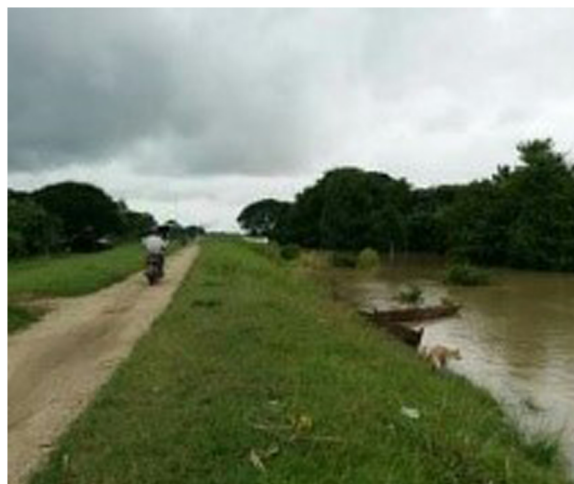
**Fig. A9.** Dyke near village B.
