# Mechanical Properties and Fatigue Behavior of Unitized Composite Airframe Structures at Elevated Temperature

**MECHANICAL PROPERTIES AND FATIGUE BEHAVIOR OF  
UNITIZED COMPOSITE AIRFRAME STRUCTURES  
AT ELEVATED TEMPERATURE**

THESIS

AFIT-ENY-MS-16-S-66

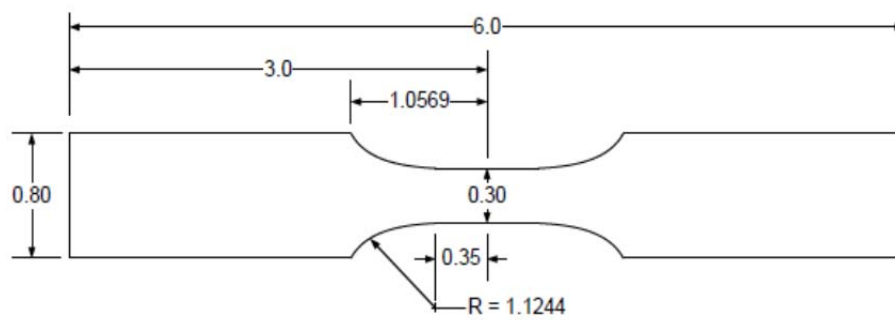
**Figure 5: Tension-tension specimen geometry, all dimensions in inches**

To ensure that failure occurred within the gage section of the test specimen standard dog bone-shaped specimens were used for all monotonic tension tests and tension-tension fatigue tests. The specimen geometry is presented in Figure 5.

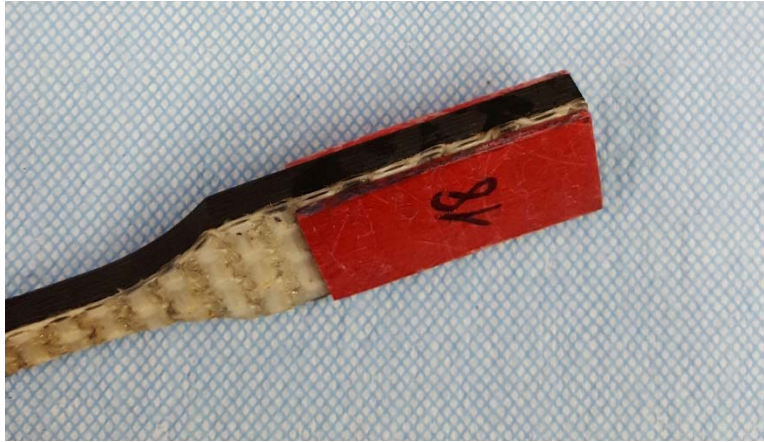
**Figure 6. Unitized composite specimen with fiberglass tabs**

prevent the wedge surface from damaging the specimen and to transfer the load. The tabs were bonded to the specimen using the M-bond 200 adhesive. Figure 6 shows a test specimen with fiberglass tabs bonded to the specimen gripping sections.

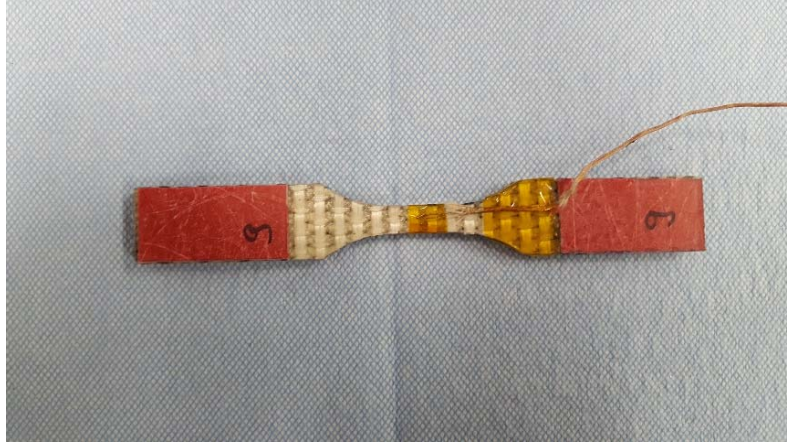
**Figure 8: Temperature calibration specimen.**

The CMC side of the unitized composite faced the furnace in all tests performed at elevated temperature. Therefore, a temperature calibration was performed to maintain a temperature of 329°C in the gage section on the CMC side of the specimen. Two K type thermocouples were attached to the specimen gage section with Kapton tape, one on the CMC side, and one on the PMC side (see Figure 8). The thermocouples were then connected to a hand-held Omega HH501DK temperature sensor for temperature read-out.

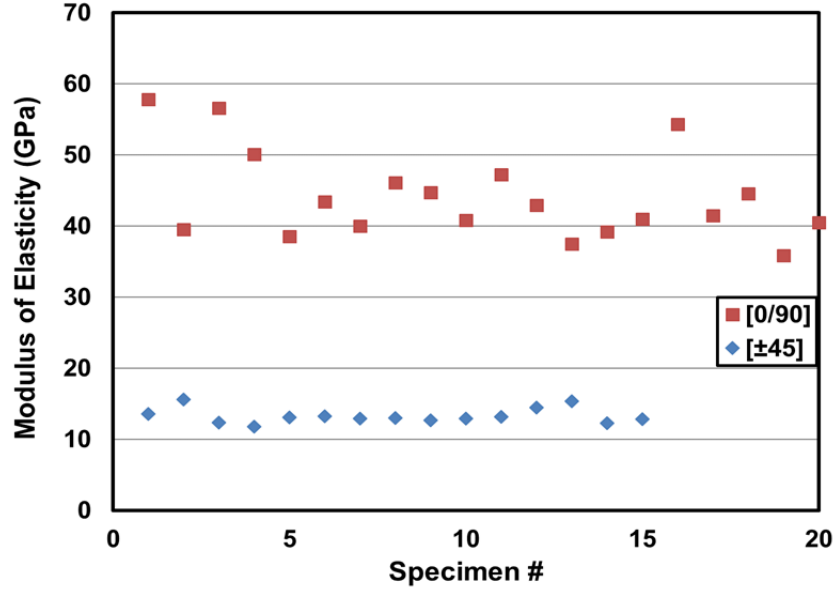
**Figure 11. Distribution of room-temperature modulus values obtained for the unitized 2D PMC/3D CMC material system**

As expected, the modulus of the 0/90 specimens was greater than that of the  $\pm 45^\circ$  specimens. However, 0/90 modulus values also exhibited greater variability. Distribution of 0/90 and  $\pm 45$  modulus values is shown in Figure 11. We note that the 0/90 specimens had considerably more observable surface defects and greater thickness variations than the  $\pm 45$  specimens. The presence of numerous surface defects and variations in thickness are likely behind the variations in room-temperature modulus values obtained for the 0/90 specimens.

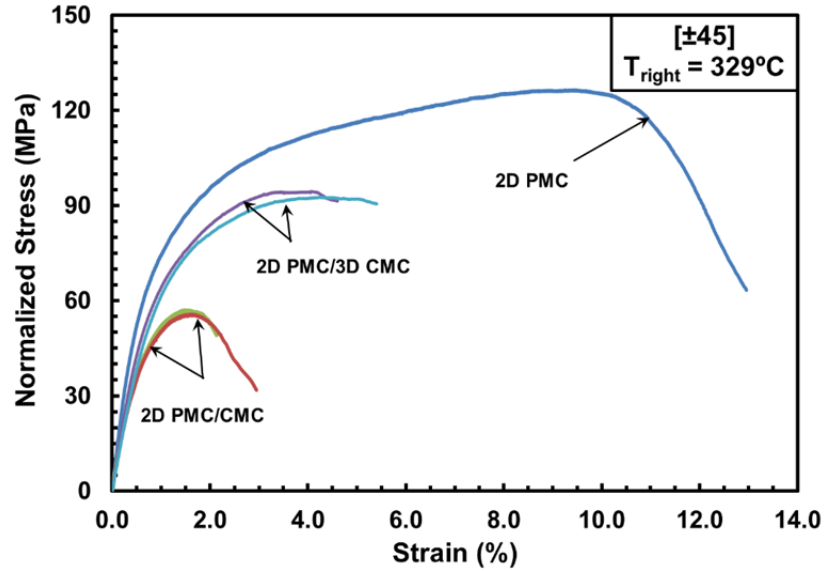
**Figure 17. Tensile stress-strain curves obtained for the MS2, MS3, and MS4 with  $\pm 45^\circ$  fiber orientation at elevated temperature. MS2 and MS3 results from Wilkinson [3].**

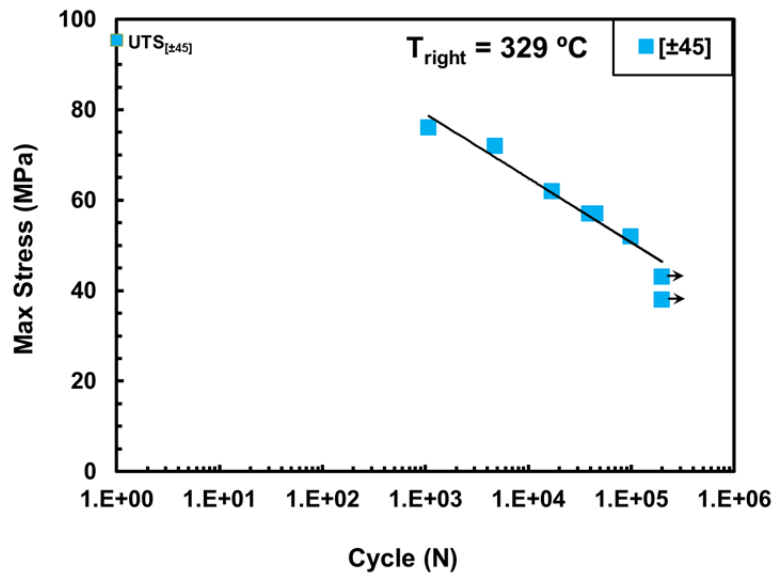
Figure 19. S -N curves for the MS4 with ±45° fiber orientation at elevated temperature. Arrow indicates specimen achieved fatigue run-out.

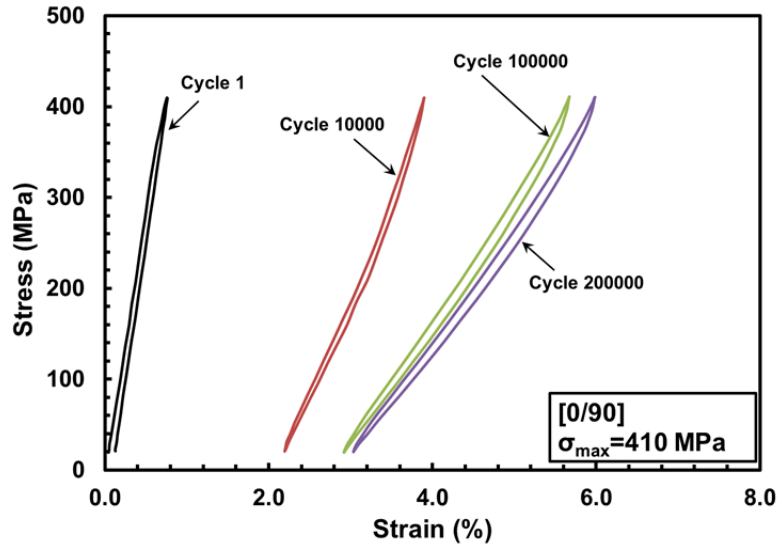
Figure 21. Evolution of stress-strain hysteresis response with fatigue cycles for specimen T7-1 of the MS4 with 0/90° fiber orientation at elevated temperature.

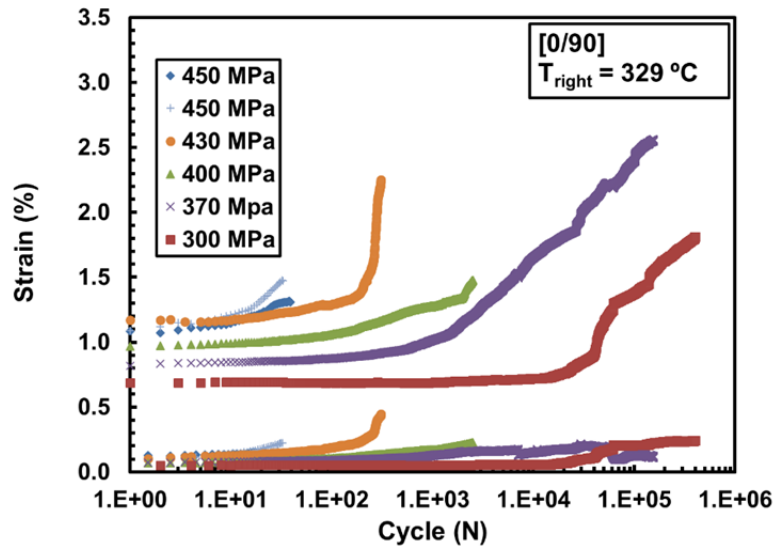
**Figure 24. Maximum and minimum strains vs. fatigue cycles for the MS4 with 0/90° fiber orientation at elevated temperature.**

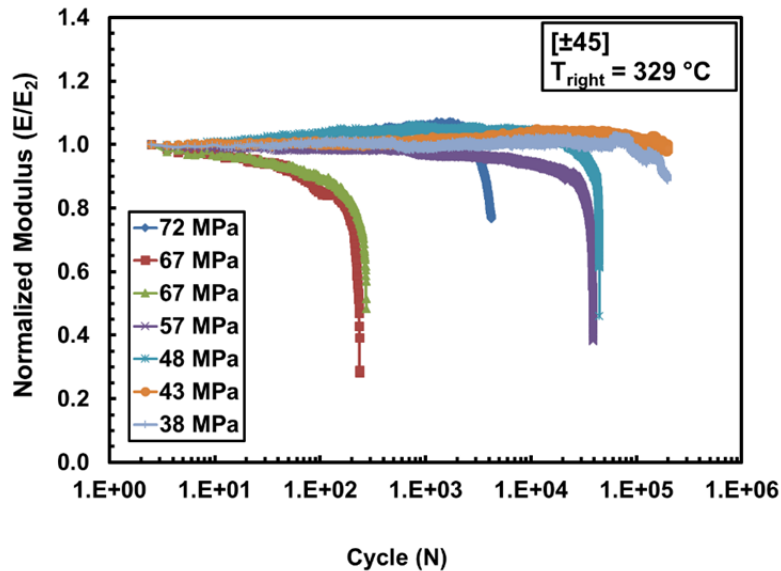
**Figure 26.** Normalized modulus vs. fatigue cycles for the MS4 with  $\pm 45^\circ$  fiber orientation at elevated temperature.

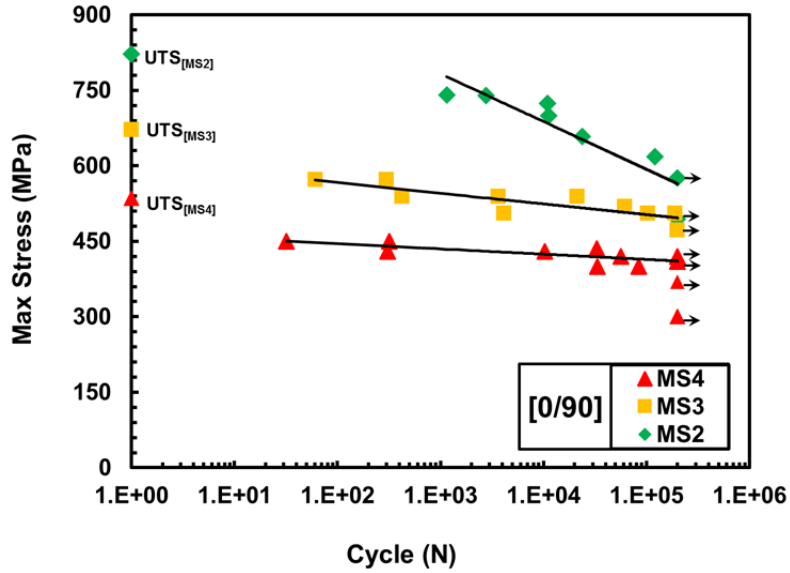
Figure 28. S-N curves for the MS4, MS3, and MS2 with 0/90° fiber orientation at elevated temperature. Arrow indicates specimen achieved fatigue run-out. MS2 and MS3 data from Wilkinson [3].

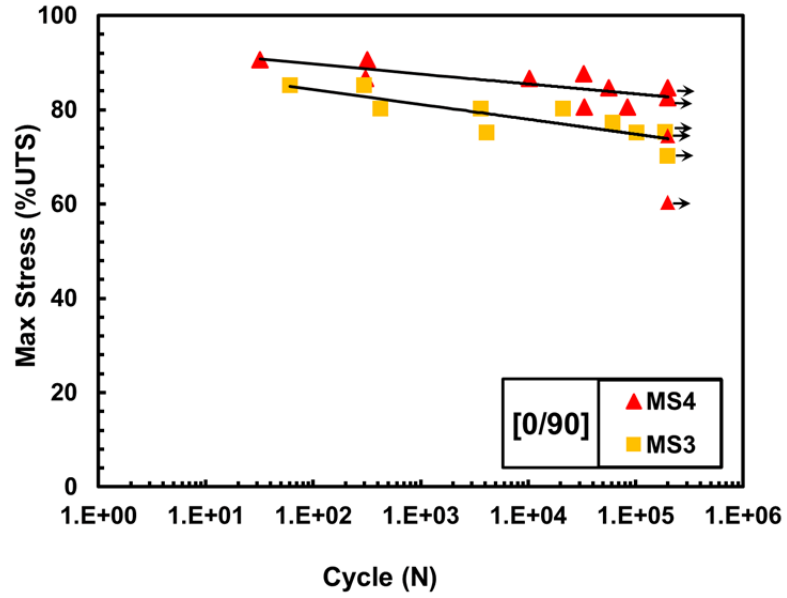
**Figure 30. S-N curves for the MS4 and MS3 with 0/90° fiber orientation at elevated temperature. Maximum stress is shown as % UTS. Arrow indicates specimen achieved fatigue run-out. Maximum stress is shown as % UTS. MS2 and MS3 data from Wilkinson [3].**

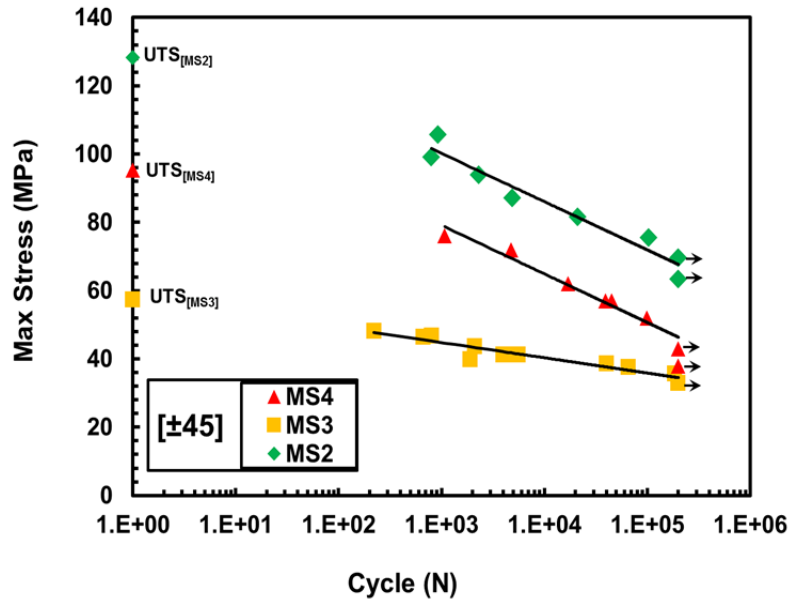
Figure 31. S-N curves for the MS4, MS3, and MS2 with  $\pm 45^\circ$  fiber orientation at elevated temperature. Arrow indicates specimen achieved fatigue run-out. MS2 and MS3 data from Wilkinson [3].

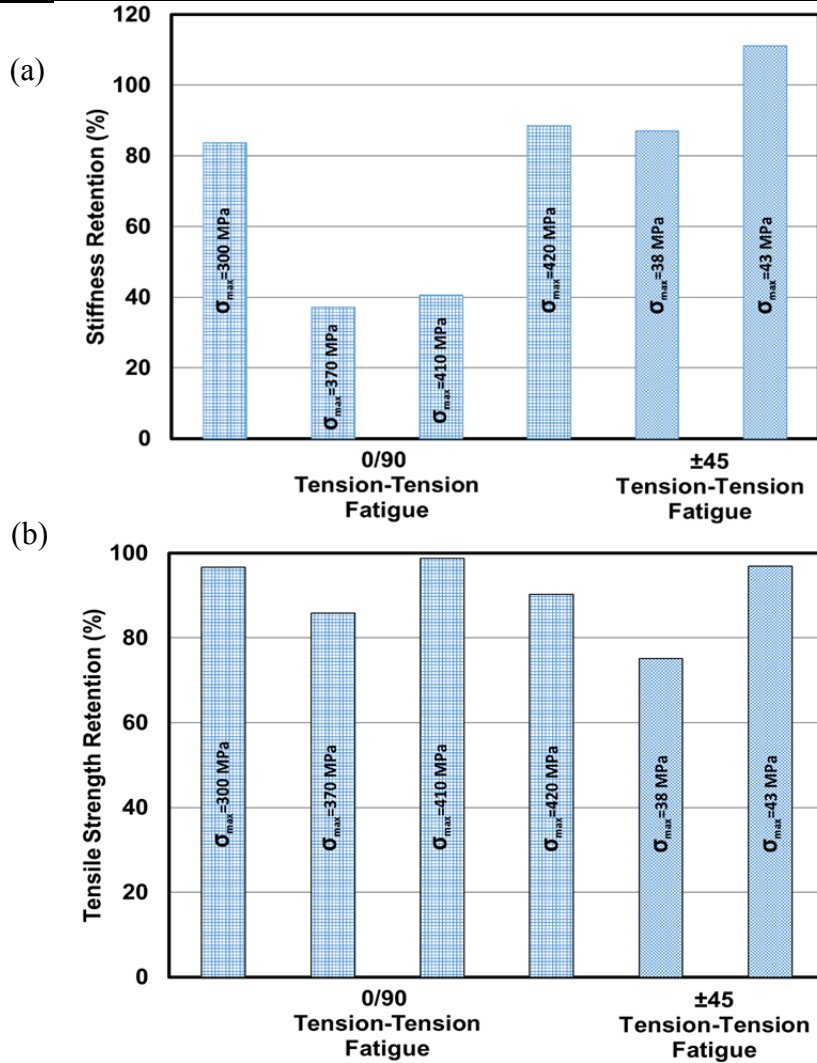
**Figure 34. Retention of (a) stiffness and (b) tensile strength of the MS4 specimens subjected to prior fatigue at  $T_{right}= 329^{\circ}\text{C}$  in laboratory air**

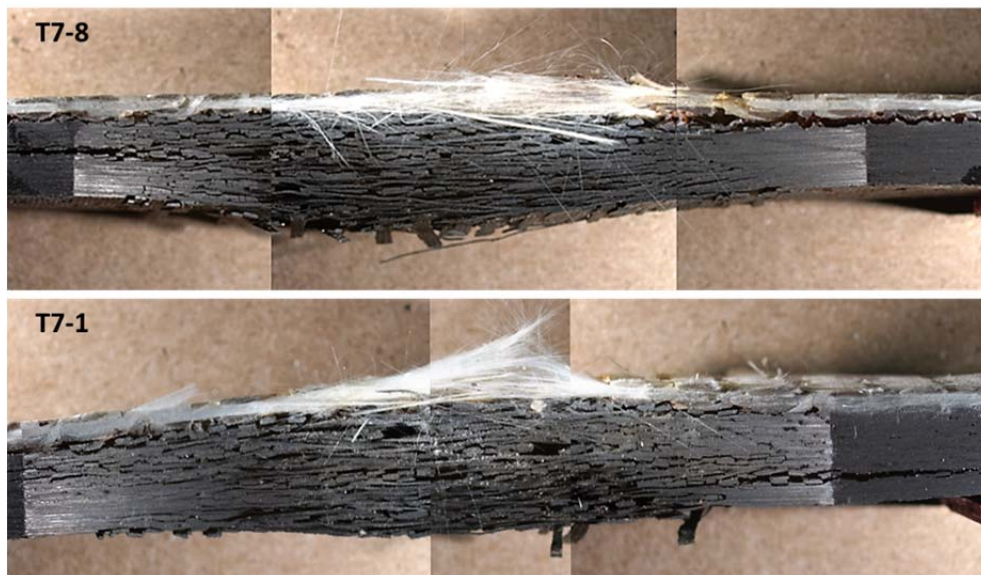
**Figure 38. Stitched optical micrographs of the MS4 0/90° specimens T7-8 and T7-1 after failure in tension at elevated temperature.**

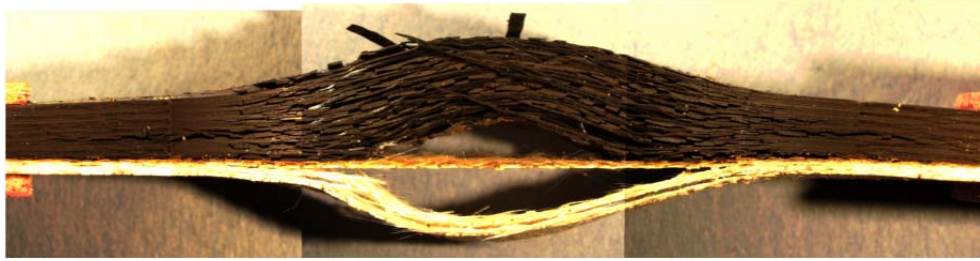
**Figure 39. Stitched optical micrographs of MS3 0/90° specimen T5-2 following failure in tension at room temperature and load removal. From Wilkinson [3]**

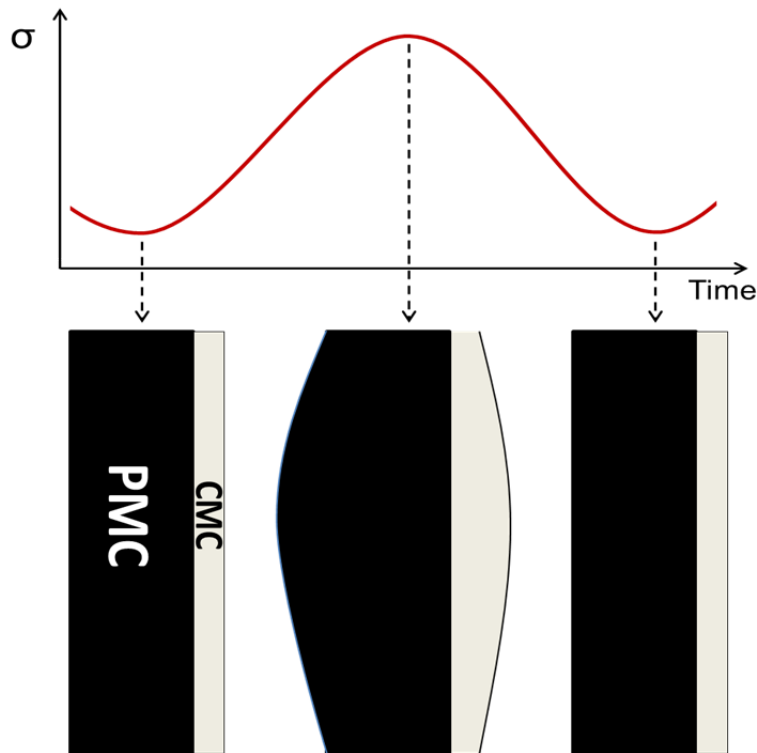
**Figure 40. Schematic of non-homogeneous deformation during tension-tension cyclic loading. Individual plies are not shown. [17]**

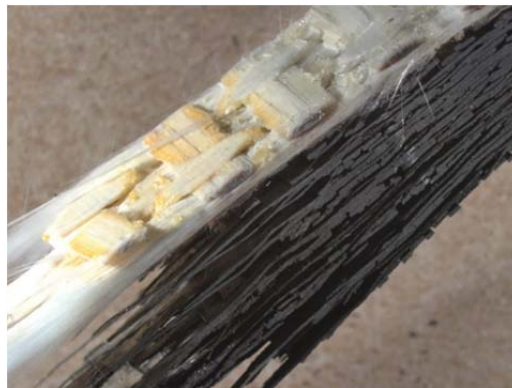
**Figure 42. Optical micrograph of specimen T7-4 viewed from an angle after failure under tension-tension fatigue at 430 MPa.**

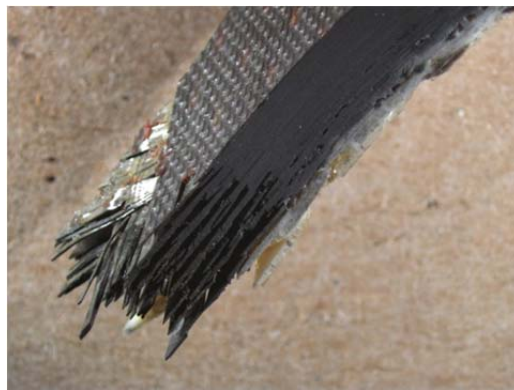
**Figure 46. Optical micrograph of specimen T8-1 viewed from an angle after failure in tension-tension fatigue at 76 MPa.**

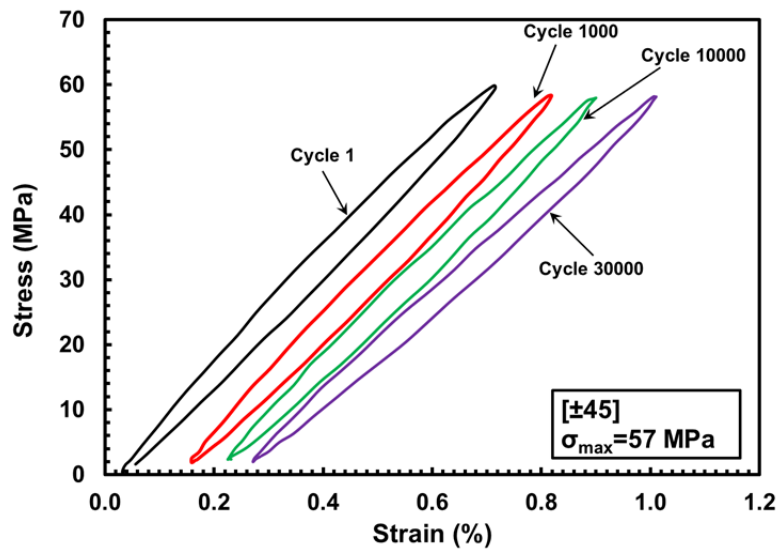
Figure 54. Evolution of stress-strain hysteresis response with fatigue cycles for specimen T8-7 of the MS4 with  $\pm 45^\circ$  fiber orientation at elevated temperature.
