Real Time Fault Detection and Diagnostics Using FPGA-Based Architecture

THESIS

AFIT/GCE/ENG/10-04

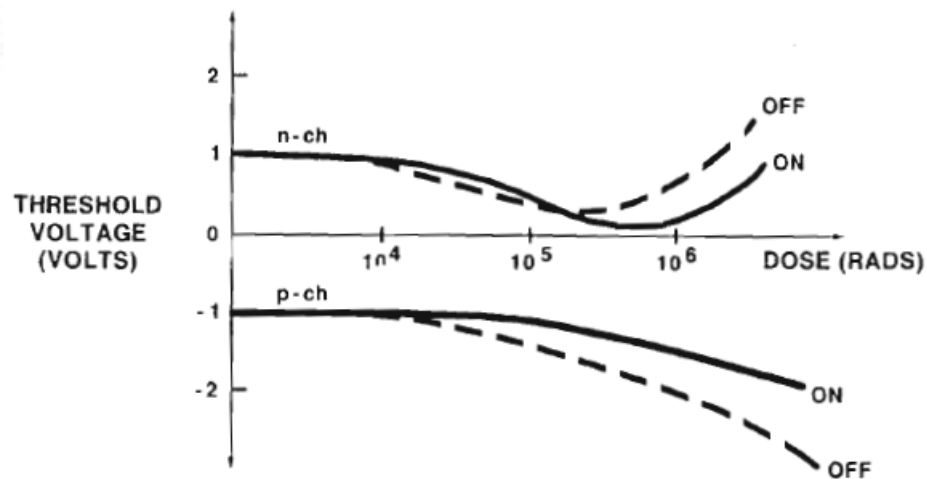
Figure 5 – Threshold Voltage of 'n' and 'p' Transistors during Irradiation [15]

overall effect depends on bias conditions and device technology. With devices becoming smaller, the gate oxides in these shrinking transistors are growing thinner. Being thinner, the gate oxide traps less positive charge overall [14]. Therefore, transistors with smaller technologies are becoming inherently more radiation resistant. Figure 5 shows how the total dose effects the threshold voltage and causes a shift in both 'n' and 'p' transistors. The threshold voltage does change during the annealing process after it has been irradiated shown in Figure 6.

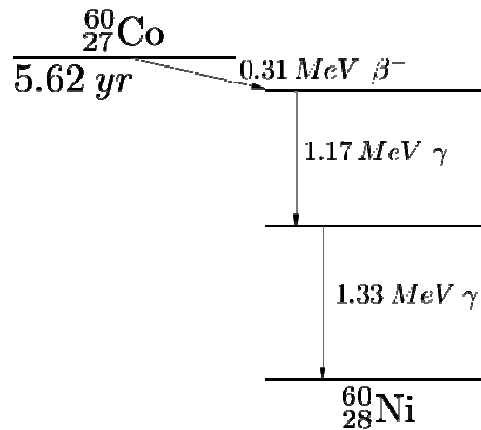
Figure 9 – Decay scheme of ^{60}Co [20]

The cobalt-60 isotope (^{60}Co) was used as the source of ionizing radiation for this experiment. ^{60}Co undergoes beta decay with a half-life of 5.24 years releasing two gamma particles and one electron, demonstrated in Figure 9.

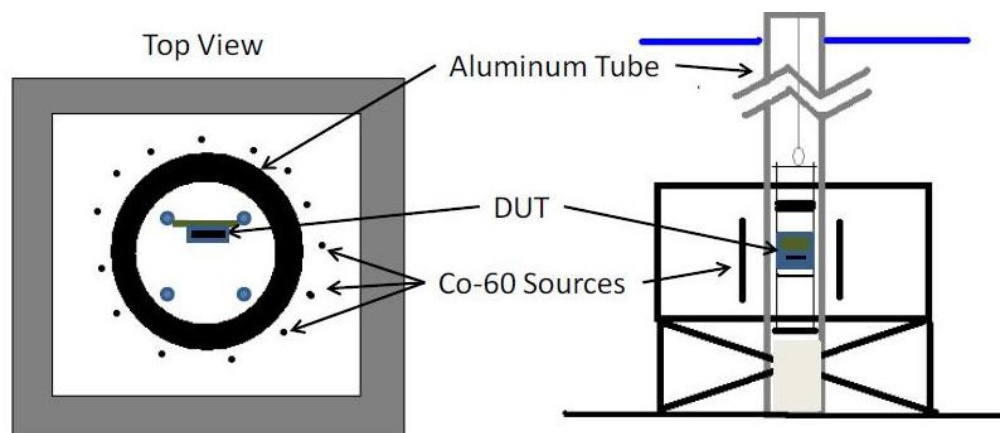
Figure 10 – ^{60}Co Gamma Irradiator Layout [17]

Ohio State University (OSU) Nuclear Reactor Lab (NRL) in Columbus, Ohio provided a ^{60}Co source. A simplified diagram showing the gamma irradiator can be found in Figure 10. It contains a six inch wide aluminum tube containing a movable platform that can be raised and lowered out of the irradiator. The gamma irradiator cell itself sits on the bottom of a pool of water and consists of 14 ^{60}Co sources evenly spread around the aluminum tube.

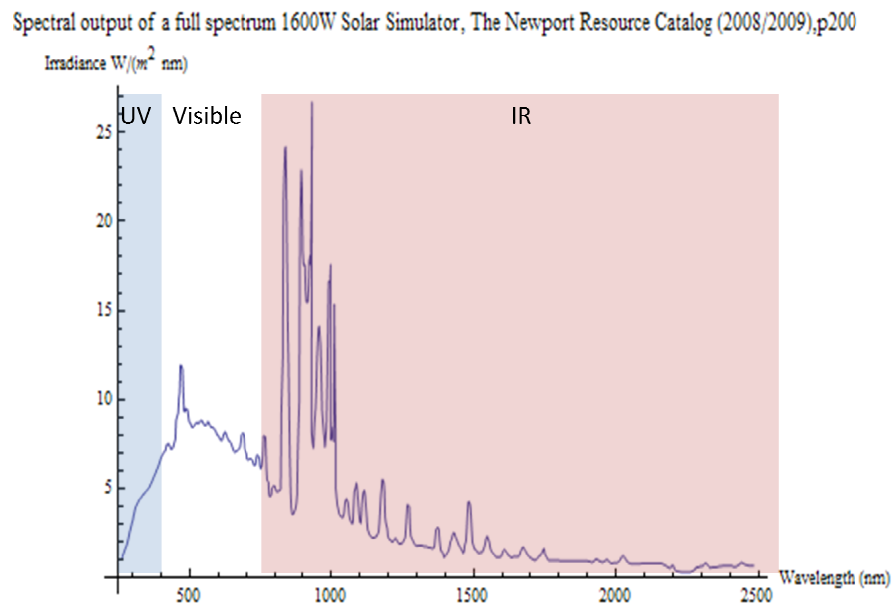
Figure 13 – Spectral Output from 1600W Thermal Simulator

The thermal simulator was assembled by Koehl [19] and the manufacturer recorded a spectral output seen in Figure 13 below.

The spectrum is largely a smooth Plankian distribution, reflecting the source plasma temperature with superimposed lines from the xenon emission spectrum. The smooth Plankian portion of the distribution is similar to the measured intensities for a 1 kT nuclear explosion [19].

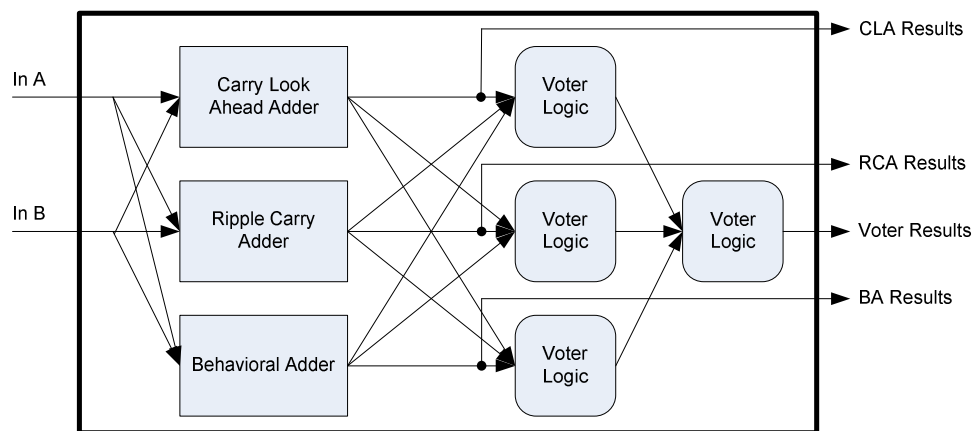
Figure 17 – Diagram of TDTMR

The DUT component consisted of the new Triple Design TMR. The design also utilized the triplicated voter enhancement [2]. The DUT contains three copies of different forms of adder logic. The Carry Look Ahead Adder and Ripple Carry Adder designs were implemented structurally using base level gates. The two adder diagrams can be found in Appendix B and C. The third adder was implemented in a behavior method, meaning it was left to the Xilinx software to layout how the adder would be designed. The three adder's results entered the triplicated voter logic in an effort to perform fault redundancy. The outputs of each adder were also sent to the controller board along with the results of the triplicated voter logic. Figure 17 shows the design of the entire TDTMR Unit.

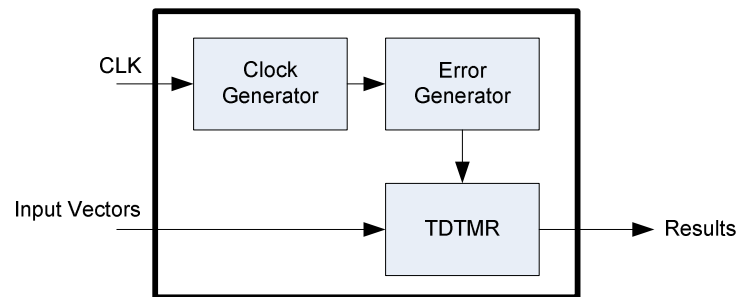
Figure 18 – Diagram of DUT

Other components were also added to the DUT as well, for testing purposes. A clock generator and an error generator were also added in the DUT (Figure 18). These units were used to simulate fault injections into the design. A fault injection is an error purposefully implanted into the integrated circuit that can be controlled by a user or automated through a computer program with specific guidelines.

The error unit generated errors at different timing intervals to simulate single errors into the TDTMR. These generated errors would lie dormant unless activated by a switch from the base board. Upon activation it would generate four errors at four different timing intervals, one microsecond, one millisecond, two seconds, and eight seconds.

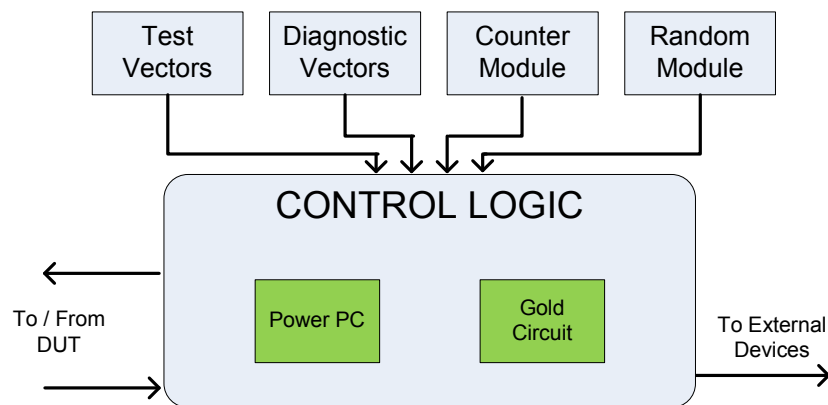
Figure 22 – Controller Board Block Diagram

results. Figure 22 illustrates the block diagram of the controller logic. Upon detecting an error, the controller board automatically switches to ‘Diagnostic Mode’ which has all the test and diagnostic vectors chosen as inputs. The PowerPC also runs the algorithm that calculates the location of the error. This will be discussed further in this chapter.

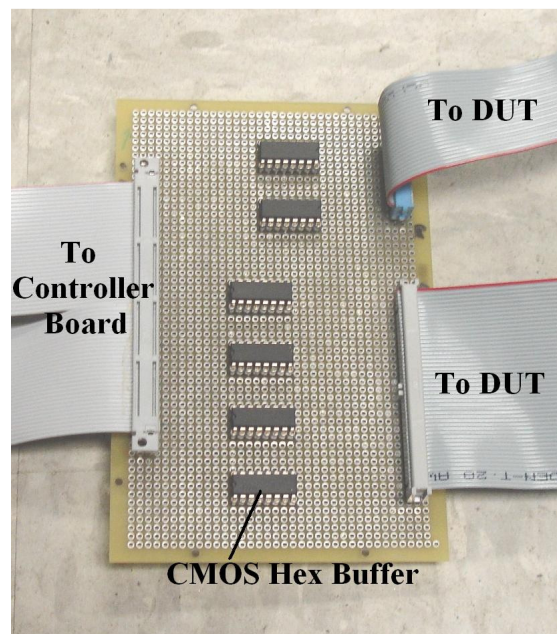
Figure 25 – Bridge Board

The Virtex 4 Mini-Module was originally chosen for its size to fit down a pipe under radiation. To communicate between the two boards, ribbon cable was used. Due to the incompatibility of the two boards to match the same pin layout, a bridge board needed to be constructed (Figure 25).

The bridge board also serves as a buffer to clean up the signal degradation between the two boards. Since there would be fifteen feet of cable between the controller board and the DUT, high speed CMOS buffers were used to aid in cleaning up the signal. Full details and specifications of the high speed CMOS buffers can be found in Appendix E. Figure 26 displays the comparisons of the signals with and without the CMOS buffers after fifteen feet. Another

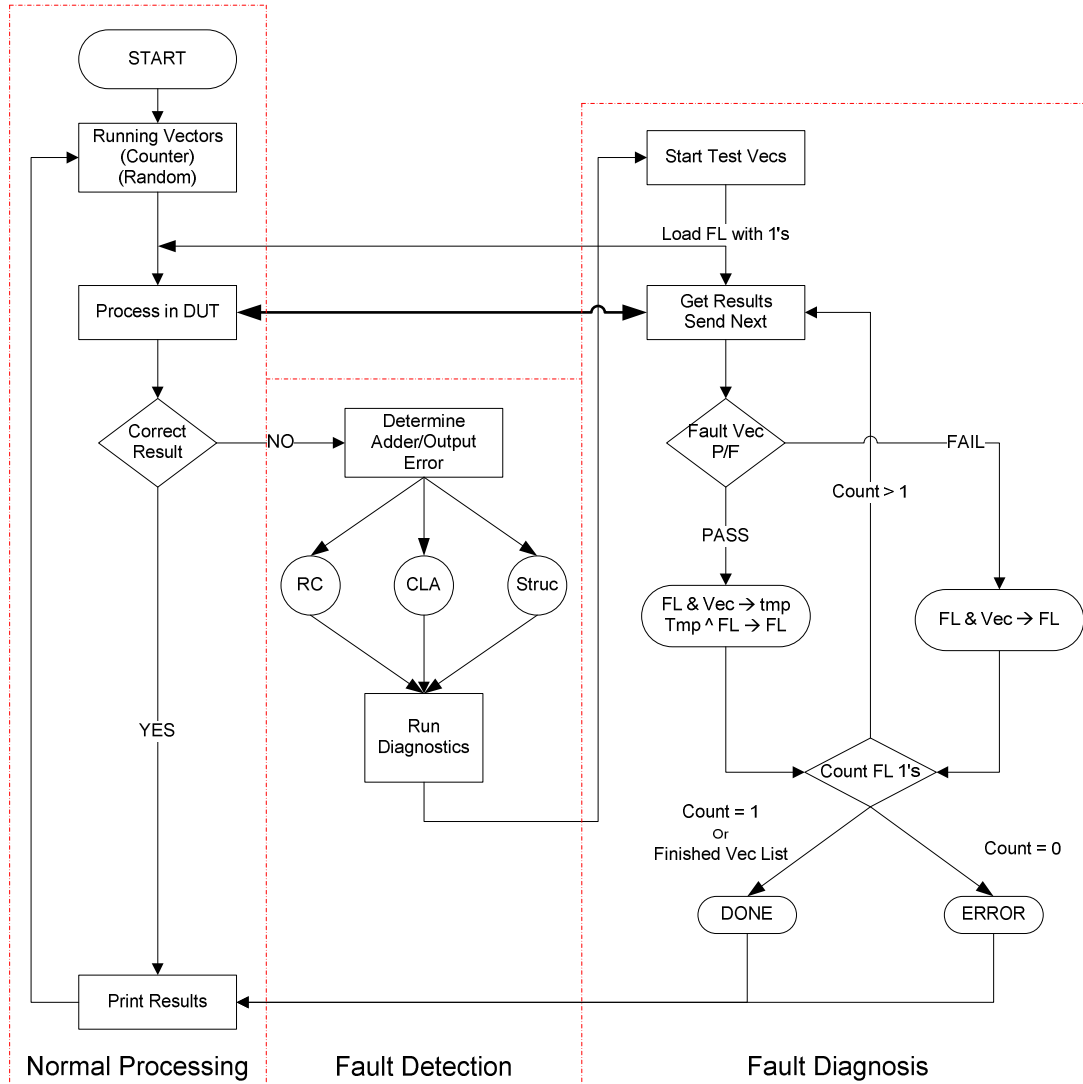
Figure 27 – Fault Detection and Diagnosis Algorithm

This section describes the process and methodology used to come up with the fault detection and diagnosis algorithm. The method used to detect faults was similar to previous work done in this field [17] with a few differences. The diagnosis algorithm was developed by utilizing the TESTCAD test generation and fault simulation tool sets. The full algorithm flow chart is displayed in Figure 27.

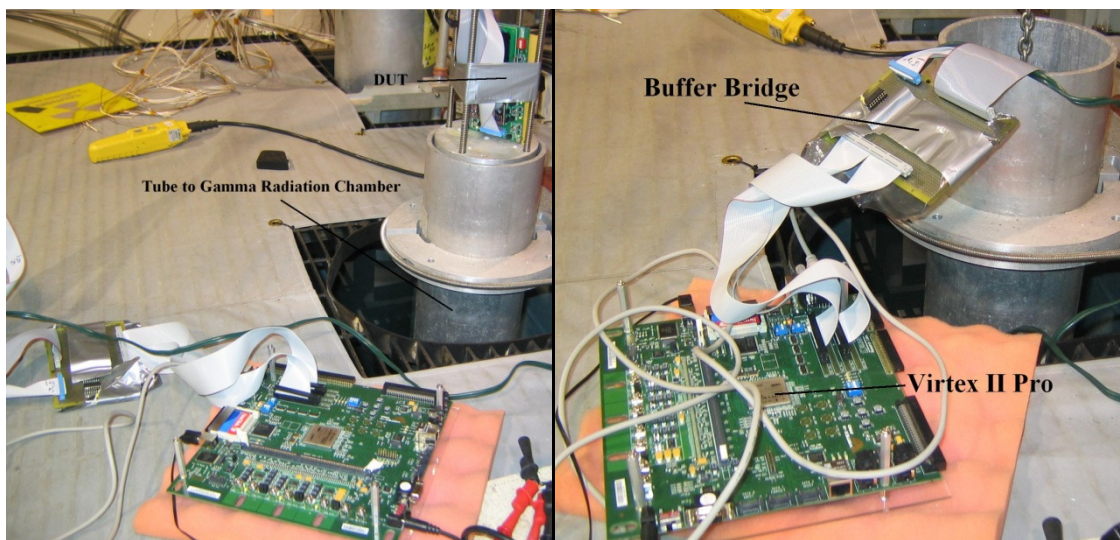
Figure 29 – Gamma Radiation Test Setup

The test platform was originally constructed to be tested under gamma radiation at the OSUNRL. The DUT was separated from the base board and placed eight inches from the bottom based on Figure 10 to achieve the highest dose rate per hour (see Chapter 2). The base board was strapped above the DUT separated by a thick piece of lead to be protected from the radiation. The bridge board, controller board, and the remaining devices stayed fifteen feet above the reactor. Figure 29 depicts the entire set up used for the gamma radiation test.

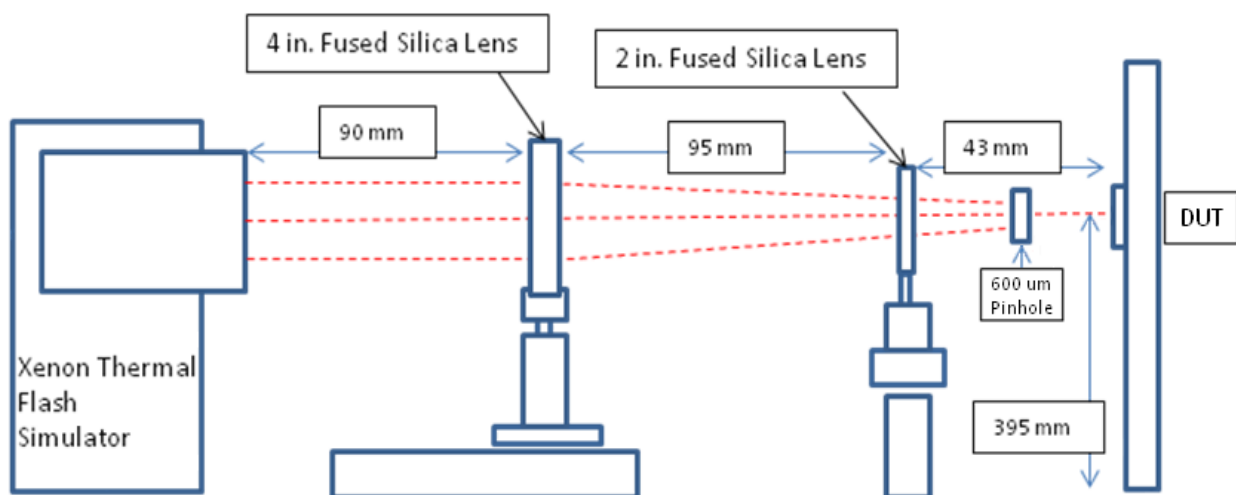
Figure 31 – Thermal Radiation Specification Setup

A two inch diameter fused silica Plano convex lens was inserted 95 mm after the focusing optic of the setup. The focal length of the second external optic is 150 mm. However, to increase the homogeneity of the beam, the target was placed closer to the second external optic than the focal length [18]. A pinhole was constructed that was placed in between the two inch Silica Lens and the FPGA to ensure the focus of the thermal radiation onto the FPGA alone. Figure 31 provides a diagram with detailed specification of the entire set up.

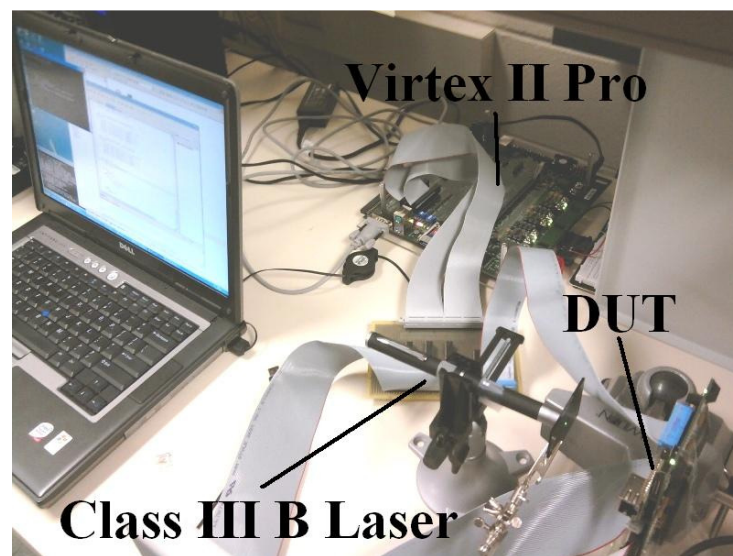
Figure 32 – Optical Laser Test Setup

The laser pointer was setup with the pinhole over the laser to get a more focused target onto the uncovered FPGA. The distance to the FPGA was 73 mm. Each laser was focused on one corner of the FPGA. Figure 32 depicts the entire set up used for the optical laser test.

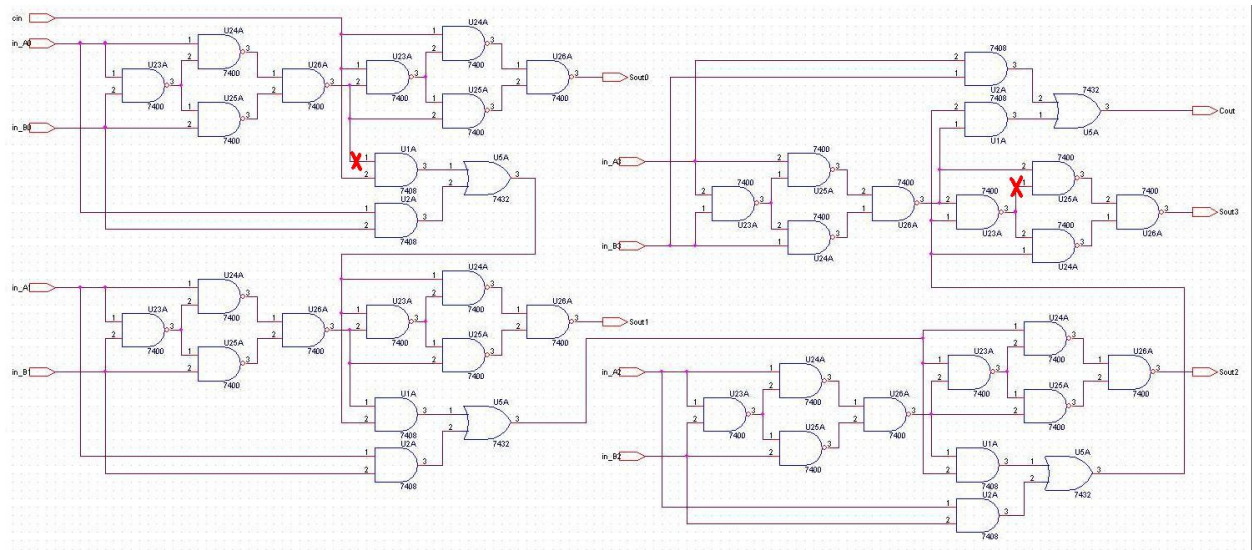
Figure 34 – Injected Fault Locations for Ripple Carry Adder

The results for this hardware simulation test setup were completed. The objective of locating the fault within the circuit and be able to diagnose the location of that particular fault in real time were achieved. The four hardware injected faults were located with the best resolution through the algorithm described in Chapter 3. The algorithm was able to pinpoint the exact location of the fault that was randomly placed in the structural design of either the Ripple Carry Adder (Figure 34) or the Carry Look Ahead Adder (Figure 35). Three of the four faults were

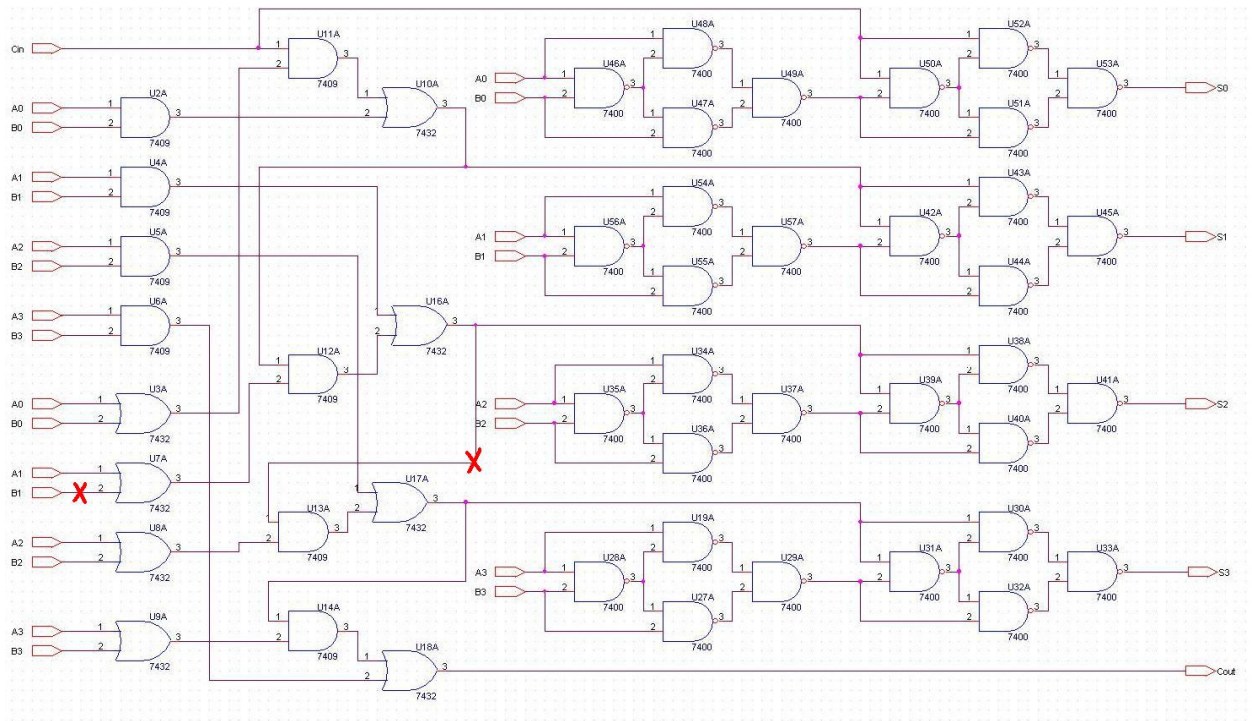
Figure 35 – Injected Fault Locations for Carry Look Ahead Adder

detected and the diagnostic algorithm pinpointed them exactly on the circuit diagram. One of the faults was not able to be located exactly; however, the algorithm reduced the number of possible locations to three. This result cannot uniquely distinguish amongst the three faults without fully

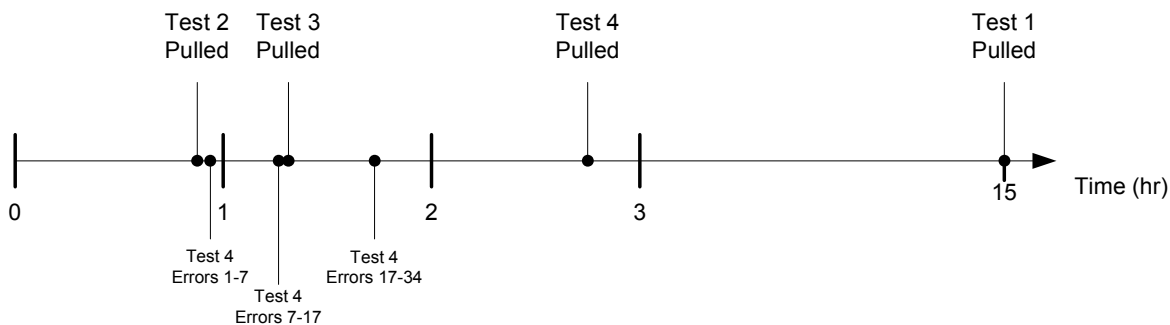
Figure 38 – Gamma Radiation Timeline

The final test for gamma radiation was met with differing results. The device was raised to seventeen inches from the bottom of the radiation chamber. By raising the distance, the dose rate is effectively reduced to 35 krad(Si)/hr based on Figure 11 found in Chapter 2. After two and three quarter hours, the baseboard and the DUT were still operational after being pulled from the radiation event. There were a total of thirty-four errors that were traceable coming in three groups of time. Figure 38 shows the timeline for all four tests for gamma radiation along with the group of errors detected in Test 4.

The three groups of errors, based on the logs, were consistent and traceable. It appeared that the voting logic produced errors at bit zero. The results showed that bit zero of the voting logic was a stuck-at-zero fault meaning a value in the output remained zero for a period of time. Table 3 presents an example of how the results represent a bit stuck at zero. Finally, Table 4 shows a summary of all four test results taken during the gamma radiation test.
