Another scenario of DDD cardiac pacemaker inhibition. Is it always caused by unipolar leads?

(Folia Cardiologica 2015; 10, 2: 133–135)

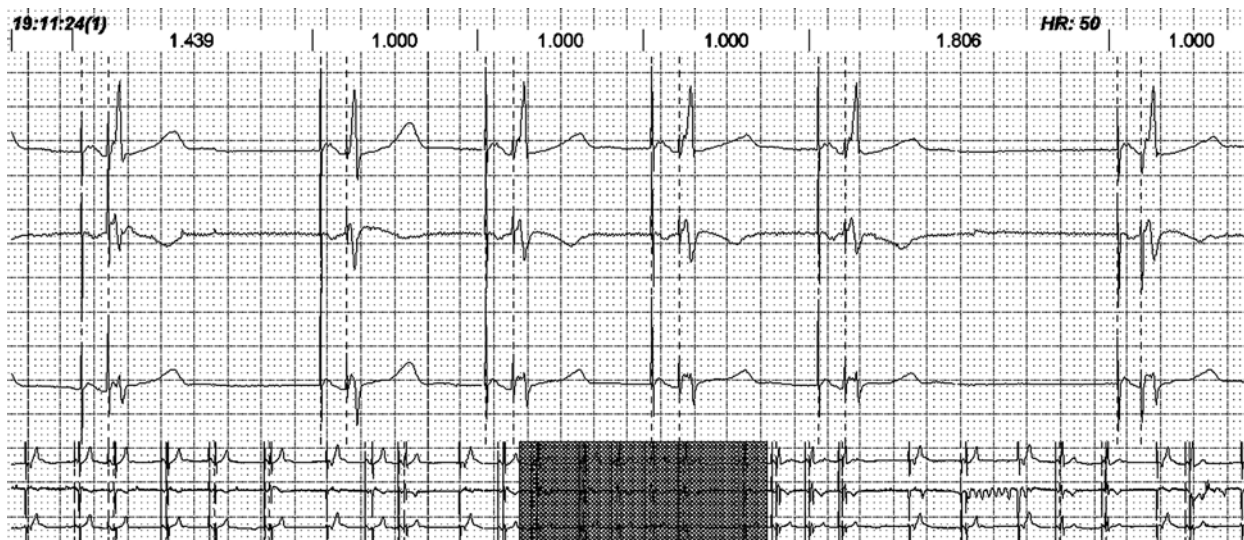
Figure 1. Holter electrocardiography (ECG) monitoring results. Predominant cardiac rhythm from DDD pacemaker ca. 60 beats/min. After first and fifth heartbeat, pacemaker inhibition is present, reaching over 1.4 second and 1.8 second. There is no artefact associated with myopotentials in this ECG recording

bipolar (Biotronik, Synox SX 53 JBP) atrial lead was located within right atrial appendage using left cephalic vein venesection. The Holter ECG monitoring was performed and its selected parts are shown on Figure 1. What caused the

pacemaker inhibition? Does the patient need any further clinical evaluation or management?

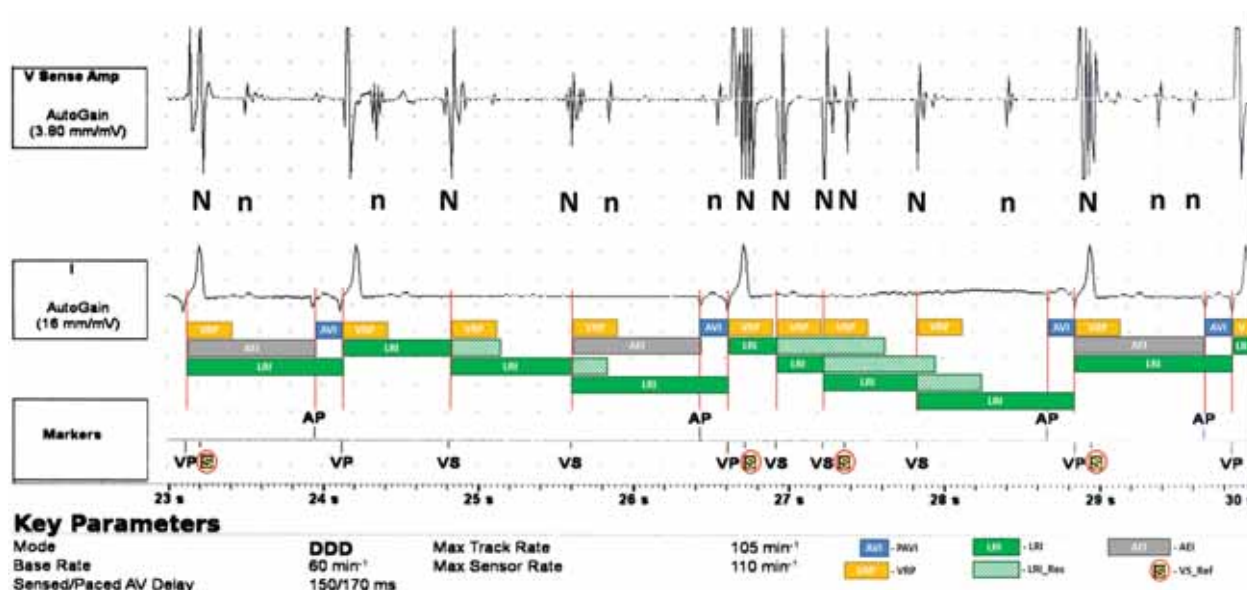
Movements of the pacemaker pocket region during pacemaker control may help to put the right diagnosis. Figure 2 shows resting ECG and EGM which reveal DDD pacemaker inhibition during this practical manoeuvre. Due to damaged ventricular lead, pacemaker lead movements caused noise oversensing, which was interpreted by the pacemaker as ventricular activity (VS, visible in marker channel) and led to pacemaker inhibition (both atrial and ventricular pacing was inhibited). Atrial lead was in working order and did not read noise from ventricular lead (marker channel), from the heart or damaged atrial lead (which would lead to only atrial pacing inhibition).

Figure 2. Electrocardiography and IEGM during pacemaker control. Letters N and n indicate ventricular lead noise. Noise marked with letter N (beyond VRP) was interpreted as ventricular activity (VS) from which the pacemaker started to count AEI and subsequently paced the atrium. Ventricular lead noise marked with letter n indicates noise which amplitude was too small to be detected by pacemaker as ventricular activity. LRI_Res = remaining part of lower rate interval (LRI) after sensed ventricular event; VS_Ref = ventricular event sensed during ventricular refractory period. Other abbreviations are defined in the text

In our case, pacing system included new (ca. 10-year-old) bipolar leads which advantage should be resistance towards reading noise from skeletal muscles myopotentials and from external electromagnetic fields. The cause of pacemaker inhibition was ventricular lead damage. Which could be also suggestive, it is more common when

the lead is implanted using subclavian vein puncture, than through cephalic vein venesection. Presented recordings confirm that bipolar pacemaker may be inhibited by myopotentials, which usually is associated with lead

damage and should influence patient management. Our patient underwent transvenous lead extraction and during the same procedure new ventricular lead was implanted.
