# Analysis of the opportunities for improving energy efficiency in public buildings

**Abstract – Reducing energy consumption and maintaining an appropriate indoor air quality in buildings is a global trend. This is achieved in several ways – improving the building envelope thermal characteristics; fuel base replacement; introduction of smart energy consumption tracking systems. The aim of this paper is an analysis of the impact of energy efficiency measures introduced in buildings that provide health services. Measures have been taken to improve the energy performance of the envelope, as well as to modernize the system for the production and distribution of thermal energy. One complete year after energy savings measures implemented the total energy savings of 37.9% have been achieved. Further economic assessment has been made regarding the profitability of the applied measures.**

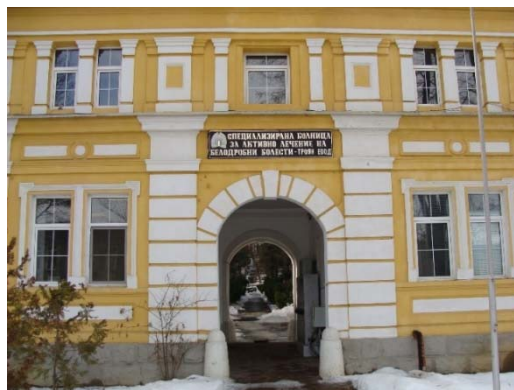
Fig. 2. View of hospital administration

building with a monolithic massive structure. The facades are lime-cement plaster, in a relatively good condition. The outer walls are masonry of solid bricks of different thickness without thermal insulation. The building is equipped with contemporary aluminium frames with double glazed windows. The roofs are tiled without thermal insulation, with the same height throughout the attic spaces. The floors of the building are made of concrete slab without thermal insulation with wooden flooring (laminare) and terracotta. All parts of the building are heated. An outline of the building is presented in Fig. 2.

The thermal performance characteristics of the building are presented in table 2.

Type of envelope	Heat transfer coefficient (U), W/(m <sup>2</sup> K)
External wall 1	<b>1.436</b>
External wall 2	<b>1.823</b>
Floor 1	<b>0.24</b>
Floor 2	<b>0.291</b>
Floor 3	<b>0.318</b>
Floor 4	<b>0.401</b>
Roof	<b>0.692</b>

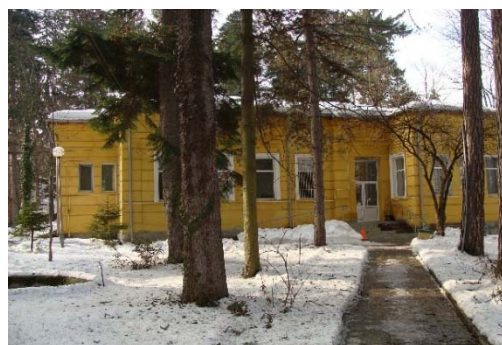
Fig. 3. View of pneumology 1 hospital building

The structure of the building is similar to that of Building 2. A general view is presented in Fig. 3.

Type of envelope	Heat transfer coefficient (U), W/(m <sup>2</sup> K)
External wall 1	1.436
Floor 1	0.241
Roof	0.694

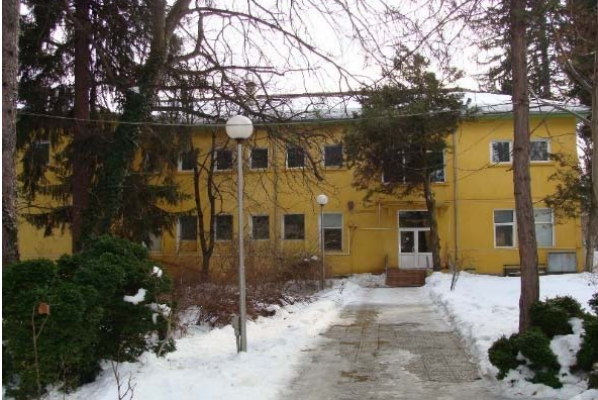
Fig. 4. View of pneumology 2 hospital building

The structure of the building is similar to that of Building 2. A general view is presented in Fig. 4.

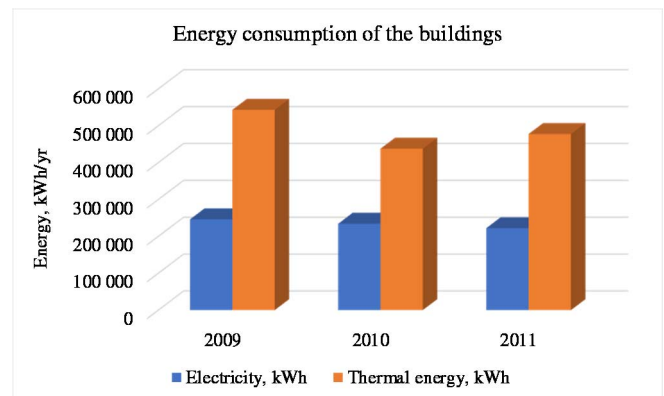
Table 5 and Figure 5 show the energy consumption by years for the period, as well as the number of heating day degrees. From Fig. 5 it is evident that the share of electricity consumption during the surveyed period is between 31% and 35% and the consumption of the thermal energy - 65-69%.

Fig. 5. Yearly annual energy consumption of the buildings

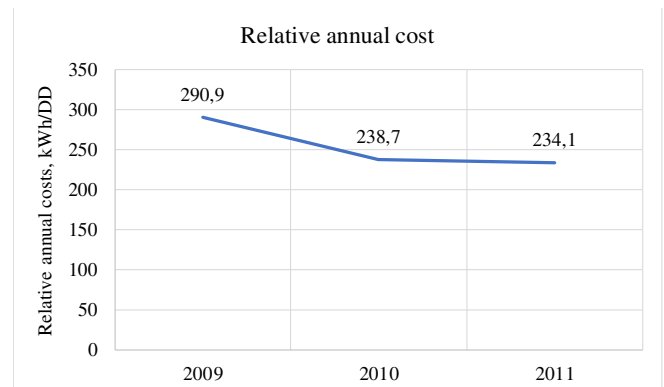
The relative annual energy consumption, as shown in Fig. 6, is calculated based on this data. It is clear that the relative annual energy costs do not significantly change over the last two years and are less than the costs in 2009. This is due to the fact that in 2009, there has been a replacement of the window frames of the building, as a result of which the specific energy consumption has decreased.

Fig. 6. Relative annual costs, kWh/DD

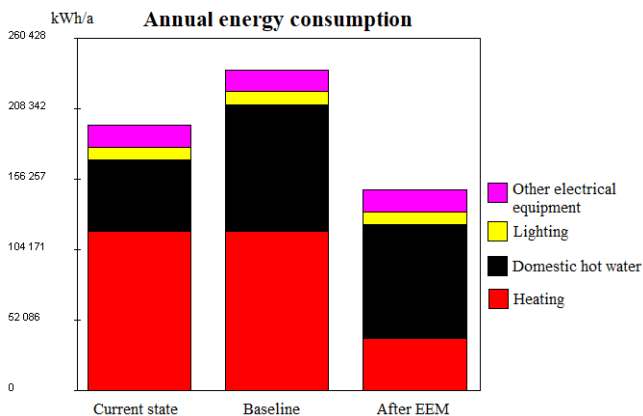
A survey of the energy consumption in the buildings was carried out. The results of the survey are presented in Fig. 7-10. The normalization of the energy consumption was needed, in compliance with the normative requirements for maintaining the necessary temperature comfort. For all four buildings, the normalized energy consumption is increased, indicating that at the time of the survey the buildings were under-heated.

Fig. 9. Outputs from the energy modeling of building 3
