# A Platform for Proactive, Risk-Based Slope Asset Management, Phase II

Alaska University Transportation Center  
Duckering Building Room 245  
P.O. Box 755900  
Fairbanks, AK 99775-5900  
**Publication Number:** INE/AUTC 15.03

**Date:** March 2015

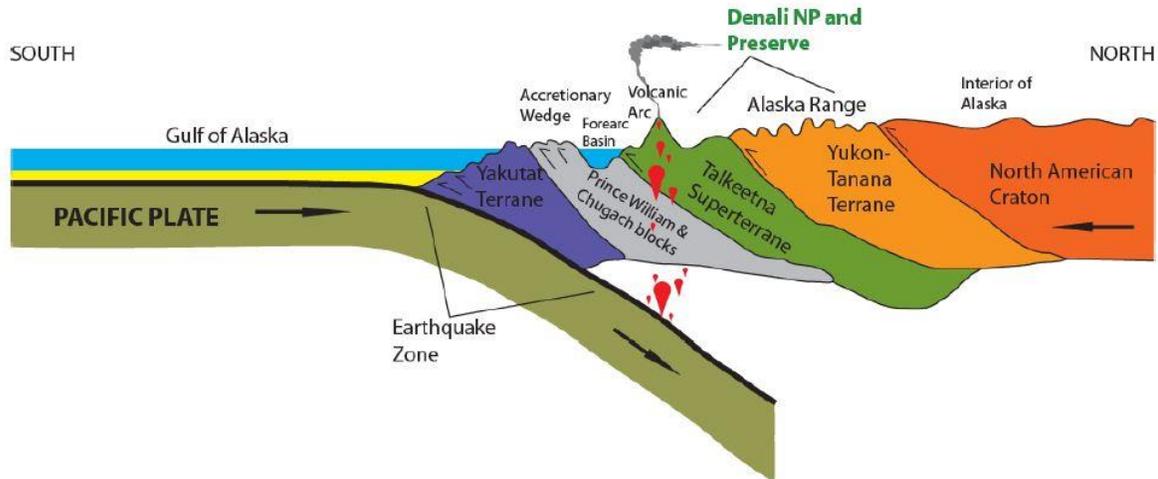
**Figure 2** Alaska Terranes (Thornberry-Ehrlich 2010)

Alaska largely consists of a number of accreted terranes, as shown in Figure 2. These terranes are the product of subduction, whereby the Pacific plate has acted as a conveyor belt for geologic material, bringing in portions of distinctly different rock that has become bound together by faults (Thornberry-Ehrlich 2010). The collision of these terranes with the existing

land mass has caused the uplift of mountains, volcanic activity, and seismicity that are associated with Alaska today.

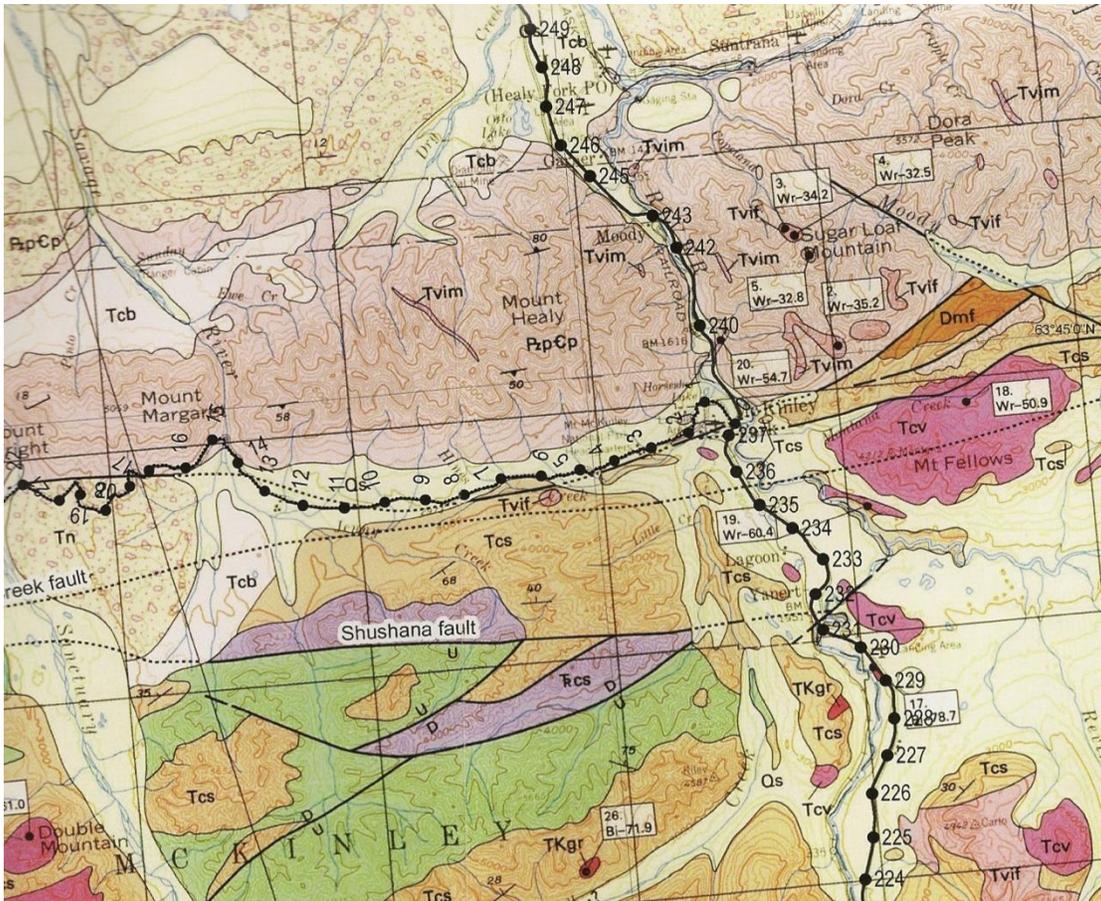
**Figure 3** Geologic map of the Glitter Gulch area.

the area that shows volcanic dikes (Tvim, Tvif) within the Healy schist (PzpCp). The volcanic rock can be clearly seen as the darker rock in Figure 4, with a lighter Healy schist layer below.

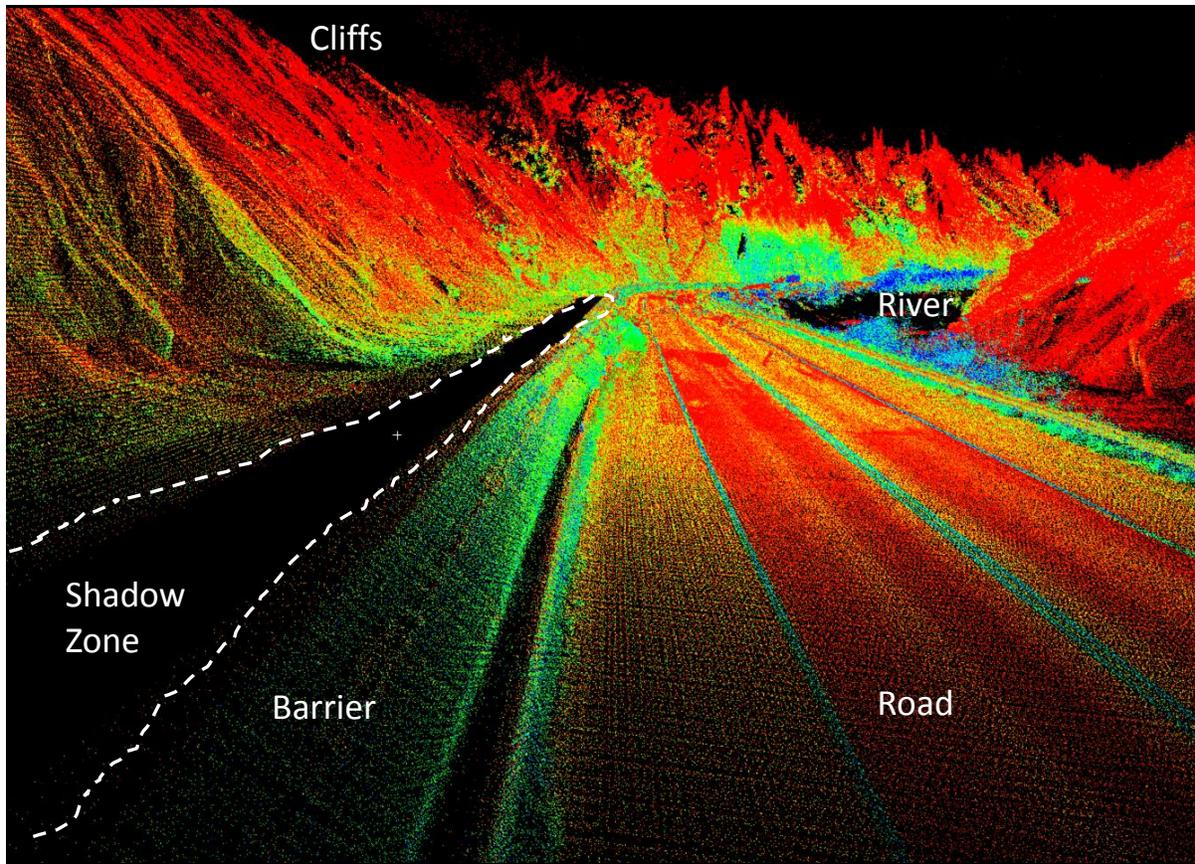
**Figure 6** Shadows in point cloud due to mobile lidar perspective

Because some features were difficult to capture from the perspective of the moving vehicle on the highway, supplemental terrestrial static scans were collected using a Leica *ScanStation*. These static collects were made from more advantageous and safer locations off the highway; however, even at these sites, surveyors were unable to collect data for some features, such as the tops of cliffs, or features behind guard rails and other barriers. Additional survey control was necessary to link the mobile and static scans together into a single point cloud.

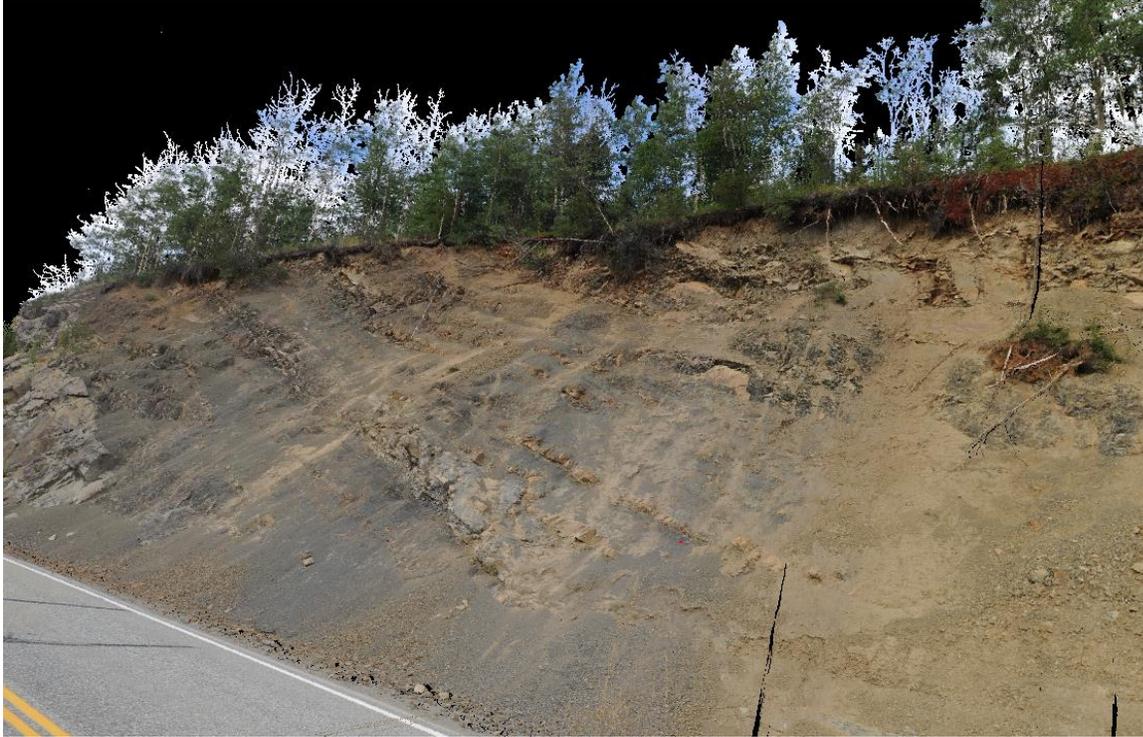
**Figure 7** Colorized point cloud of Long Lake geology

Cameras facing forward and to the side of the vehicle collected video at one frame per second. This imagery was later used to colorize the lidar point cloud. The colorization of the point cloud allows better interpretation of the lidar point cloud including the complex geology of the slope with natural colors for the different rock types and talus.

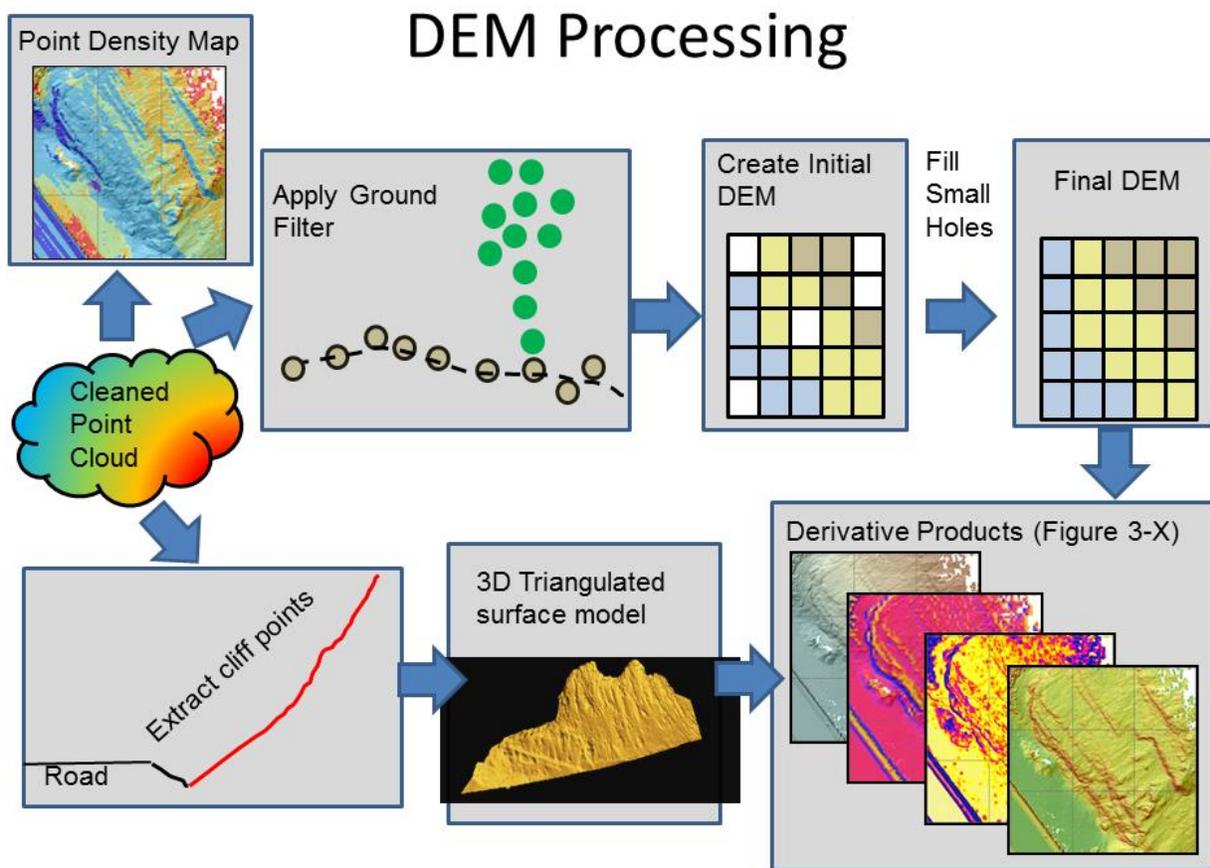
**Figure 8** DEM Processing and creation

The software used to scrub and classify the lidar point cloud has sophisticated automation utilizing a variety of statistical methods. However, these algorithms require considerable human supervision and assistance to ensure that the algorithms perform correctly. Additional software was developed for this project to assist with processing special morphologic features that characterize the slopes being analyzed – including the curvature of the slopes – and to account for rock overhangs. Finally, manual quality control was performed to remove any remaining lidar artifacts.

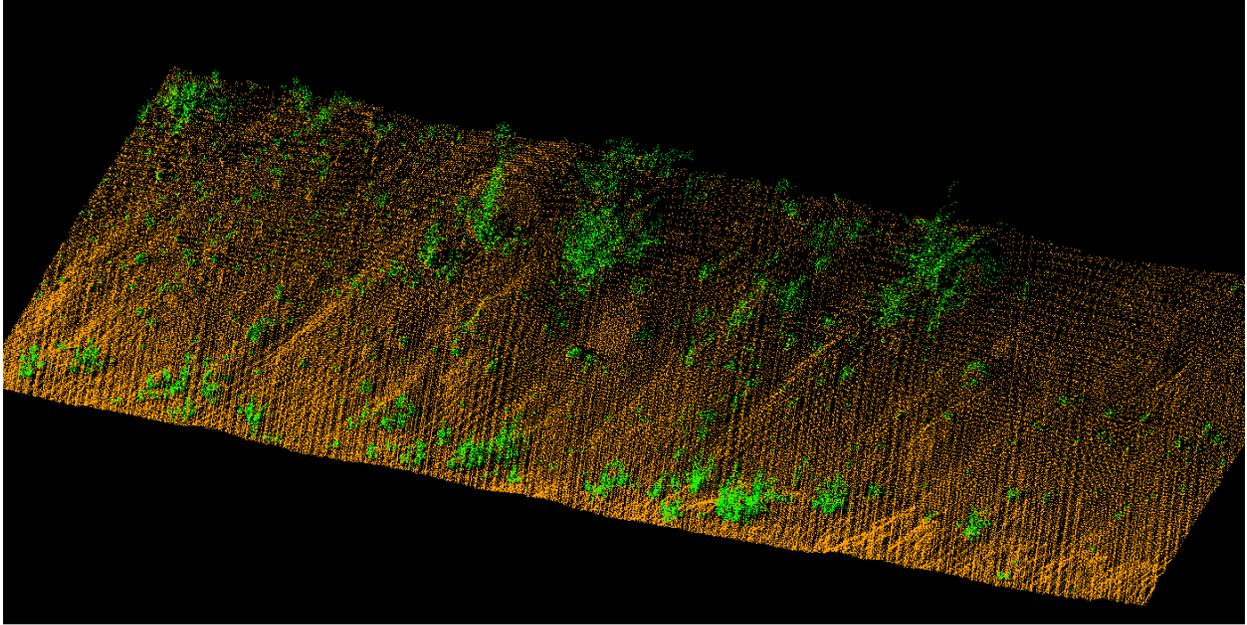
**Figure 9** Oblique Ground Filter applied to the 2012 mobile lidar data at Long Lake  
Green = classified as vegetation, brown = classified as ground

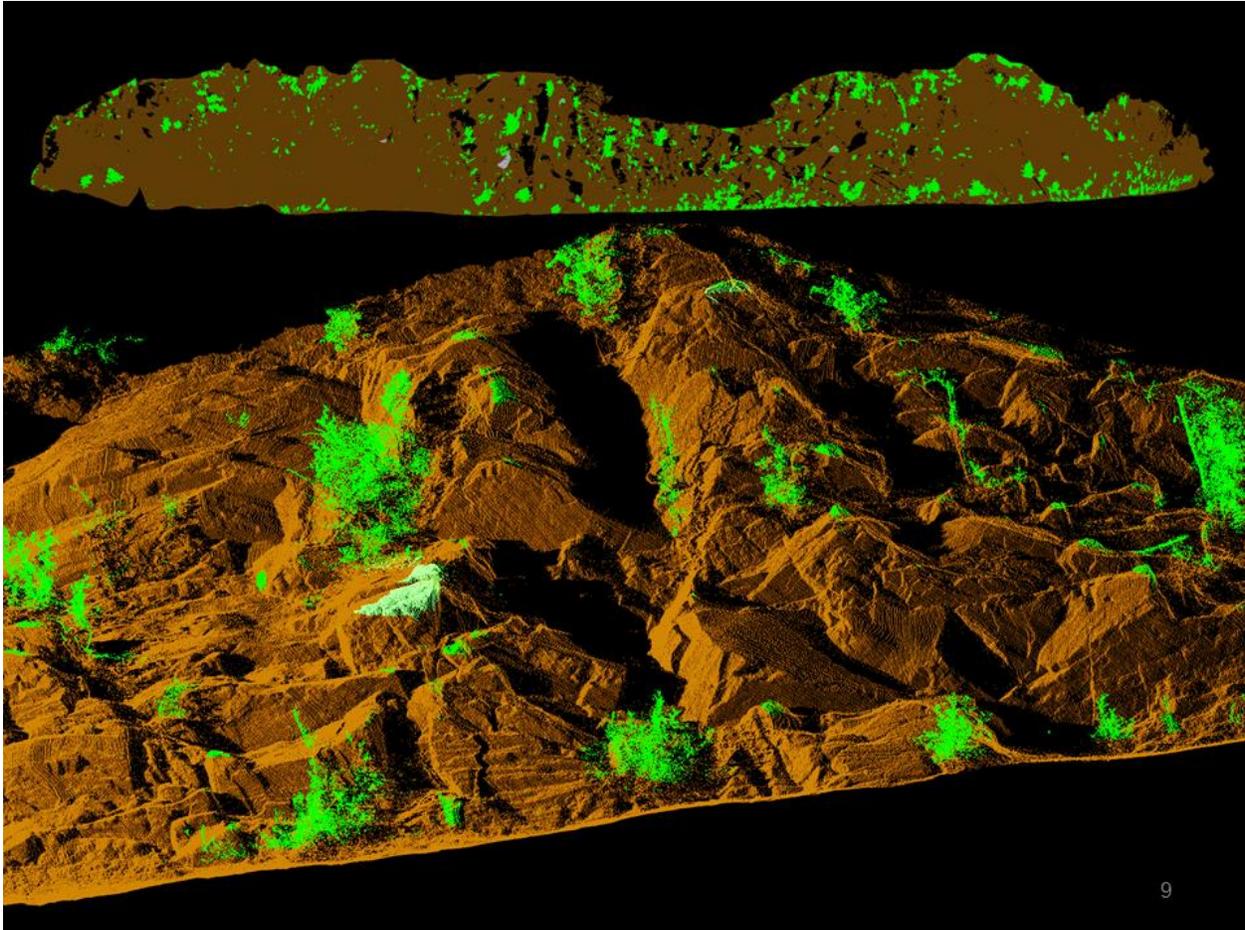
**Figure 10** Oblique Ground Filter applied to the 2014 lidar data at Long Lake MP87  
Green = classified as vegetation, brown = classified as ground  
Top = entire section, bottom = close-up view.

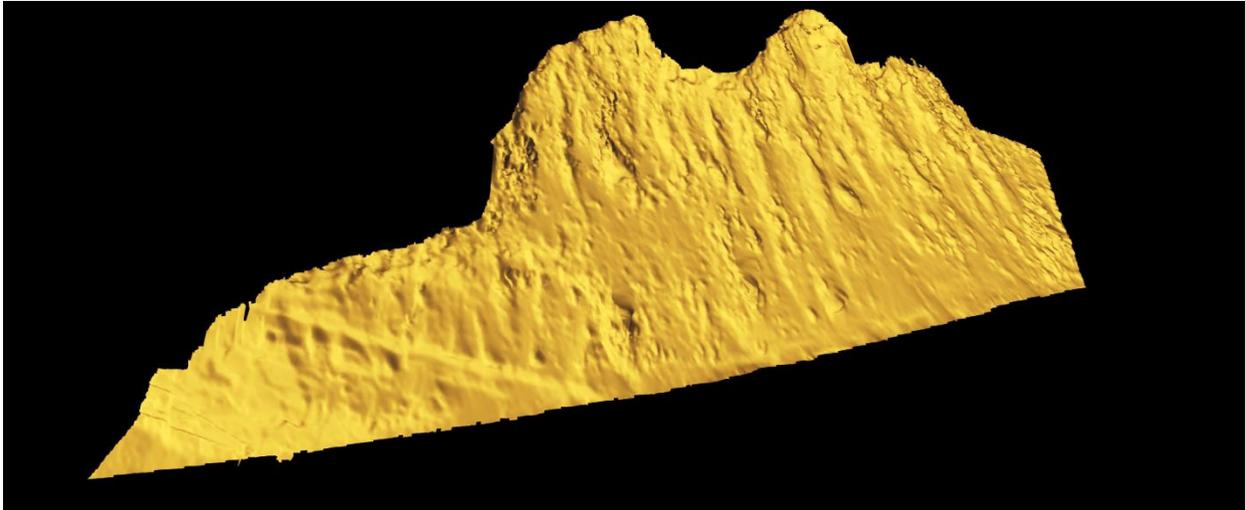
**Figure 11** Example of a triangulated surface mesh at the Long Lake site

The TIN is a surface model that can be viewed from any perspective, even from beneath. This can be an advantage if processing techniques can utilize the perspective of the slope in various calculations; for example, the lidar point cloud can be analyzed from a look angle that is generally orthogonal to the slope. This technique improves the quality of later change detection, but also minimizes issues related to slope curvature and rock overhangs. The TIN also has the advantage of being able to visualize surface roughness better than the DEM, because the surface can be shaded with arbitrary angles of illumination in order to help the human visualize the slope. The Phase I report describes TIN surface modeling in greater detail.

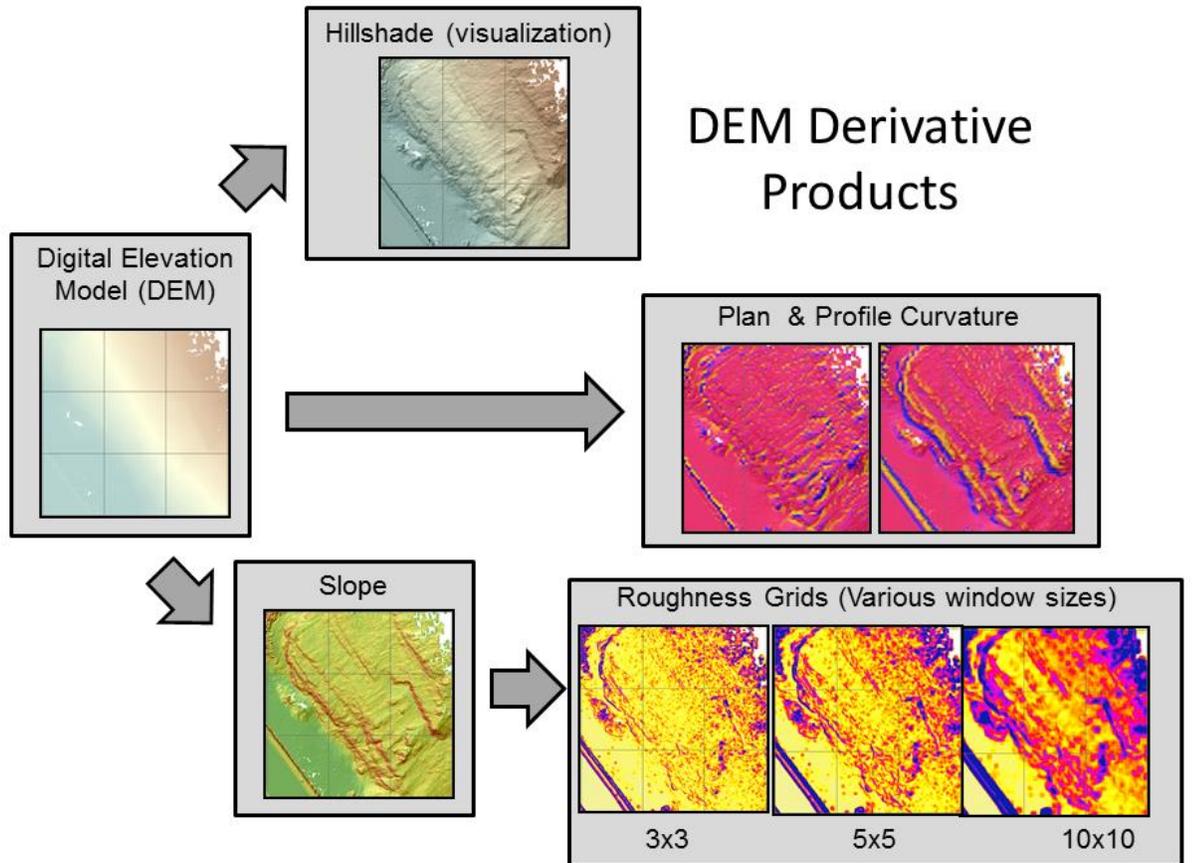
**Figure 13** DEM Processing Steps and Products

A variety of derivative products were developed from these TINS to improve analysis. These products were created with a grid that was set to the best fit plane to the cliff rather than in the XY plane for improved classification results and modeling of overhangs. Figure X below shows an example of the types of products that can be produced from the 2.5D TIN model. The key steps in generating these models are

14. Calculating the 3D slope for each cell from its surface normal
15. Obtaining several surface roughness values by determining the standard deviation of slope within a variety of window sizes centered on the pixel of interest (e.g., 7x7 cells, 17x17 cells).

16. Perform clustering analysis using a connected components algorithm to identify clusters of positive and clusters of negative change for individual failure analysis.

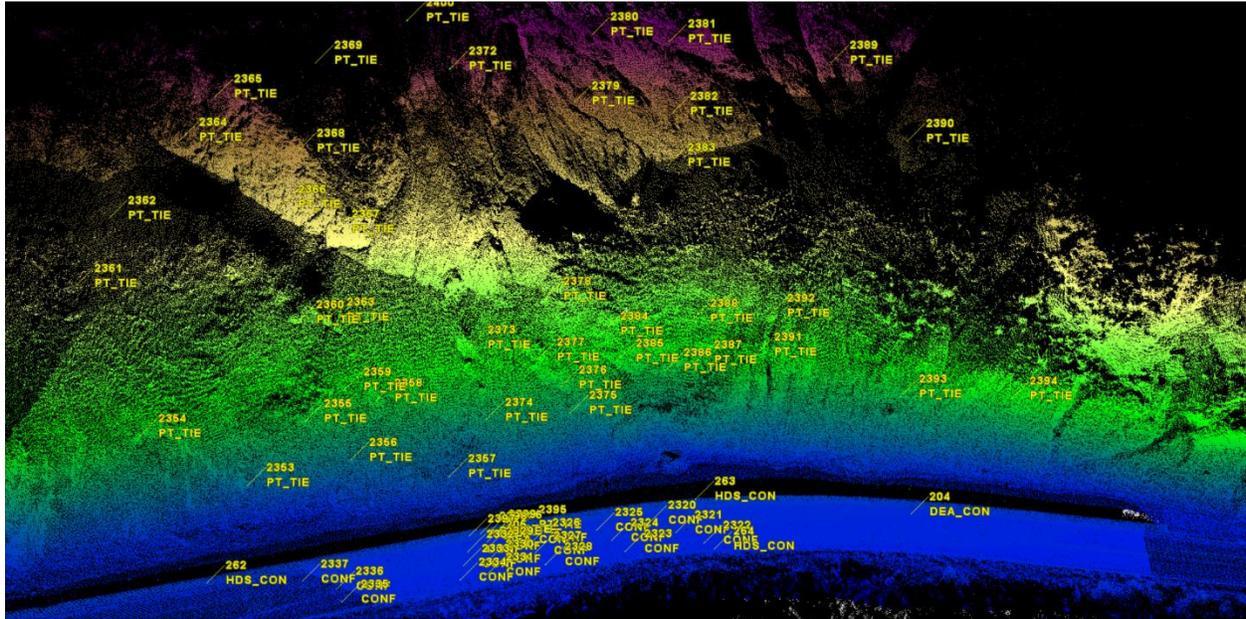
**Figure 14** Example of validation points collected with a total station

To ensure that the change detection methods are accurate, a rigorous quality control process was implemented. For this slope study, significant time was spent to ensure that any detected change is accurate. One component of the quality assurance process is comparing the lidar point cloud to another set of survey data. The accuracy comparisons were typically in the

range of 3-4 cm (3D RMS) at both the Long Lake and Glitter Gulch project sites; however, in some cases, poor GPS quality resulted in degraded accuracies of 7-8 cm (3D RMS).

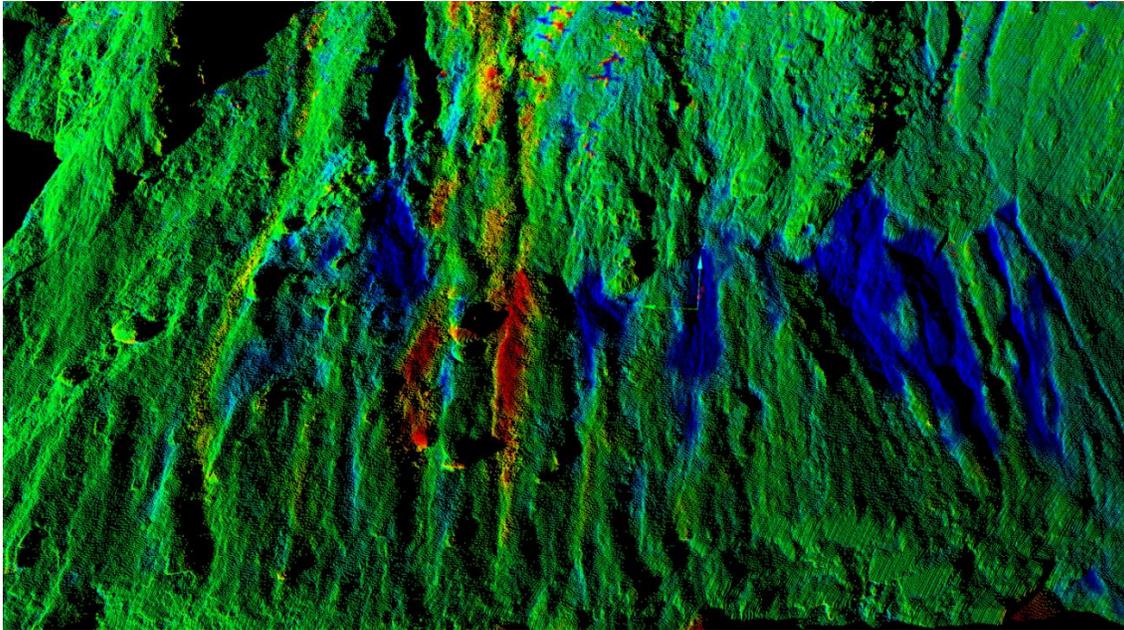
**Figure 15** Close-up of eroded material (blue  $< -0.25\text{m}$ ) at Glitter Gulch.

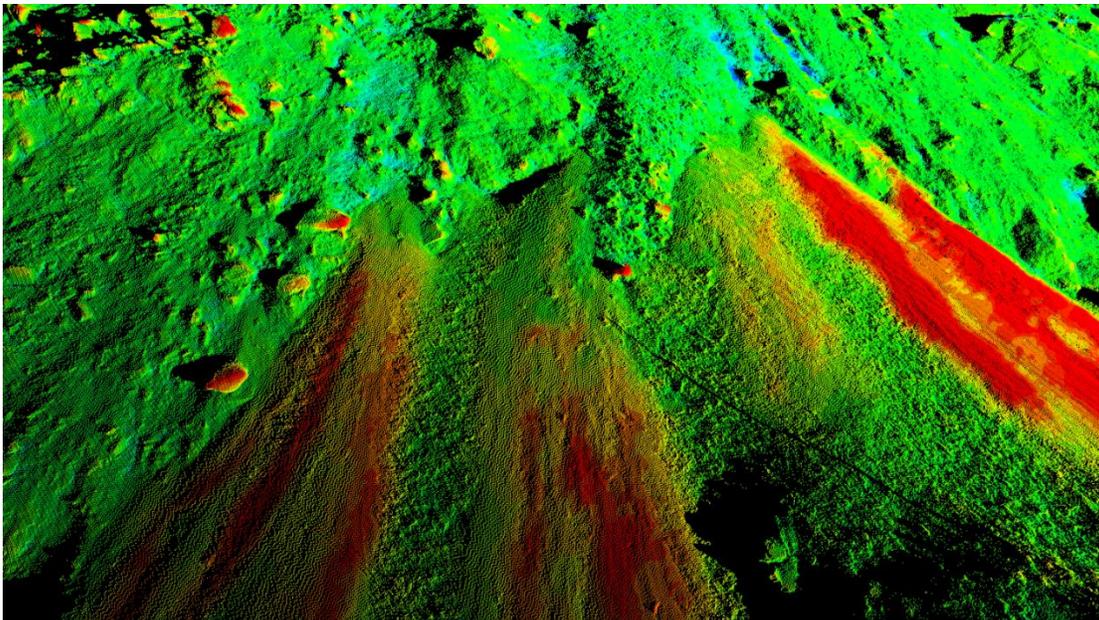
**Figure 16** Close-up of accreted material (red  $> 0.25\text{m}$ ) and eroded material (blue  $< -0.25\text{m}$ ) at the Glitter Gulch.

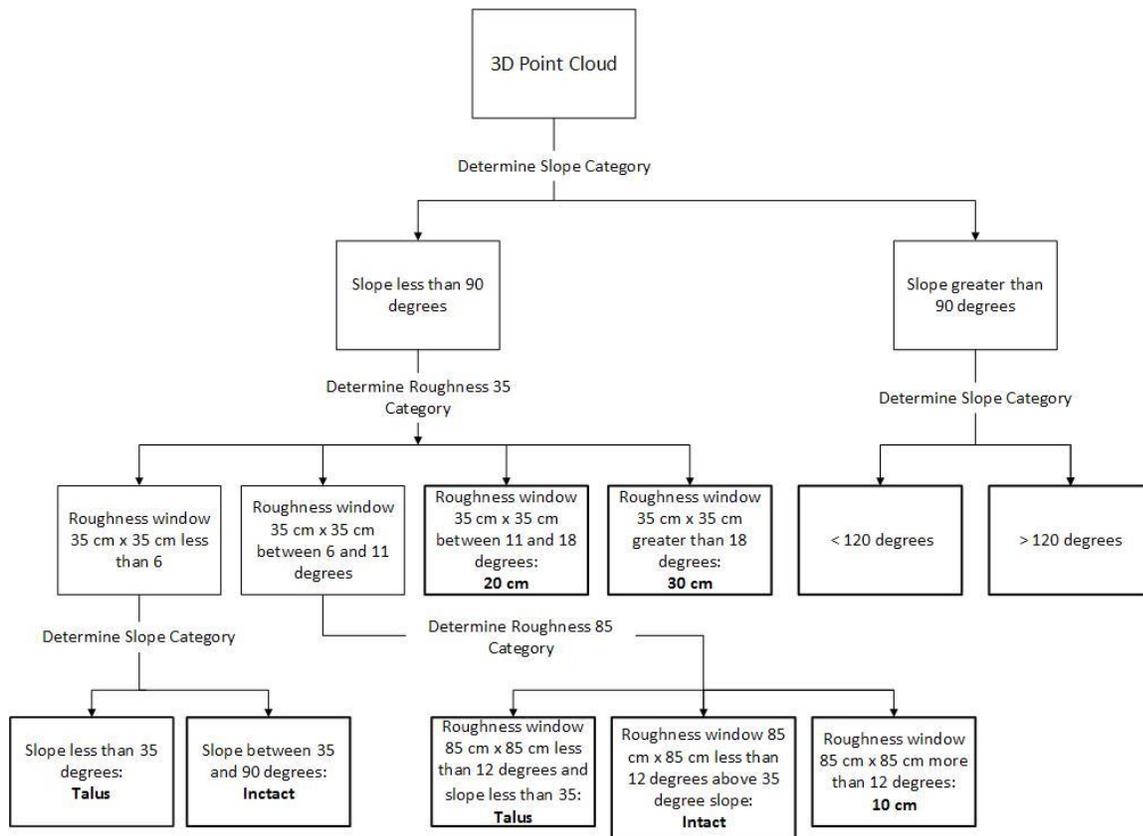
Rock-slope classification for point-cloud derived grid cells are determined based on the logic tree algorithm shown in figure 1. , the class of each cell of the grid can be determined through a process of elimination resulting in 7 categories described in table 1. Figure 2 are simple cross sections depicting two different classes of rock overhangs. Figure 3 shows the difference between the 10 cm, 20 cm and 30 cm classes. These sizes are approximate and there is some overlap between these. Generally these classes represent the size of rock which will fail from these areas. Smaller rocks may be large enough to do damage to vehicles when run over such as cracking windshields or oil pans. The 30 cm classification is more indicative of rock failures that might be such that a vehicle would have to swerve to miss. Figure 4 shows talus and intact. These two classes are difficult to fully distinguish between with the morphological indices but act similarly in that they are most likely not the trigger points for failure but areas surrounding them such as overhang are more likely to fail such that they too will fail. Another strong distinguishing point between intact and talus is that talus normally does not occur above a soils angle of repose, so areas with smaller angles are more likely to be talus.

**Figure 19** Flow chart of the RAI system. Starting with the 3D point cloud, the slope is first considered so that overhangs can be immediately categorized. After slope, roughness at a small window size (35cm x 35 cm) 30 cm and 20 cm. The last three classifications are determined in part by slope and part by large roughness with a larger window size of 85 cm x 85 cm.

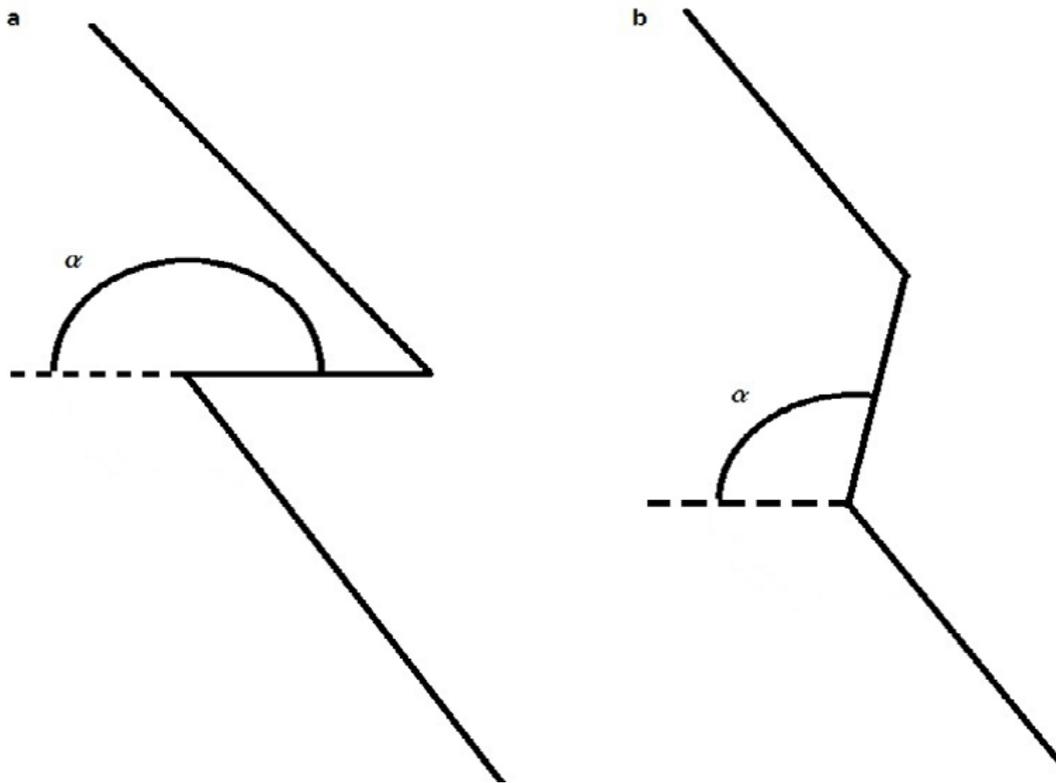
**Figure 20** Representation of the difference between overhang  $> 120$  degrees (a) and overhang  $< 120$  degrees (b). Alpha is the angle which is measured for the slope. Larger slopes indicate that more material is above them if failure were to occur, therefore they are considered more hazardous.

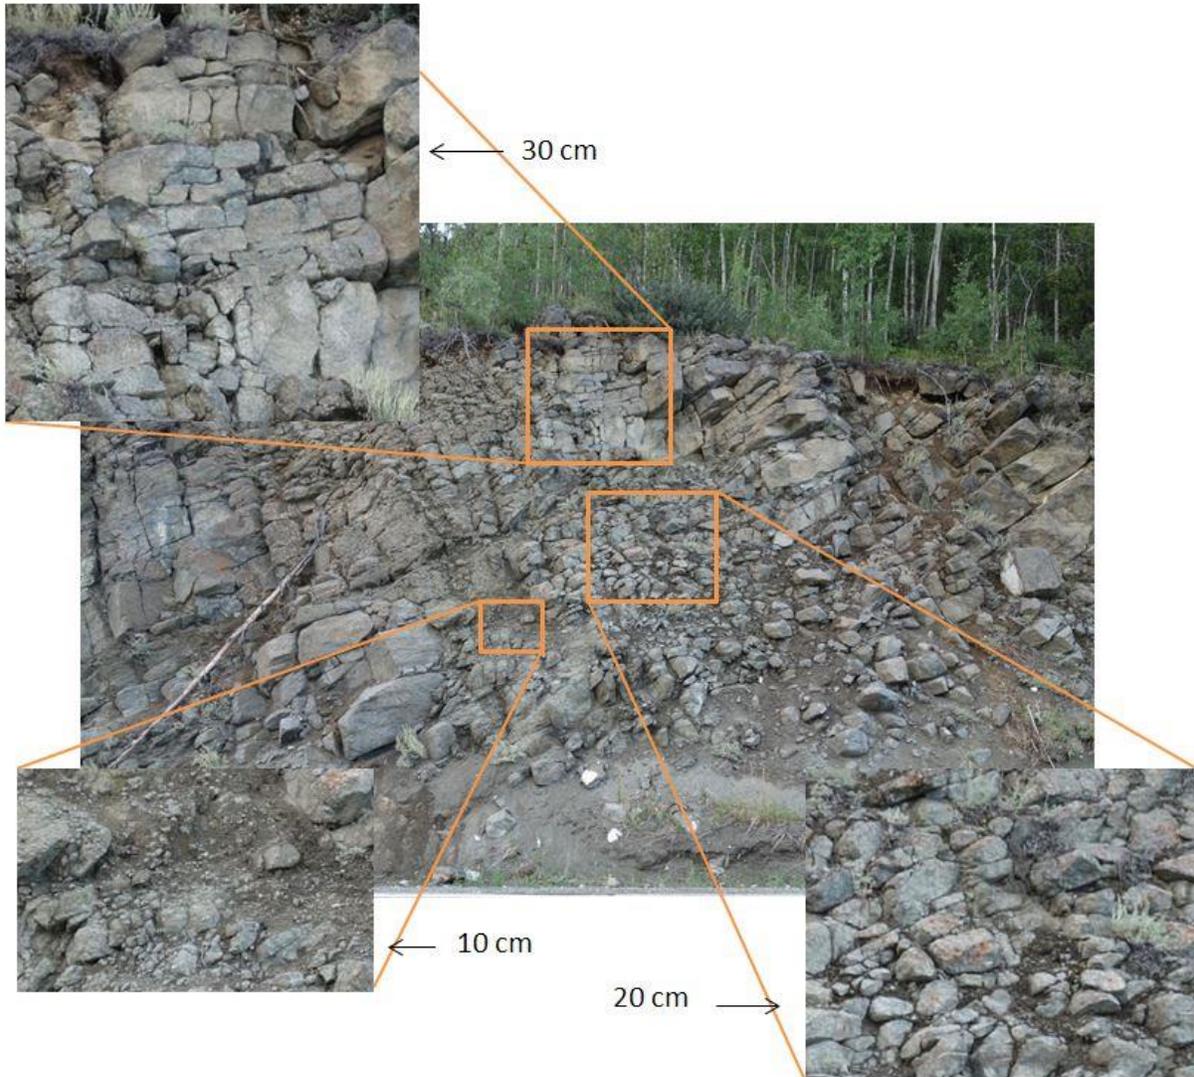
**Figure 21** Examples of 10, 20 and 30 cm size categories. These categories are approximate sizes.

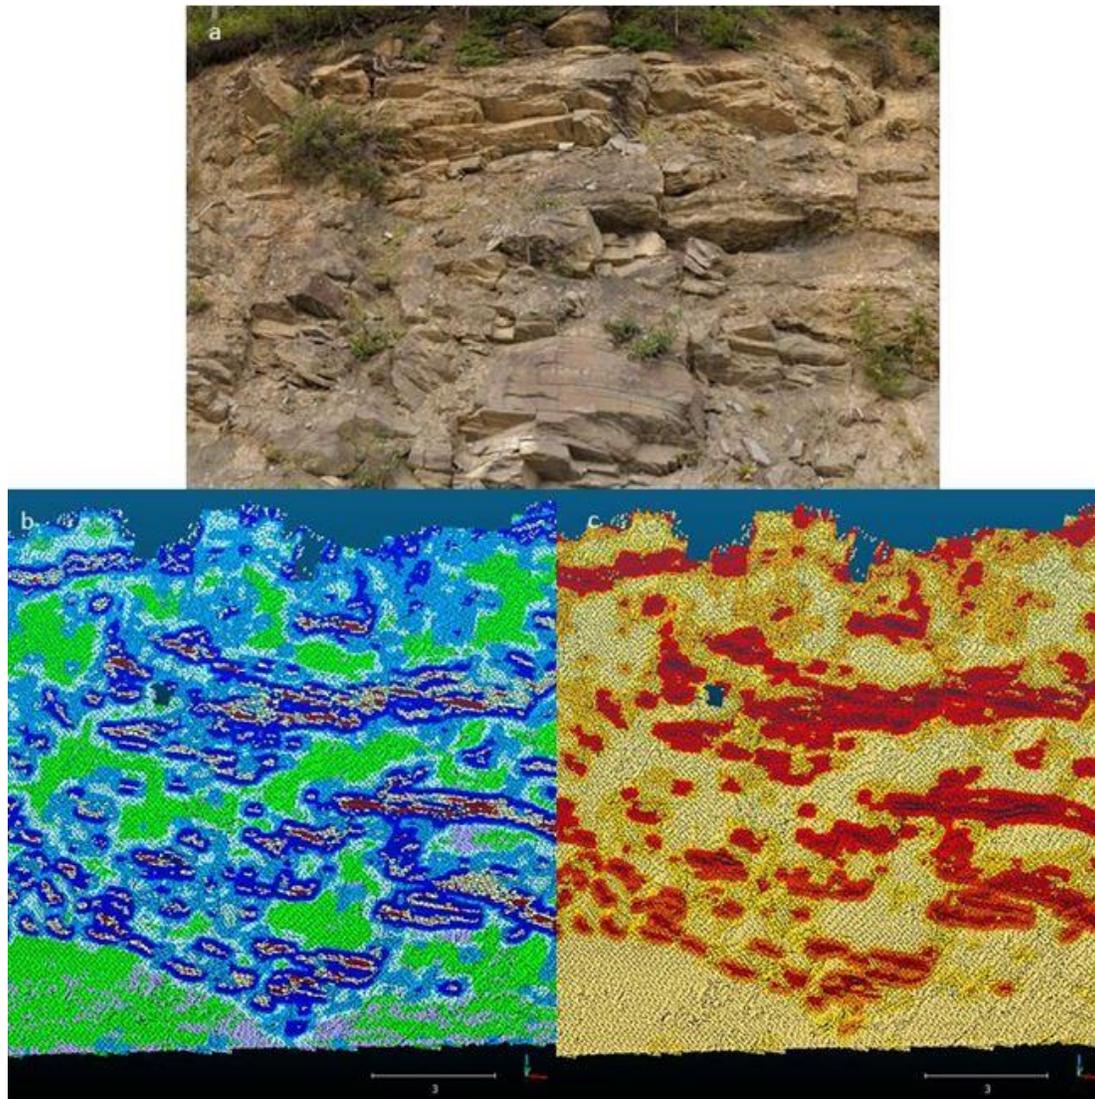
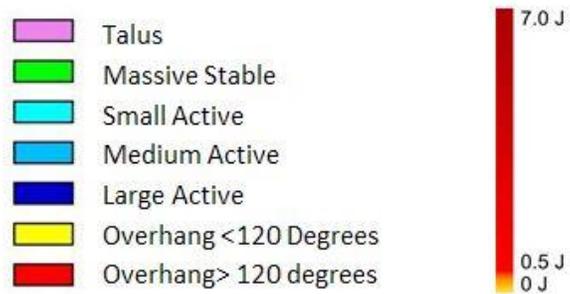
shows a close up of one section showing a) a photograph of the area, b) the RAI classification and c) the RAI hazard rating. From a 2D perspective of a photograph, overhangs can be difficult to distinguish. However, the classification system readily highlights overhang areas highlighting them in red and yellow coloring. Areas in blue are those in the 10 cm, 20 cm and 30 cm classifications, while the purple and green are talus and intact, respectively. The hazard map (c) also highlights the overhangs because of the greater potential for failure. Another aspect that affects the hazard rate is the height (h) of slope from the road; as height (h) increases up, the hazard also grows.

**Figure 22** RAI examples: a) photo of the area shown in b) RAI classification and c) RAI hazard rating, that shows the highlighting of overhangs within a system.

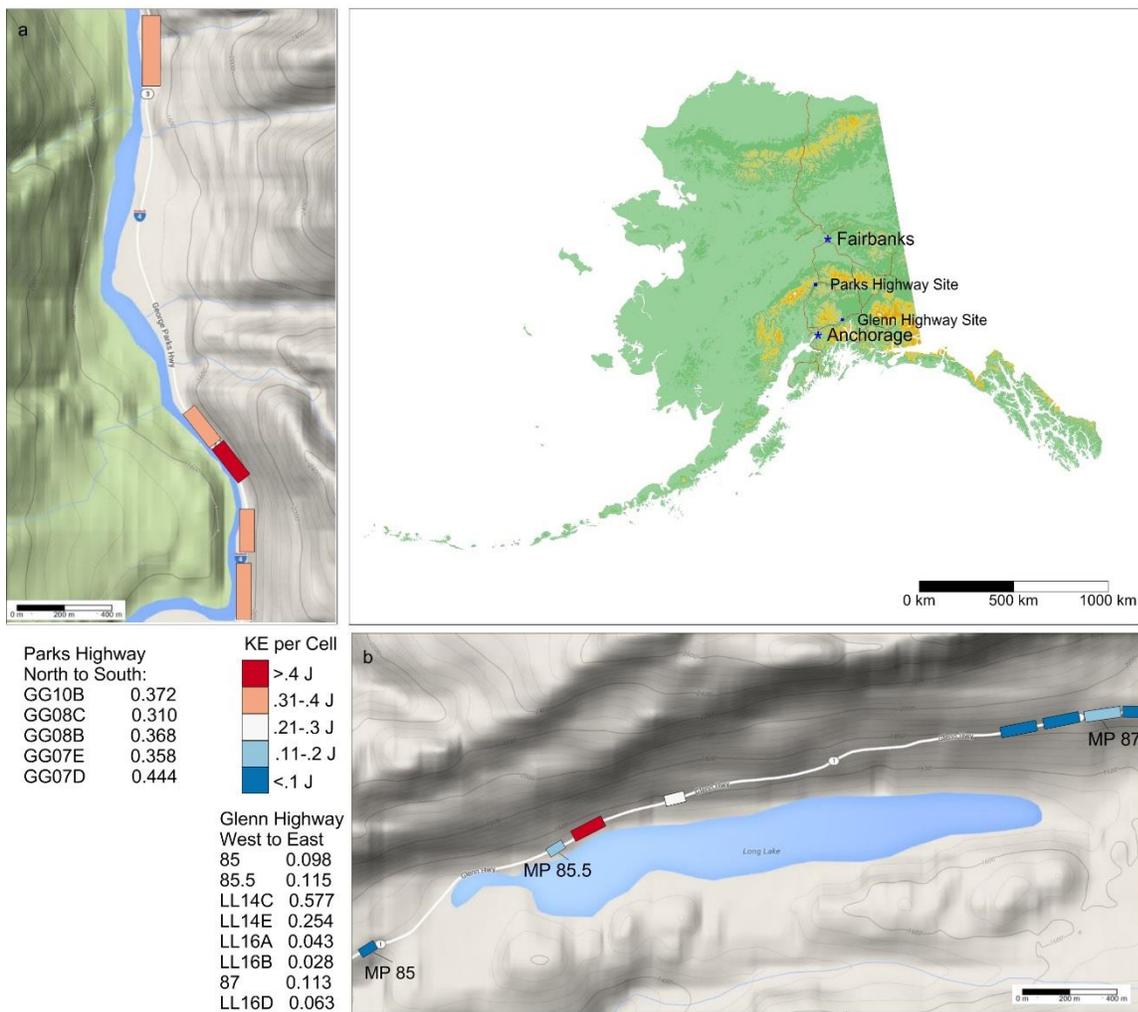
The next figure shows the classification of all the sites along Parks Highway and Glenn Highway. The areas along Glenn highway, with the exception of one have lower energy release than those of Parks Highway. Parks Highway geology is of a weaker schist compared to Glenn Highway geology of sedimentary rocks which might partially drive this difference. Other drivers might be the maximum heights at a site or the length of the site. The latter will be addressed in a later section.

**Figure 23** Map of the study areas their RAI scores, a) Parks Highway and b) Glenn Highway

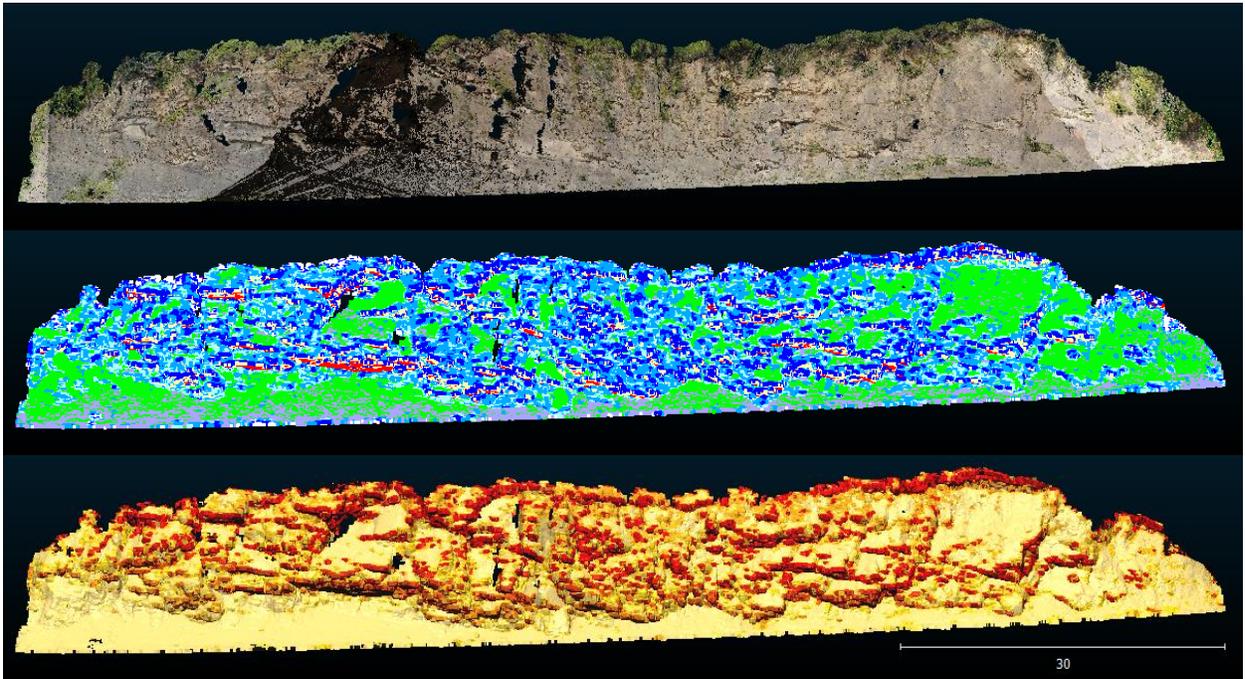
Figure 7 show an example of the RAI for MP 87 of Glenn highway. The figure shows (a) the lidar point cloud data, (b) classification system and (c) and hazard rating. Similar data for other sites are included in the Appendix. Visually comparing the RAI with the photographs suggests that the RAI preforms well for classifying the rock-slopes. It is difficult for the RAI to identify individual rock sizes correctly, so the categories of 10cm, 20 cm and 30 cm should be regarded as a generalization of what is occurring within an individual area. For example, a large rock will act more like an intact area towards its center, so the edges of the large rock are picked out, and the center is classified as if less erosion is taking place.

**Figure 24** MP 87 of Glenn Highway: a) lidar point cloud data, b) RAI classified cloud and c) RAI hazard rating. Note the small black sections are areas where there are holes in the coverage due to shadow and lidar scanner positions.

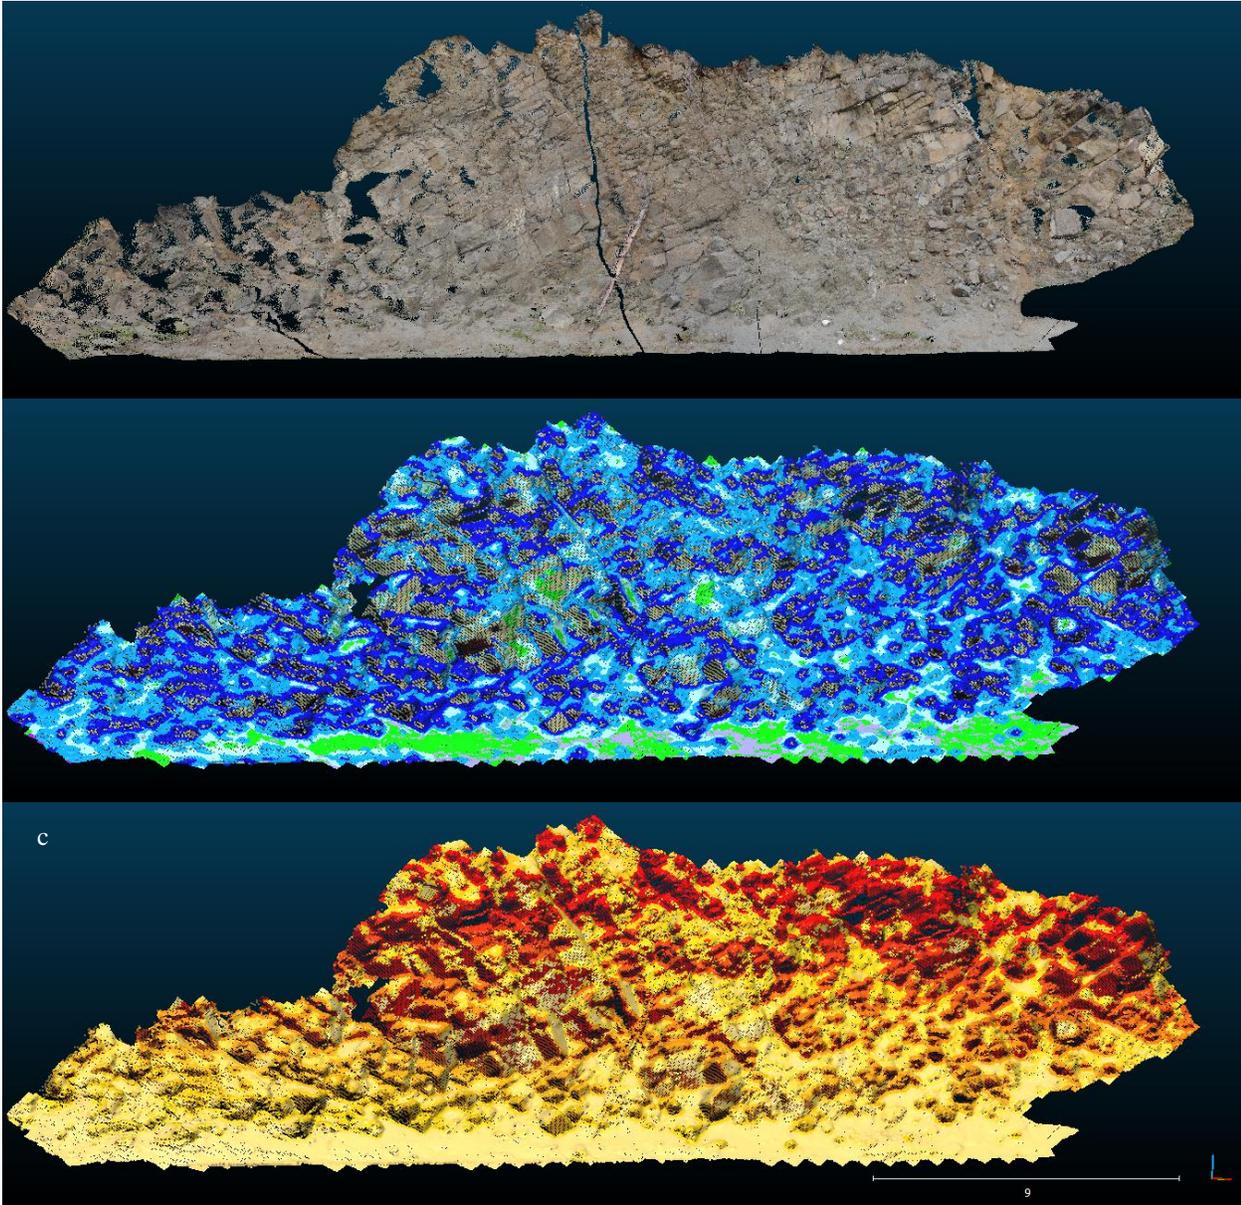
**Figure 25** MP 85.5 of Glenn Highway: a) lidar point cloud data, b) RAI classified cloud and c) RAI hazard rating. Note the small black sections are areas where there are holes in the coverage due to shadows and lidar scanner position.

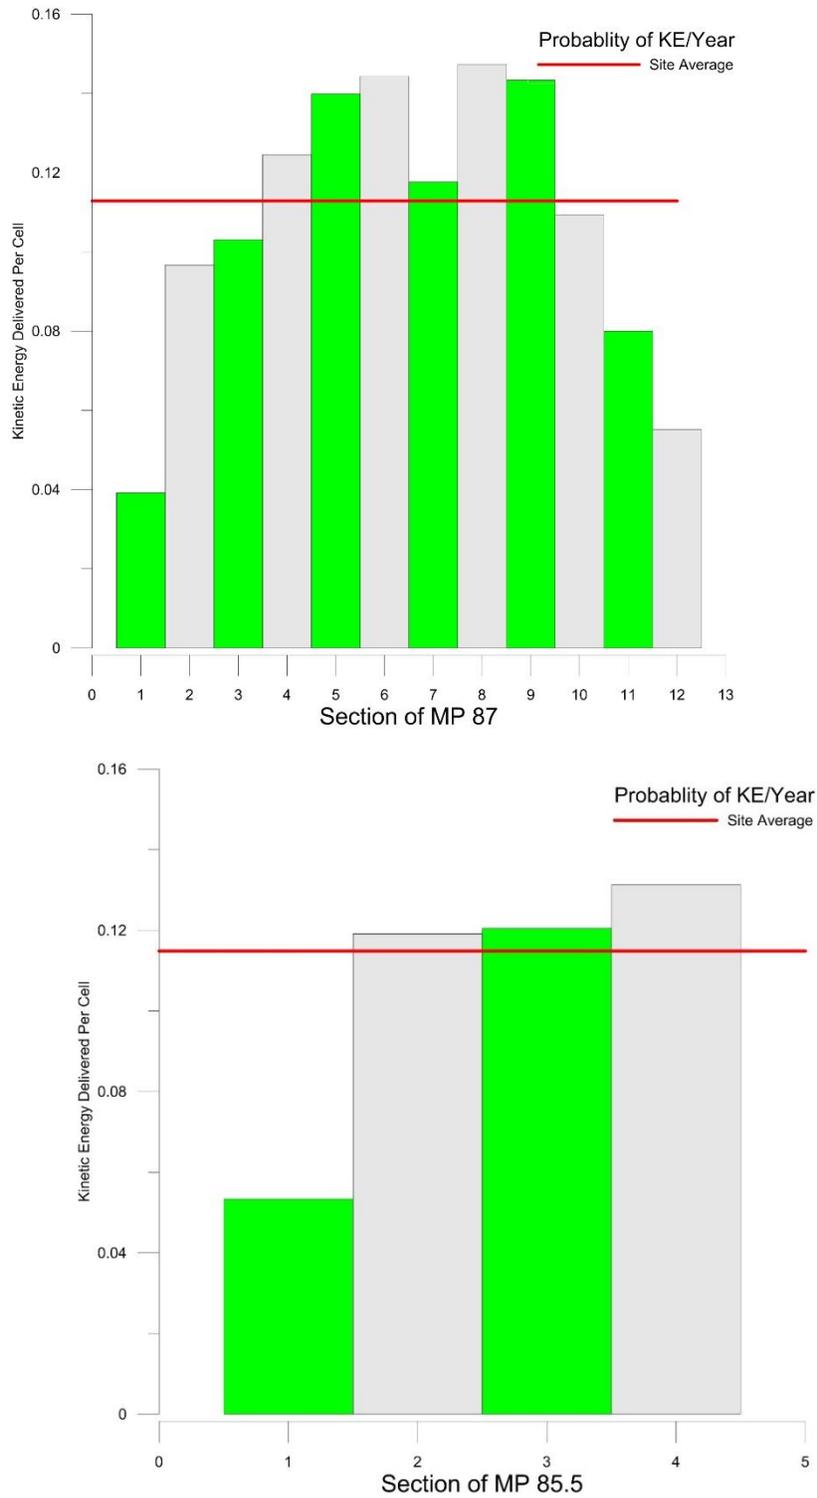
In the next three figure, the overall score for each site was shown, but each site can be divided into smaller geographic segments for a more generalized quantitative analysis of the risk along the highway. Figure 9a represents the cumulative RAI score across 10-meter road-length segments for MP 87. These generalized RAI assessments allows one to identify the sites which present the highest risk and find what portions of the slope are contributing to that risk.

**Figure 26:** Energy cell segments: a) section 87 and b) section 85.5 are split into 10 m segments and the energy per cell is calculated for each segment. The red line is the site average.
