# A Platform for Proactive, Risk-Based Slope Asset Management, Phase II

Alaska University Transportation Center  
Duckering Building Room 245  
P.O. Box 755900  
Fairbanks, AK 99775-5900  
**Publication Number:** INE/AUTC 15.03

**Date:** March 2015

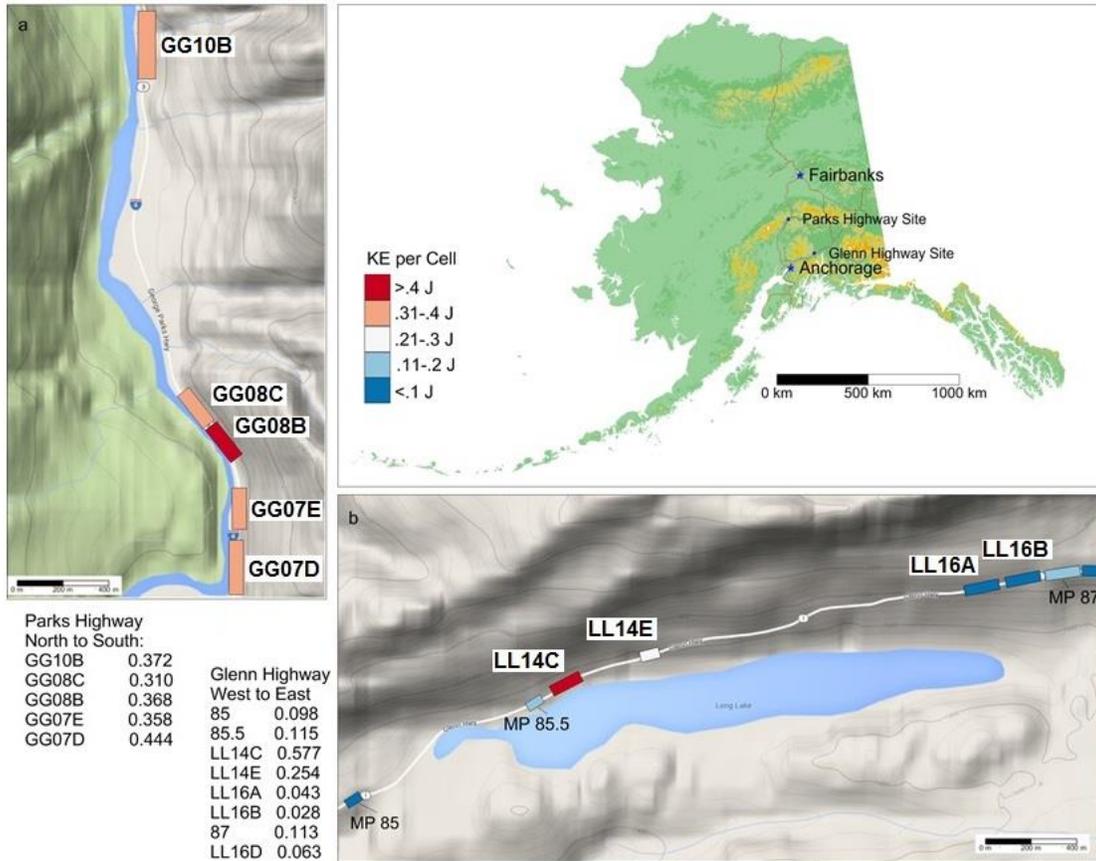
**Figure B-1** Site map showing location of study sites along the highways in Glitter Gulch (GG) and Long Lake (LL) in Alaska. The total Kinetic Energy (KE) for each site/cell is shown, highlighting locations with higher levels of activity.
