Development of resilient and environmentally responsible highway infrastructure solutions using geopolymer cement concrete

Allstair Wilkinson¹, Bryan Magee¹, David Woodward¹, Svetlana Tretsiakova-McNally²

¹Studies Allied to Built Environment Research (SABER), Ulster University, Shore Road, Newtownabbey, Northern Ireland.

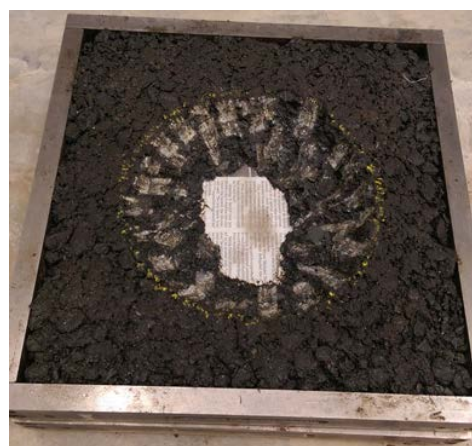
2.5 Pothole Repair Material

Figure 1. Simulated pothole for geopolymer repair material investigation.

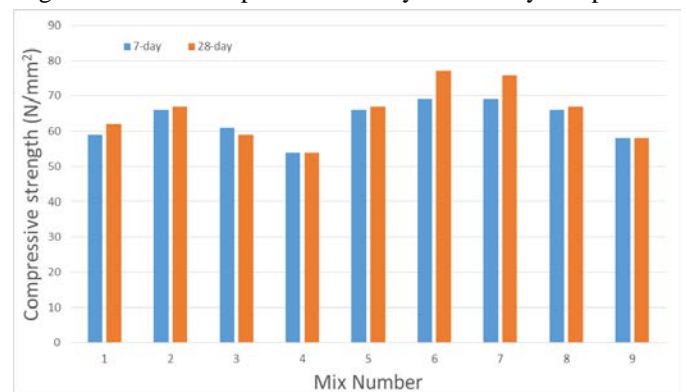
Figure 3. Relationship between 7 day and 28 day compressive

strengths of geopolymer mortar mixes.

Table 2 shows the mean 7 day compressive strengths, and mean 28 day compressive and flexural strengths. As shown in the results, all specimens exhibited 7 day compressive strengths of at least 89% of the 28 day compressive strengths. Mixes 4 and 9 achieved the 28 day strength after 7 days, while mix 3 showed a slight reduction in compressive strength of around 3%, between 7 days and 28 days. As mix 3 had a higher activator content than the other mixes, this may suggest that the activator content exceeded the maximum content level of this component. Figure 3 illustrates the relationship between 7 day and 28 day compressive strengths. It was also found that the majority of 28 day flexural strength results were around 4% of the corresponding 28 day compressive strengths. This is a common trend when testing mortars using only fine aggregate. However, no trend between 28 day compressive strength and 28 day flexural strength was obvious from this investigation.

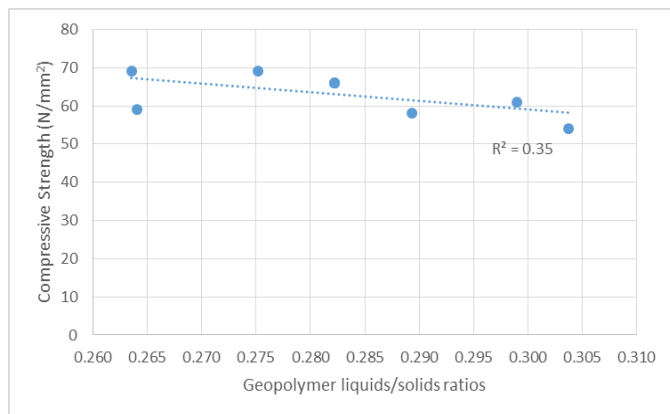
Figure 4. Effect of geopolymer liquids to geopolymer solids ratio on the 7 day compressive strength of geopolymer mortar.

The ratio of geopolymer binder liquids to geopolymer binder solids is thought to play a role in the compressive strength of geopolymer mortar, much like the effect of water/cement ratio when using ordinary Portland cement. Figures 4 and 5 show the effect of geopolymer liquids to solids, for 7 day and 28 day compressive strengths respectively. As shown in figure 4, after 7 days, the general trend is that compressive strength decreases, as the geopolymer liquids to solids ratio increases ($R^2=0.35$). Figure 5 shows that this relationship becomes more apparent for 28 day compressive strength ($R^2=0.54$).

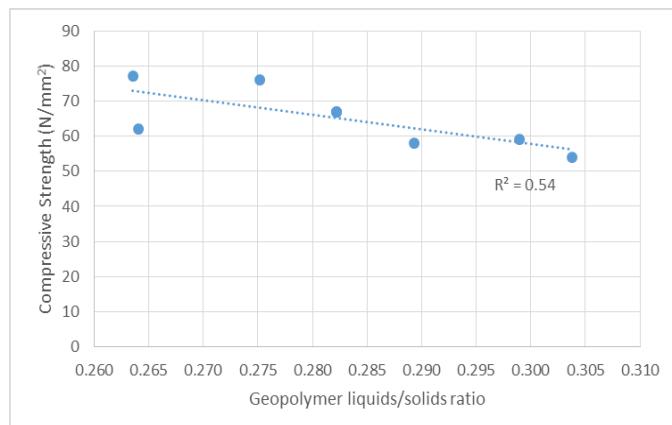
Figure 5. Effect of geopolymer liquids to geopolymer solids ratio on the 28 day compressive strength of geopolymer mortar.

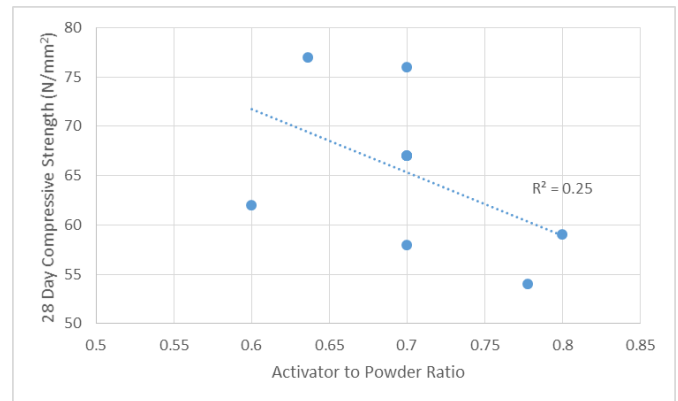
Figure 6. Effect of activator to powder ratio on 28 day compressive strength of geopolymer mortar.

The ratio of activator to powder also appears to play some role in the 28 day compressive strength of geopolymer mortar. This trend is shown in Figure 6, where $R^2=0.25$. However, some variance in the results would indicate that the geopolymer liquid to solids ratio plays a more important role in the geopolymer strength development.

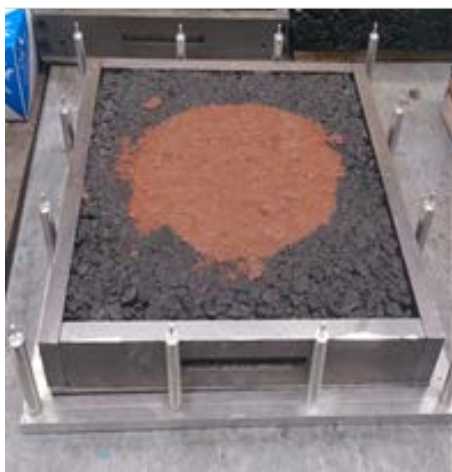
Figure 7. Geopolymer pothole repair material after simulated wearing.

After 20,000 wheel-passes, a visual assessment of the specimen was carried out. As geopolymer mortar is an untested material in this application, using this test method, it was expected that some performance issues would occur during the initial testing. Concerns about potential failure were due to the stiffness of hardened geopolymer cement mortar, and the possibility of the geopolymer mortar being incompatible with the existing asphalt surrounding the defect. However, after 2000 wheel passes, no surface defects were noticed (Figure 7). The visual assessment focused on surface cracking, delamination, de-bonding of the geopolymer from the asphalt, and material loss. The only indication of wear was some shining of the material surface. The skid resistance was measured before and after the accelerated wearing of the sample. The skid resistance decreased slightly from 43 to 41

after wearing. While this was a positive initial test, the performance falls short of the requirements set out by RRL Road Note 27 [15]. The minimum skid resistance value for materials used on public roads is 45, with trunk roads and motorways requiring 55, and bends and roundabouts requiring 65. Therefore, further work involving surface texturing will be required to develop a geopolymer mortar which is suitable for road pavement use. Also, it is suggested that samples should be subjected to $100,000 \pm 1000$ wheel passes [14]. While initial durability results appear positive, a more extensive testing programme will be required to determine the performance of the repair material after much greater exposure to wearing conditions.

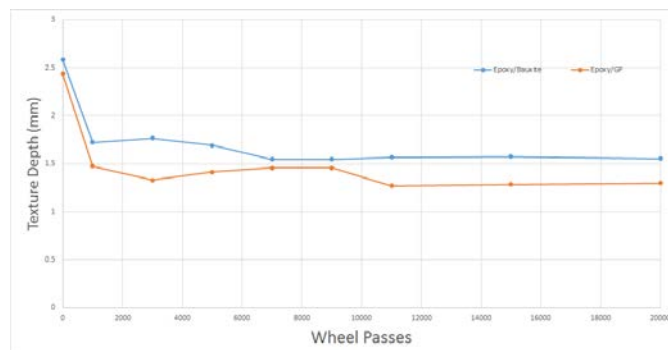
Figure 8. Effect of simulated wearing on surface texture depth.

The high friction surface slabs were subjected to 20,000 wheel passes, with texture depth and skid resistance measured prior to testing, and at various intervals during testing. Prior to testing, the texture depth of the geopolymer aggregate sample was recorded as 2.43 mm, with a skid resistance value of 80. The control slab had an initial texture depth of 2.58 mm, and a skid resistance value of 94. Figure 8 shows the changes in texture depth during testing. Figure 9 shows the changes in skid resistance during testing. After 20,000 wheel passes, the geopolymer slab retained a texture depth of 1.3 mm, and a skid resistance value of 55. This represented a 47% decrease in texture depth and a 31% decrease in skid resistance. This is compared with the calcined bauxite, which has a retained texture depth of 1.55 mm (40% texture loss) and a skid resistance value of 74 (21% skid resistance loss). Both slabs showed a significant decrease in texture depth after 1000 wheel passes. The geopolymer aggregate texture depth reduced by 39% after 1000 wheel passes, and the calcined bauxite texture depth reduced by 33%. After the initial 1000 wheel passes, the texture depth loss of the samples was more stable. While the retained texture depth of the geopolymer aggregate slab was significantly lower than the initial value, the 1.3 mm texture depth exceeds the minimum requirements for a road surface. The reference slab had a retained texture depth of 1.6 mm.

From the results, the skid resistance value differences between the samples may be attributed broadly to a difference in macrotexture depths. However, the results show that a decreasing texture depth doesn't directly compare with decreasing skid resistance values. This may suggest that factors other than macrotexture, such as aggregate shape and size may also have an effect of the skid resistance of a high friction surface. Also, some unexpected texture depth readings, such as the increase in geopolymer slab texture depth between 11,000 and 20,000 wheel passes, may be attributed to some aggregate being removed during testing. Further work is required in this area to better understand the factors which affect the skid resistance of high friction surfaces.

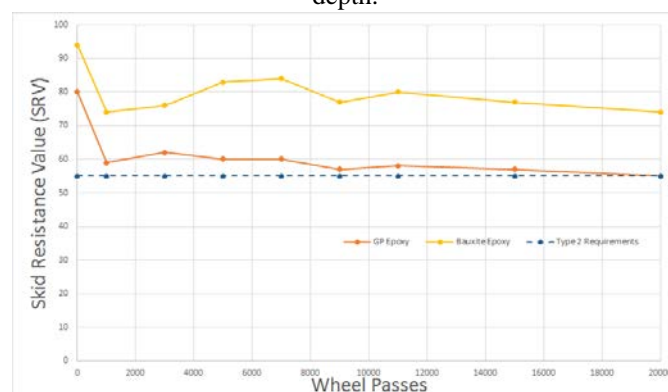
Figure 9. Effect of simulated wearing on skid resistance values.

The skid resistance value of the geopolymer aggregate slab can be classified as a Type 2 surface, according to RRL Road Note 27 [15], while the calcined bauxite slab achieved a Type 1 classification, as expected. This means that the geopolymer aggregate, without any further work or development, would be suitable for use in a type 2 application, such as trunk roads or motorways.
