Development of an embedded thin-film strain-gauge-based SHM network into 3D-woven composite structure for wind turbine blades

Development of an Embedded Thin-film Strain-gauge-based SHM Network into 3D-woven Composite Structure for Wind Turbine Blades

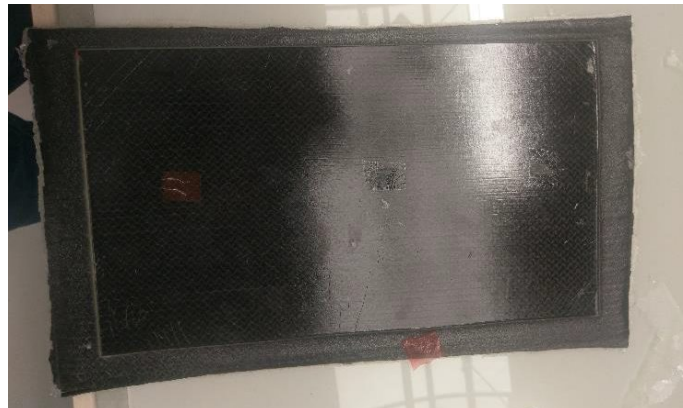
Figure 2. Laminate sample of three gauges embedded 1 ply deep in a 4 ply 2D laminate.

A prototype laminate was manufactured to assess the adhesion of the gauges to the powder epoxy. Three gauges were embedded 1 ply deep in a 4 ply 2D laminate. The sample was cured in the oven and it is C-Scanned and cut up for micro-section analysis. The following figure shows the ultrasonic C-scan of the laminate panel with three strain gauges embedded. The colours suggest there is no indication of delamination or void formation in the laminate. This is a good indication of the sensory is well bonded inside the laminate. It means there is no indication of delamination or void formation inside the laminate.

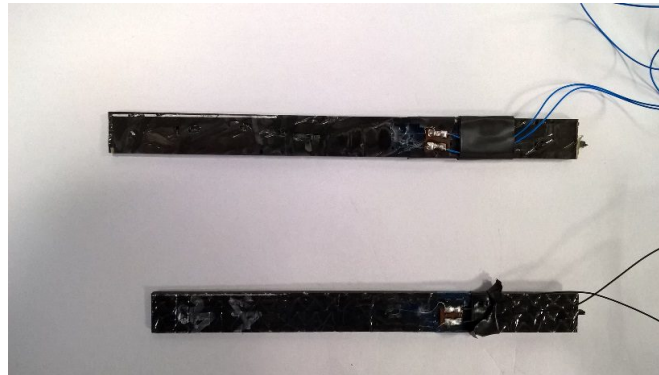
Figure 8. Pictures of 2D (bottom) and 3D-woven (top) test coupon.

The composite laminate with the integrated SHM system were to be tested under flexural loading test standards of ASTM D790, which is Standard Test Method for Flexural Properties of Polymer Matrix Composite Materials. To verify

the mechanical coupling at resin matrix around sensor, and determine any detrimental effect caused by embedment, a three-point bending / flexural test was used initially. As delamination would have no effect on the sample strength during a tension test because there are no inter-laminar forces being exhibited, tensile test is not conducted in our experiment.

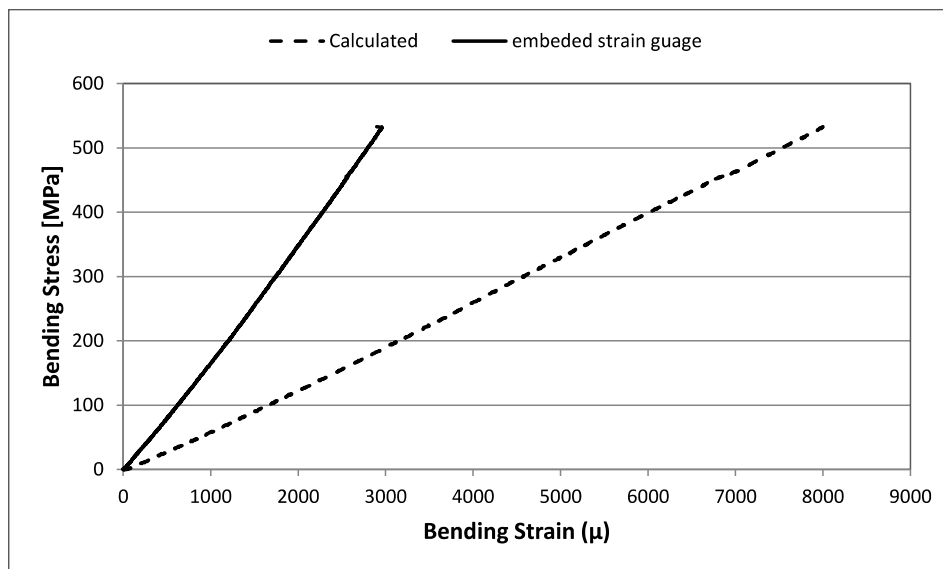
A comparison of the stress-strain curves of 2D material with calculated strain using ASTM 790 as well as strain measured through strain gauge embedded inside the 2D material is shown in figure 9. A similar comparison of 3D-woven composite is given in figure 10. In both cases, strain gauge survived the manufacturing process and provided corresponding internal strain data.

Figure 9. Comparison plots of measured internal/embedded strain value against theoretical value inside 2D laminate.

For both 2D and 3D materials, the calculated strain is higher than the strain measured with embedded strain gauges. The possible reason for this behaviour is that the calculated strain is obtained from the displacement in the outer fibre as a result of application of force. The distance of embedded strain from neutral axis is less as compared to the surface of the laminate. The strain is directly related to the distance from the neutral axis. A similar behaviour has been observed by Archer et al [10] in tensile strain behaviour of 3D woven composite with embedded fibre optic sensor. They have
