## VALENCIAN RECONQUEST CHURCHES. STUDY OF THE ARCHAEOLOGICAL REMAINS FOUND IN THE ALGEMESÍ CAPILLA DE LA COMUNIÓN

### Abstract

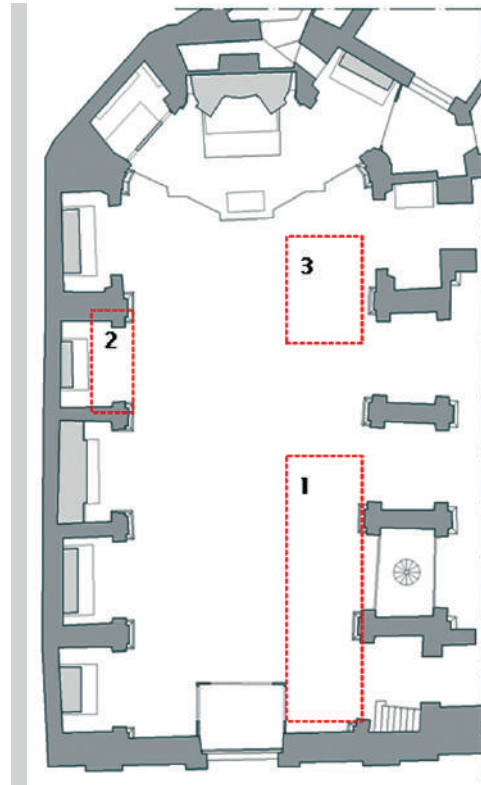
Figure 1. Archaeological exploration conducted in the interior from the *Capilla de la Comunión* of Algemésí. Source: authors

Taking into consideration testimonies that promulgated the existence of a buried temple, a series of archaeological campaigns were programmed in the course of a year (Figure 1). At first, two explorations were conducted during the months of July and August 2017; stopping the work to clean up the church for the patron saint festivities, resuming in October of the same year. Subsequently, given the positive results, a new campaign was proposed and the first one broadened with the purpose of gathering as much data as possible; fact that would materialize during the months of June and September of 2018.

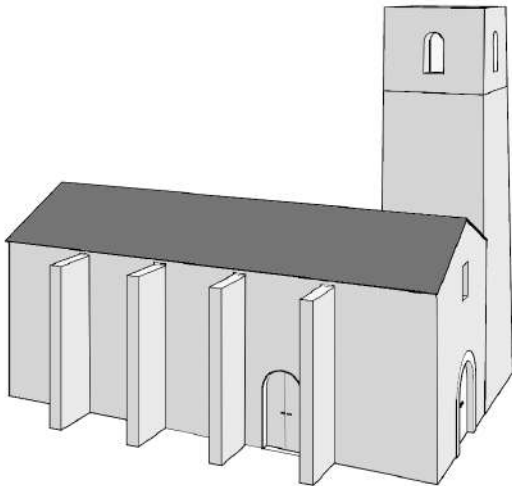
Figure 2.  
Exterior three-dimensional modelling of the disappeared Algemesí diaphragm arches church. Source: authors

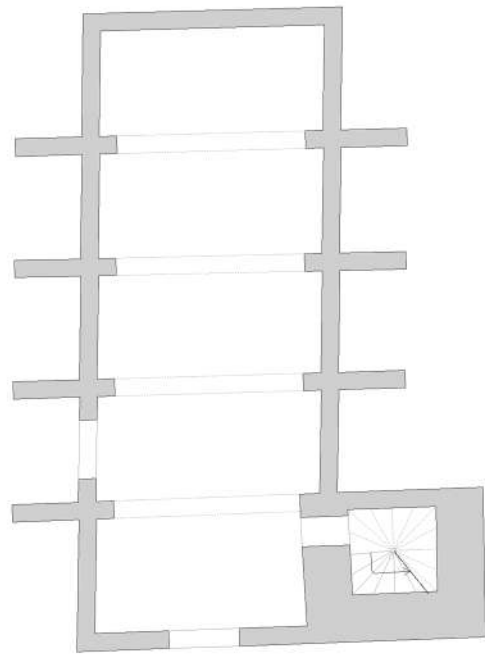
Figure 3.  
Hypothetical plant of the church of Algemesí in the thirteenth century. Source: authors

The pre-existing parish would be presented as a modest open space with a woody coffering with double slope, with a morphologically rectangular mono nave plan (Figure 3), divided into five sections by marked arches and whose buttresses would extend outwards beyond the enclosure. Lacking any apse, its flat head-like the current presbytery – would respect the traditional eastbound orientation. In terms of access, two possible hypotheses could be able: one on the western flank, since “the entrance, frequently, is lateral. [...] and in buildings that have not been enlarged the door is located in the penultimate section of the nave” [3]; and another, coinciding with what is now

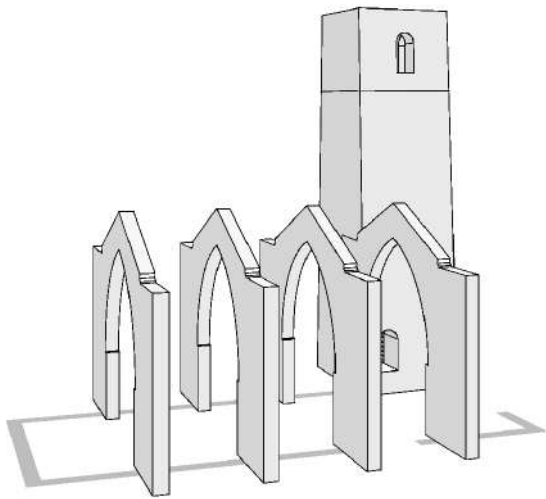
**Figure 4.**  
Three-dimensional modelling of the diaphragmatic structure of the disappeared church of Algemesi. Source: authors

Covering large spans, arches arranged as ribs were responsible for supporting all the weight of the cover (Figure 4). The pointing of its curvature translated into a lower thrust that, even so, needed robust stirrups to counteract the efforts. Its layout conditioned the final result of the church; being able to find true diaphanous spaces, in which, it gave the impression that the diaphragm arches started in height support-

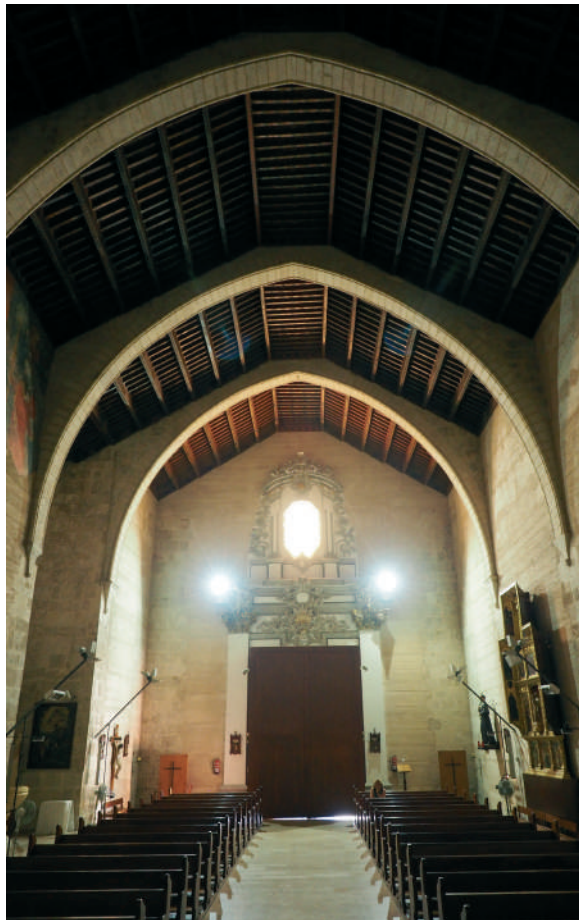
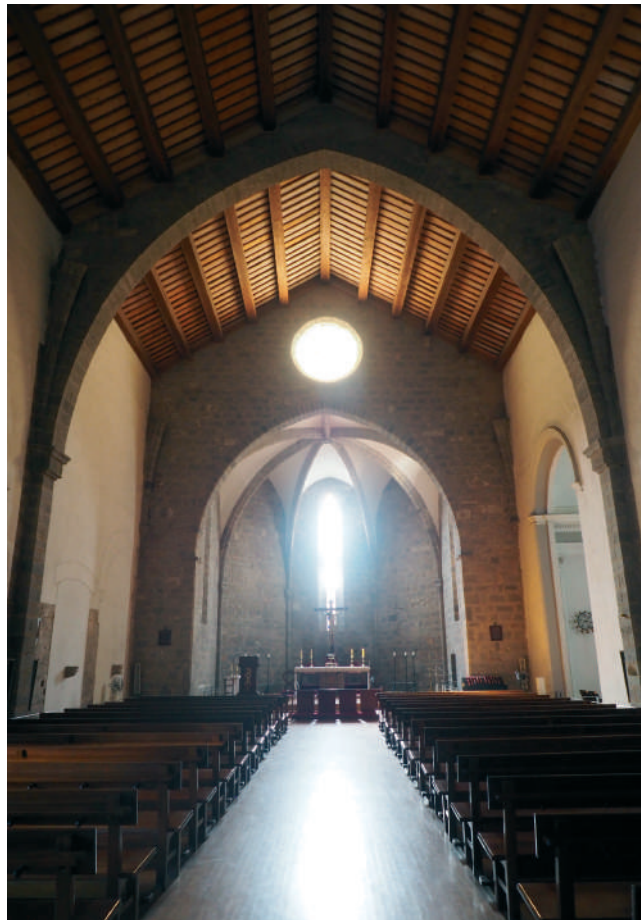
**Figure 5.**  
Church of San Pedro, Xàtiva (left). Church El Salvador, Sagunto (right). Source: authors

ed by simple brackets embedded in the wall. Church of San Pedro de Xàtiva (Figure 5 left) and others that, invading part from the nave, they were evident from the level of paving, Church of Salvador, Sagunto (Figure 5 right).

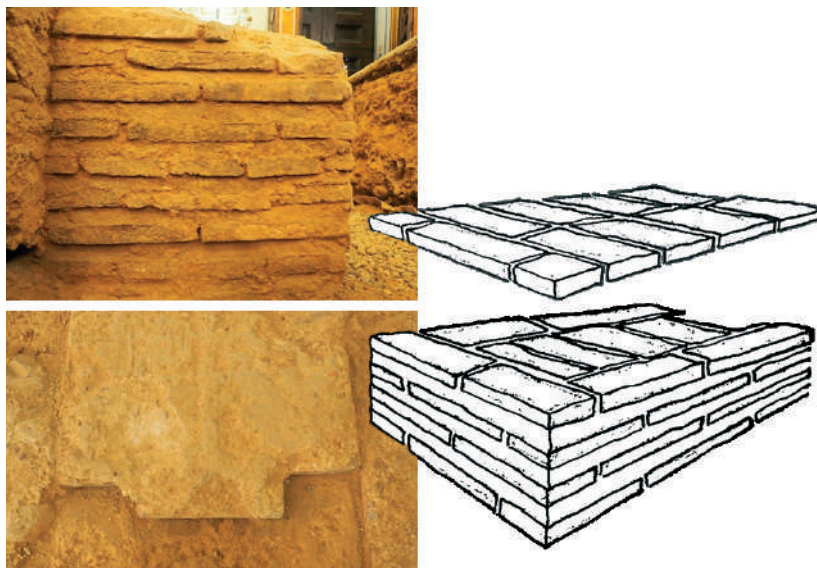
Figure 7.  
Archaeological remains and sketch of the brickwork of the diaphragmatic arches of the 13<sup>th</sup> century Algemesí church (exploration 1).  
Source: authors

American rigging, conformed to a predetermined number of rope courses. The result would be that of a diaphragmatic arc conformed by the orderly sequence of: four courses placed on a rope plus another one to blight, in charge of “sewing” the factory, breaking the continuity of the nucleus (Figure 7).

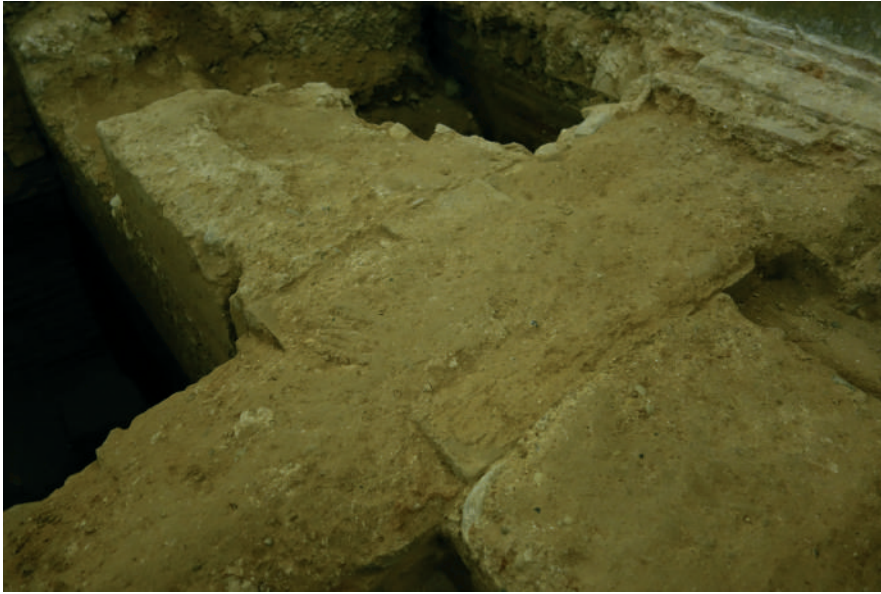
**Figure 8.** Vestiges of one of the buttresses of the primitive church of Algemésí (exploration 1). Source: authors

The configuration of the buttresses with respect to the enclosing wall (Figure 8) was an indicator of what its original form might have been. The stirrup, remaining part of the interior of the nave, would act as a base on which the arch would rest. Based on the premise of Arturo Zaragozá who argues that, “the height of the starts, except in the case of convent churches or large parishes, is very low, standing at a height ranging between two and three meters” [3] said sockets could have had a height of around 3’00 meters.

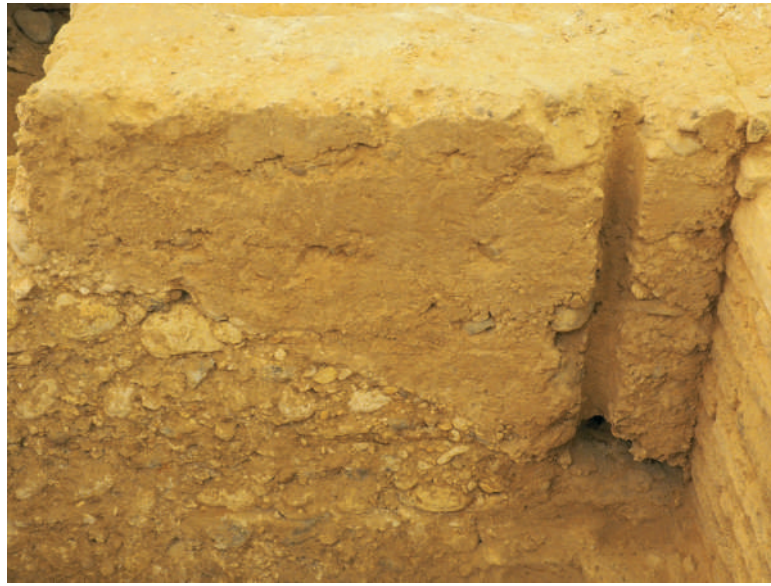
**Figure 9.**  
Ruins of the fence wall (exploration 1). Source: authors

According to the archaeological remains found in the Algemésí Capilla de la Comuni3n, which stood out for their constructive singularity, the enclosure was built by walls of concrete wall 60 centimetres thick (Figure 9); variant that, according to Fray Lorenzo de San Nicol3s, was composed of a heterogeneous and strong mortar of “small stone and lime, all taken out to tamper” [7].

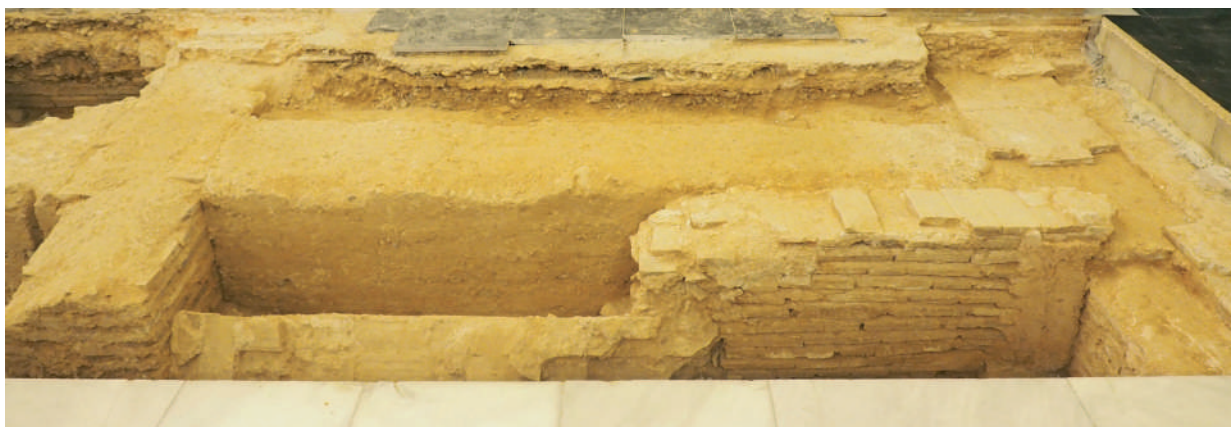
**Figure 10.**  
Hypothetical length of the boundary wall (exploration 1). Source: authors

In the absence of conclusive data, as the size of the vestiges avoid it, it could be said that: the lime concrete wall that formed the perimeter of the XIII century parish of Algemesí, was executed by means of a continuous shuttering. Length equal to the space between diaphragm arches (Figure 10) – with a height of boundary wall comprised between sixty and ninety centimetres, which, would modularly increase the closing to the cornice line.

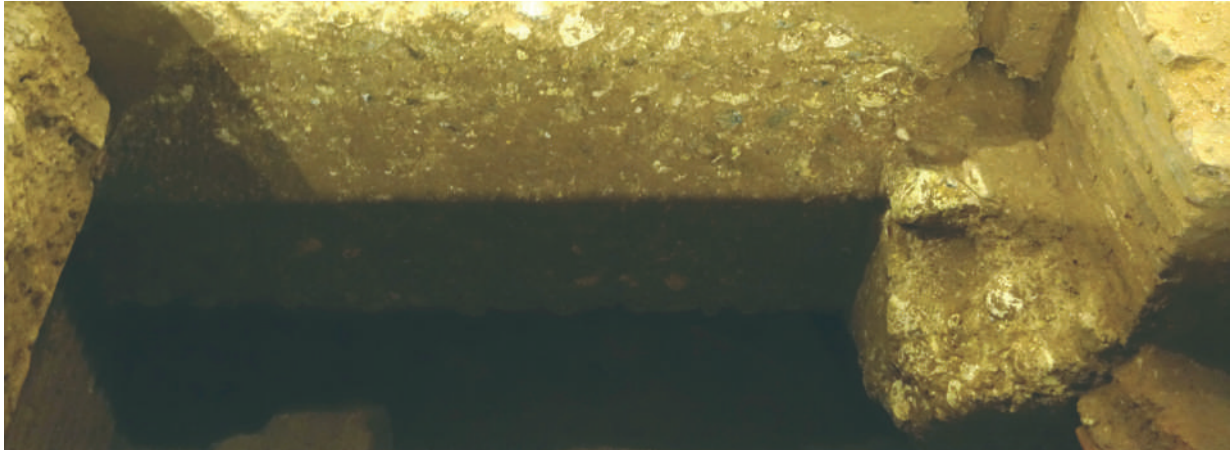
**Figure 11.** Foundations: Boundary wall in the central area and, on the right side, one of the diaphragm arches (exploration 1). Source: authors

During the archaeological excavation, two different types of foundation were identified (Figure 11): one relative to the diaphragmatic arches and another one of the wall itself.

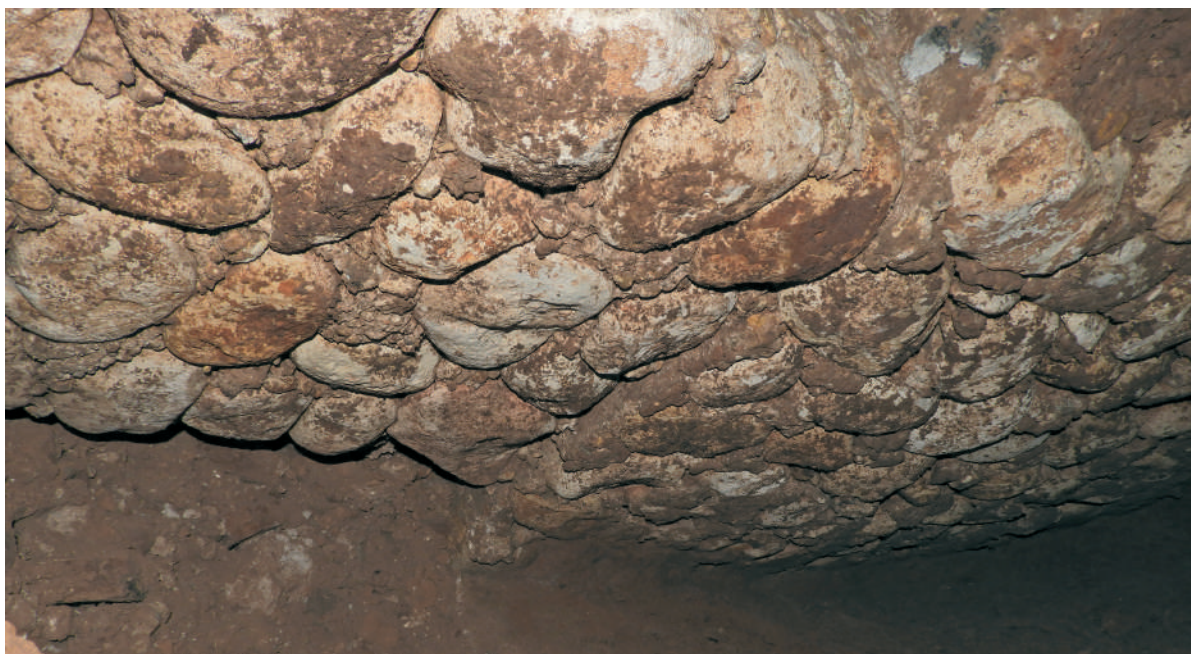
**Figure 12.** Regularization layer (top view, exploration 1). Source: authors

But, regardless of the constructive element intended to sustain, the foundations of the temple were supported by a thin layer of regularization, made up of river boluses of different sizes (Figure 12); for, “whatever the type of wall that is built must sit on a well-leveled foundation” [9]. This was also in charge of the uniform distribution of loads to the land.

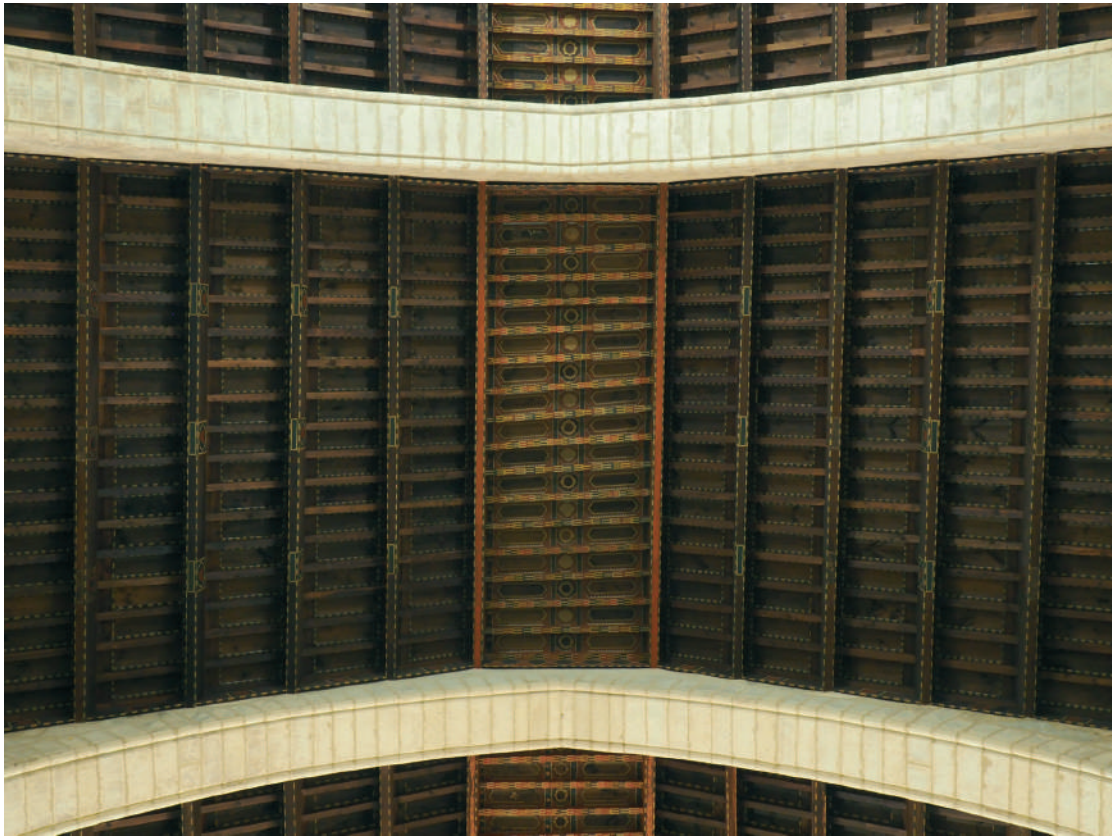
**Figure 13.**  
Roofing church San Pedro, Xàtiva. Source: authors

the Islamic-style alfarjes in buildings of Christian worship, are still preserved; as it is, the coffered ceiling in San Pedro de Xàtiva (Figure 13).

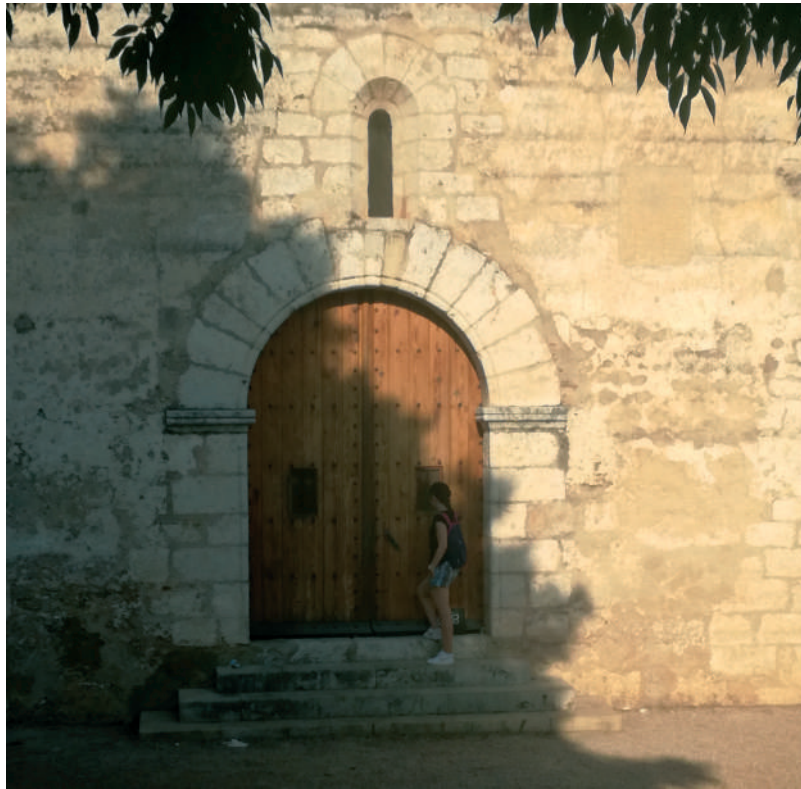
Figure 14.  
Hermitage of San Roque de Ternils, Carcaixent. Source: authors

In this building typology, the most usual way to solve the access to the temple was through Romanesque style entrance (Figure 14); where delicate archivolt on

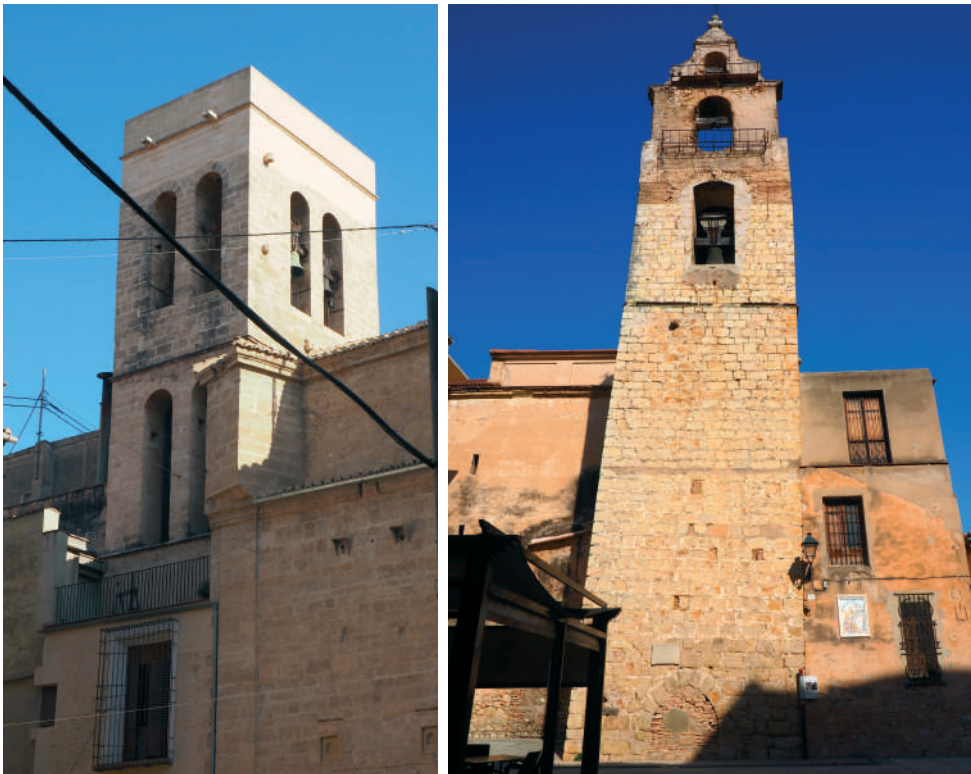
Figure 15.  
Bell tower church Santísimo Cristo del Salvador, Valencia (left). Old bell tower Santa Catalina church, Alzira (right). Source: authors

From the few examples of Christian colonization that have managed to remain standing, some of them have been forced to partially rebuild the upper part in order to consolidate them (Figure 15 left) and others that, according to the different artistic currents, have been so altered that they have lost their original late-Romanesque countenance (Fig. 15 right).

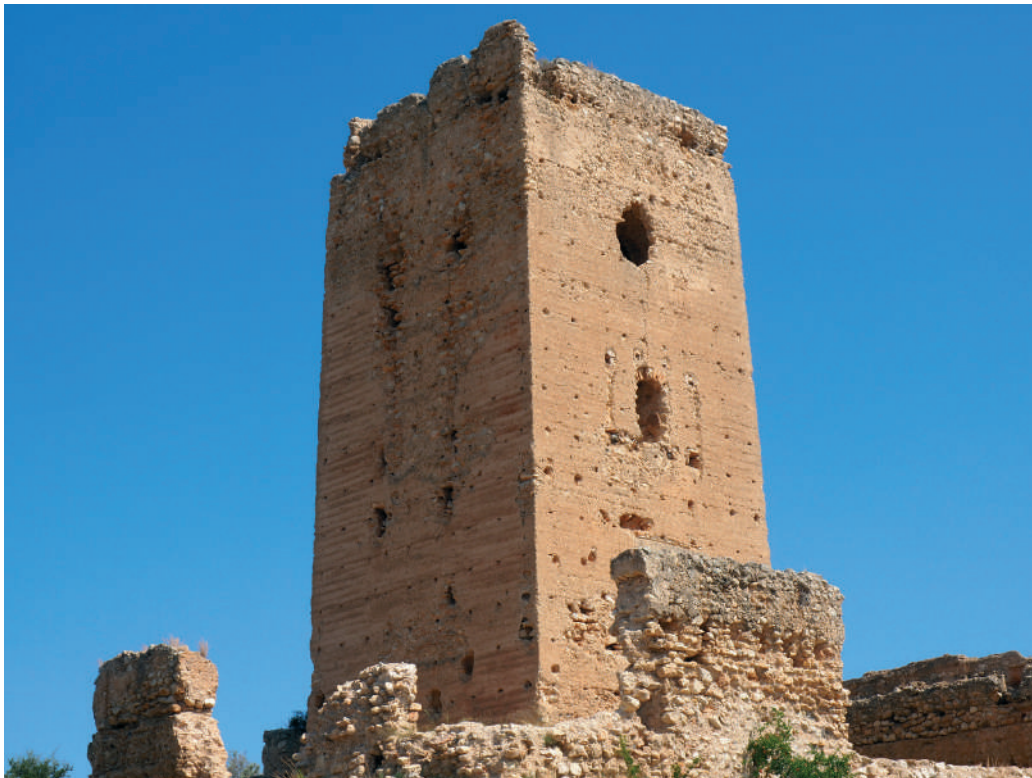
**Figure 16.**  
Tower of the castle of Aledua, Llombai. Source: authors

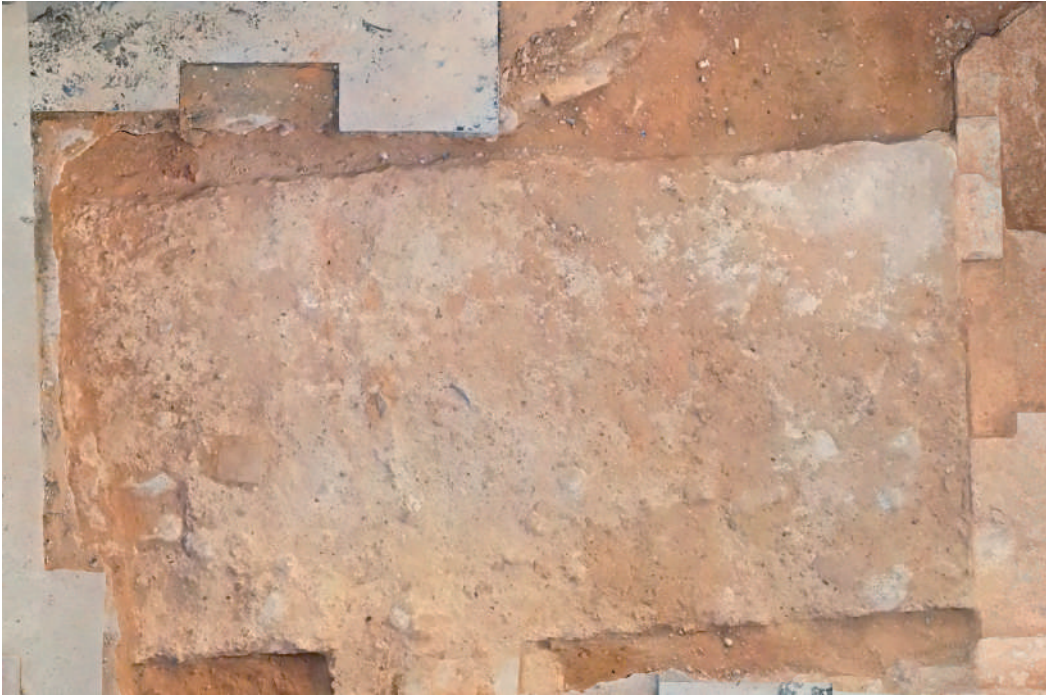
**Figure 17.**  
Lateral wall of the 13<sup>th</sup> century bell tower, the bottom of which used the buttress of the diaphragm arch to close the structure (exploration 1). Source: authors

The powerful wall found in the subsoil (Figure 17) – 1'60 meters thick; even to the tower of Albal and Serra, both Islamic – had to be part of a structure slightly troncopiramidal that, narrowing as it took height, settled on a regular base of 4'50×6'00 meters crowned, with all probability, with a cabin designed to house the bells.

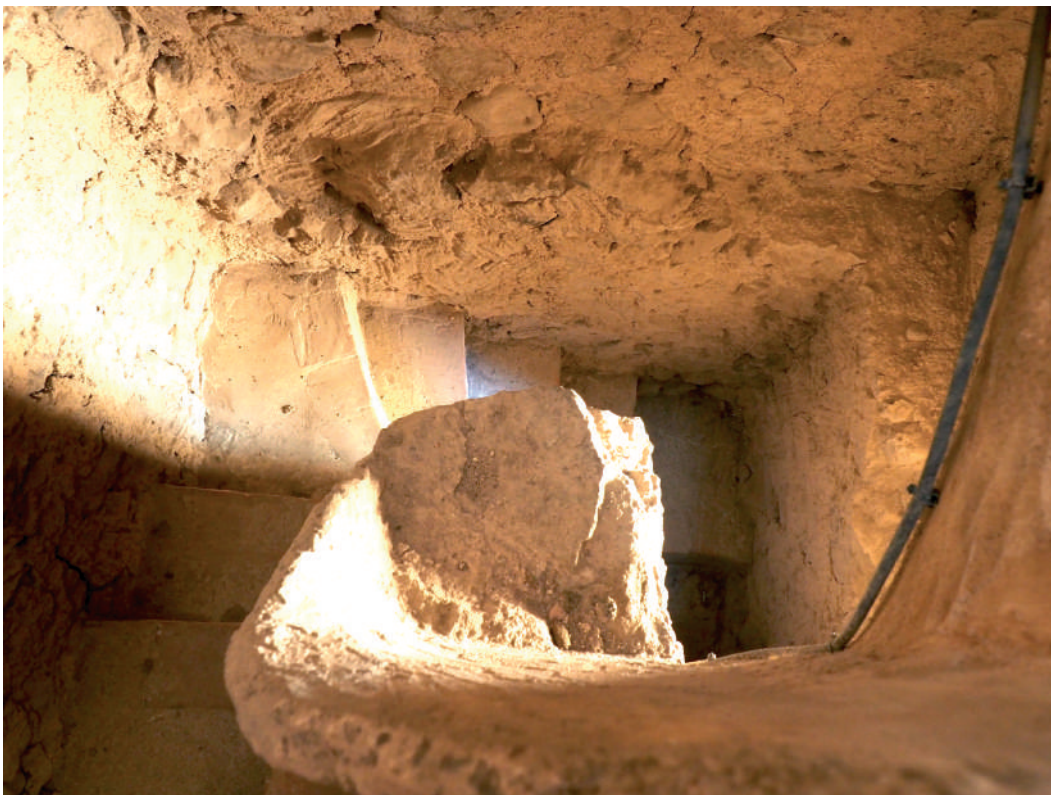
**Figure 18.**  
Lateral wall of the 13<sup>th</sup> century bell tower, the bottom of which used the buttress of the diaphragm arch to close the structure (exploration 1). Source: authors

The stairs used to be solved by prismatic steps in stone that ascended converging to the same axis. These are known as spindle spiral stairs or central turnip. It was usual for the perimeter box that contained them to have a circular shape. But once again, another of the elements of the disappeared temple of Algemesí again disagreed with the pre-established constructive canons; it could have been executed, in brick, a spiral vaulted staircase of the type “La vis de Saint Gilles” of square plan, where the helical dome – of quadrangular generatrix- would fit the interior perimeter of the tower (Figure 18).

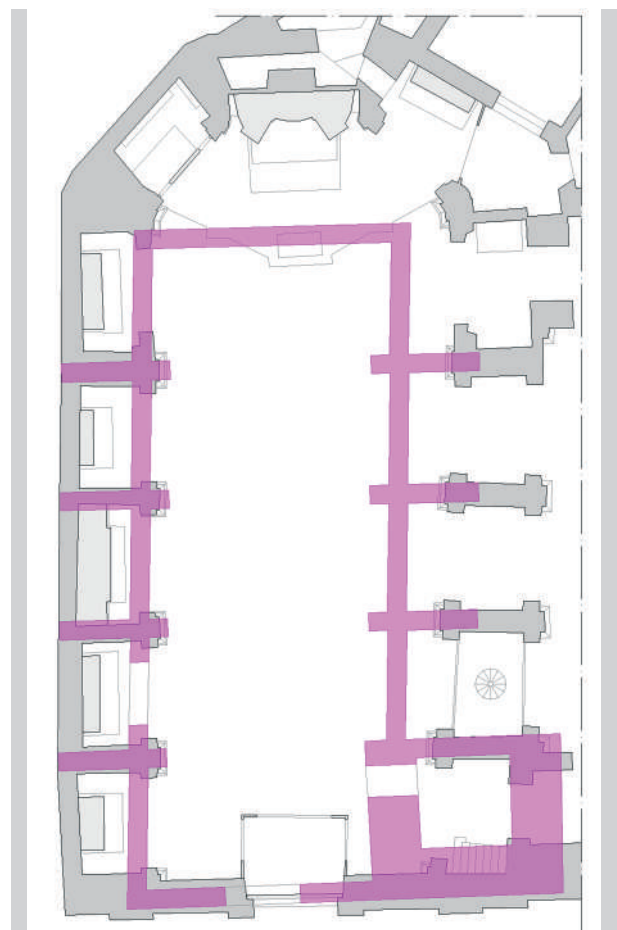
**Figure 19.** Hypothetical plant of the church of Algemesí in the 13<sup>th</sup> century with respect to the floor of the current *Capilla de la Comuni3n*. Source authors

The architects of the new church, aware of the firmness with which its predecessor was forged, opted to reuse its structure as a supporting base, generating an irregular plant with marked skewness. Such a determination implicitly involved the mutilation of the old

building until it reached the required flooring level. The walls that gave form to the chapels started from the very surface created by the cutting of the diaphragmatic arches of the 13<sup>th</sup> century; without more connection than, a lime mortar slurry in charge of guaranteeing the interrelation between the founding vestiges converted into a foundation and the new vertical structure. On the right side, these lateral spaces partially supported the vestiges because, as can be observed (Figure 19), the diaphragmatic arches would not pick up the entire length of the new transverse walls. But part of those walls drawn by project requirements, which required the widening of the central nave would have needed a new foundation connected to the primitive church that was to be buried. On the contrary, on the gospel side, the new counter-structure would fully support the original stirrups.
