Analysis of the Challenges and Technical Solutions for Revitalization of Traditional Buildings in Hot and Humid Climate (Case Study: Anthropology Museum of Local Residents in Kish Island)

7. Introducing the Case Study: Anthropology Museum of Local Residents in Kish Island

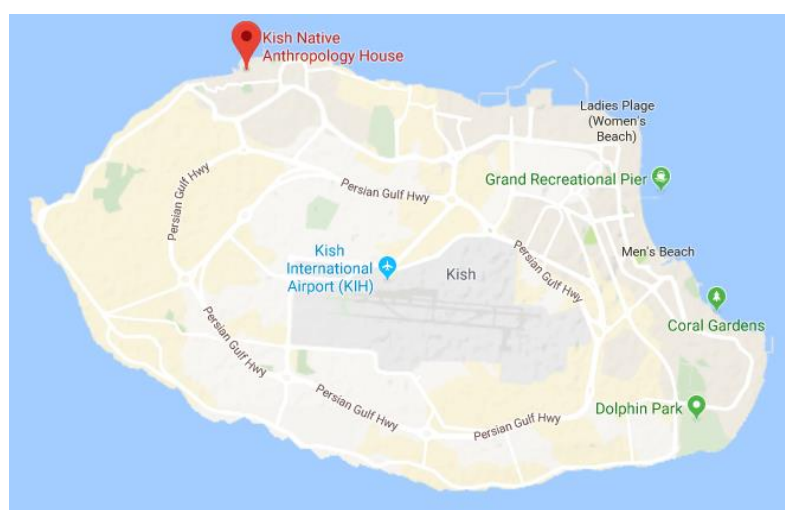
Figure 1. Anthropology Museum of Local Residents in Safin, Kish

To complete analytical section of research, a case study is done on a building in hot and humid climate of Iran. Case study is the building of Anthropology Museum of Local Residents in Kish Island. The old building is located in northwest of Kish Island and in old neighborhood of Safin, Kish. The building has been a residential building belonged to a merchant before revitalization. The building has a complete form and has all essential factors and spaces of living in ancient times including two courtyards and rooms with different functions surrounded the yard. Same absolute form and providing all required traditional spaces can help providing more comprehensive analysis and results for this study.

The building includes two central courtyards, one used as indoor space and one used as outdoor space. Moreover, rooms and more private space are placed around the indoor courtyard and the public spaces are placed around the outdoor yard. Although the building has an antiquity about 200 years, it has provided good opportunity for revitalization and changing the use due to appropriate protection of the building. The building has been reconstructed over the years and has been used publically as Anthropology Museum of Local Residents in Kish Island.

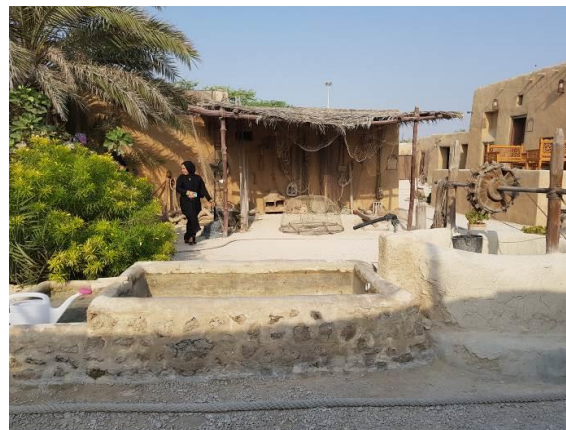
Figure 2. Protecting central courtyard and semi-open spaces

Topic	Solutions in Kish Case Study	
Architecture	Courtyard in building	Preservation of central courtyard in old form and increasing semi-open spaces (figure 2) Maximum use of central courtyard for sitting spaces due to new public function of building (figure 3)
	Shading on open spaces and terrace	Using canopy in different parts of courtyard (figure 4)
	Building height	No change in 4-meter height of building
	Building façade	Preserving physical form of building in old form and 1-storey form and using same spaces in the flat floor Using local materials and furniture like mat and thick rope to form courtyard and sitting spaces (figure 5)
Structure	Earthquake	Using brace for courtyard walls and outdoor walls for more resistance (figure 6)
	Skeleton and materials	Using wood and local and natural materials for shading ceilings Using thick walls as insulator (figure 4 and 8)
	Building subsidence	Protecting wooden frames of doors for resistance of openings (figure 7)

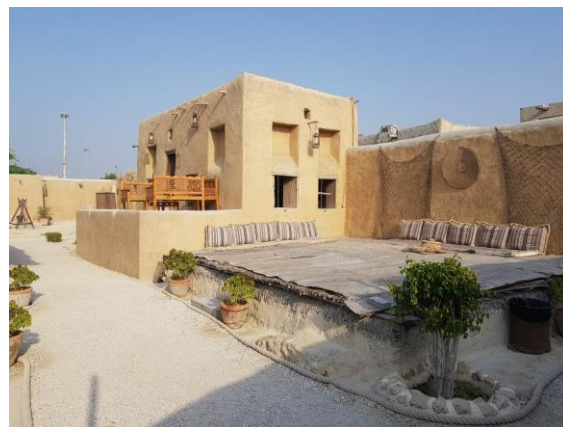
Figure 3. Using central courtyard for new public spaces for rest of visitors

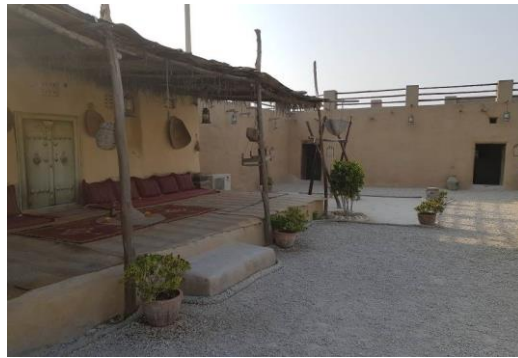
Figure 4. Using local materials to make shading space at the courtyard

Achieving favourable interior temperature	Using split to make inside spaces cool (figure 8) Placement of condensers in less-observable corners of courtyard and under the shade of walls (figure 4)
Infrastructure	Insulation	Protecting old materials like Sarouj (mortar) for inside and outside façade of building causing resistance and relative insulation Protecting thick walls of building causing reduced thermal wastage
	Reduced air humidity	Using platforms for rest spaces at the courtyard to reduce air humidity (figure 9)

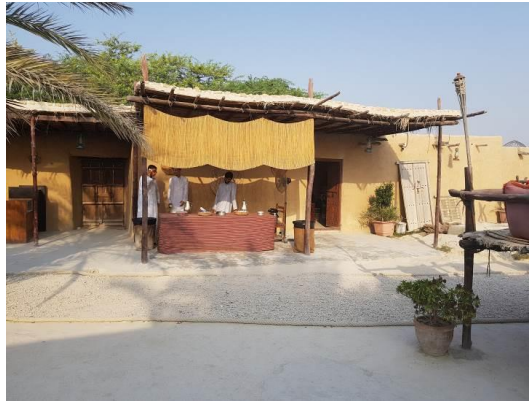
Figure 5. Using local and simple materials like wood mat and rope to form courtyard and create furniture

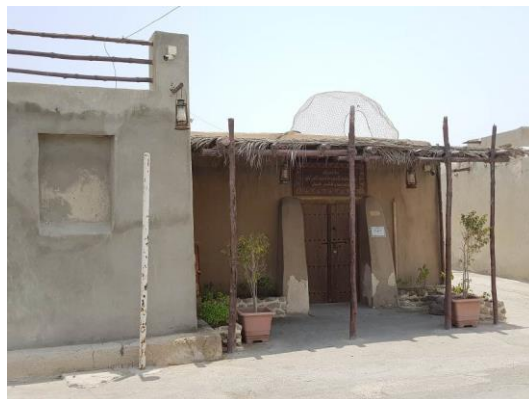
Figure 6. Using bracing in walls and wood in skeleton of canopies for relative resistance against earthquake

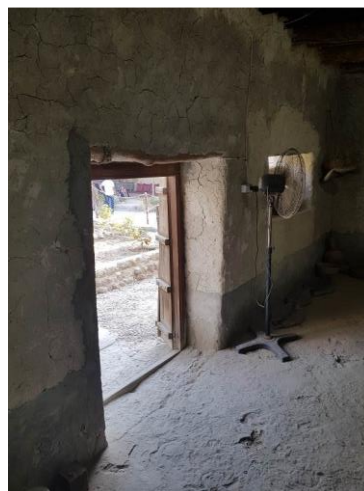
Figure 7. Using wooden frame of doors for resistance of walls, protecting thick walls with high thermal capacity causing suitable insulation of inside spaces

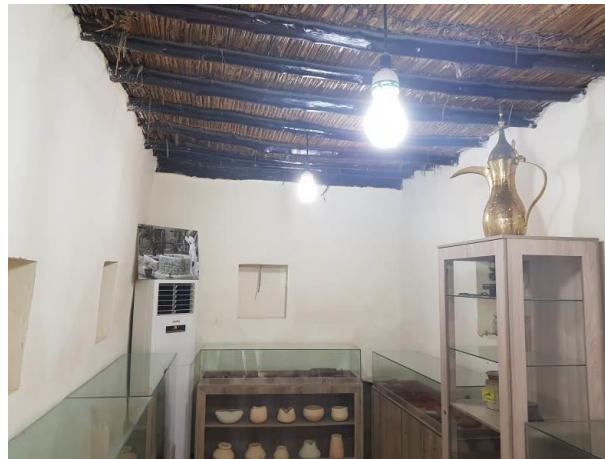
Figure 8. Using separate split systems to cool each space

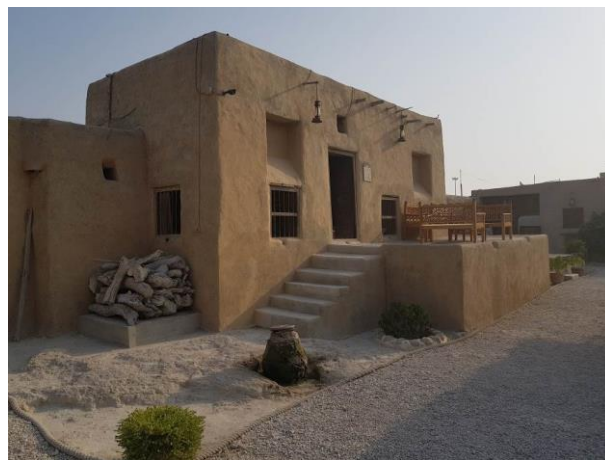
Figure 9. Using platform and different platform levels in several spaces to reduce the problems caused by ground humidity
