**Journal of Human Sciences**

## The conservation and restoration performances under Seljuk Architectural Patronage

Tülay Karadayı Yenice<sup>1</sup>

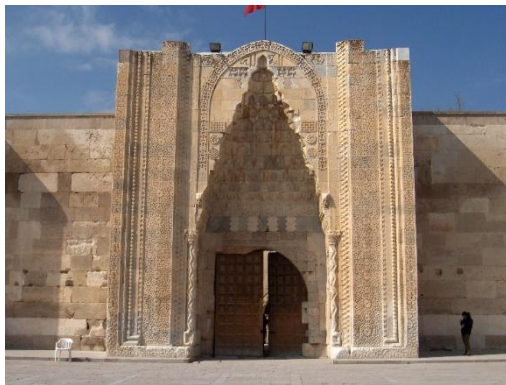
Figure 1. Sultan Han Portal in 2018

The waqfiyyes of Sultan Han which was built by Sultan Alaaddin Kayqubadh I can be seen an important case according to the Turkish restoration history. In 1129, the famous architect of the time it was built by Havlanoğlu Muhammed from Damascus. According to information obtained from historical documents, Sultan Han used as a fortress in the sultanate struggle between Sultan II. Kaykavus and IV. Kilij Arslan and its gate was destroyed and burned during this chaotic period. In 1278, Sultan III. Gıyaseddin Kayhüsrev period, gate was partially renovated and restored (Yınanç, 2007). The traces of this destruction and subsequent restorations are still visible at the full marble constructed gate of Sultan Han. The entrance of Khan is an arched opening inside this gate mass, framed by various profiled decoration line (Figure 1). The original stones of this opening, which was traversed by a lancet arch, could not survive. However, a curved arch stone can be seen in the photographs taken in the 19th century (Figure 2).

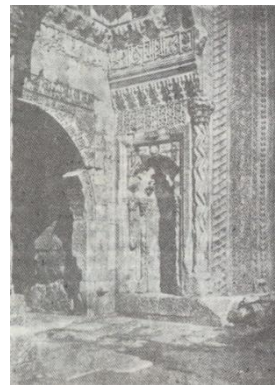
Figure 2. Sultan Han Portal 19 century (Y.Önge's archive)

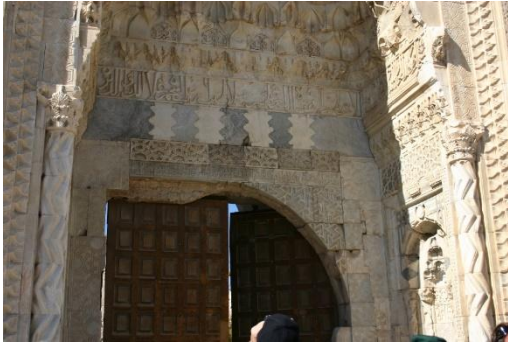
Figure 3. The Flat Camber Arch and The Inscription

The faces on both sides of the 2.75 meters arch opening, are decorated with a pattern of geometric composition are partly imbalanced. At the level of the keystone of the arch, there is another tectonic belt, which is filtered through stylized floral motifs, with a booklet strip, and a deeply carved geometric pattern filled with floral motifs. The upper level consists of a flat camber arch made of two-coloured roller stones and an inscription (Figure 3).

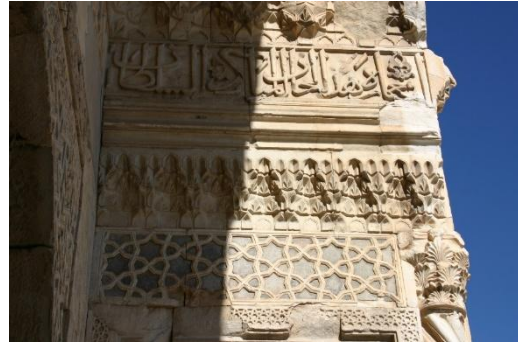
Figure 4. The Inscription details

After inscription this strip, there is a bracelet with a muqarnas covering the door. In this façade layout, the arched opening beneath the flat of camber arch, as can be understood from the restoration tablet, gained this appearance after the restoration. During this restoration, the original style of the door around the door opening we know that the sound of the originals are preserved, using them, if necessary, by adding new additions around the door cavity, has been restored in the form of a pointed arched passage. In accordance with the tradition of the restoration of this restoration, it was placed on the new belt. (Figure 4).

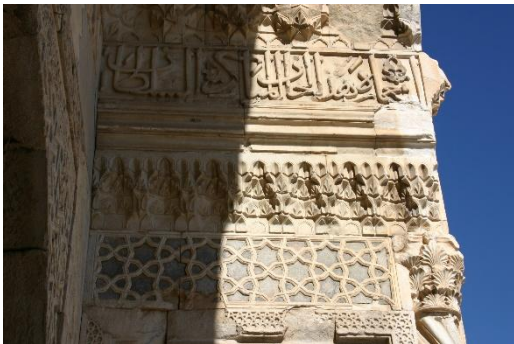
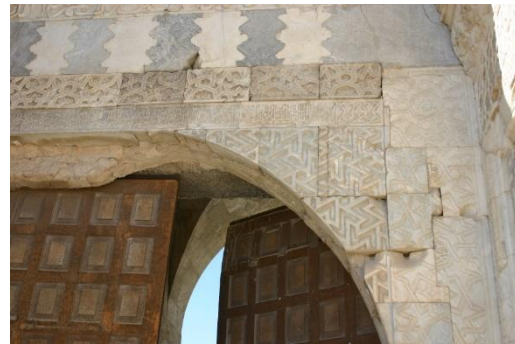
Figure 5. different materials using and architect's name found the octagon decoration

The remaining pieces of old stones and the subsequent patches and the new pieces added are determined by the irregularities in the decorations and the colour differences. The name of the architect placed in two octagons one under the other in the lower part of the geometric composition of the original ornament on the right side of the arch, was lost due to these restorations (Figure 5). The restoration tablet reads; “this sacred gate was destroyed as it was burned is restored by the hands of the Sultan's trustee an poor servant, indigent for God's mercy, Hussein's son, Siracüddin Ahmed in the days of the son of Kilij Arslan Sultan, religion and the world's deputy, the father of the conquest Kayhüsrev in 667” (Konyalı, 1974).

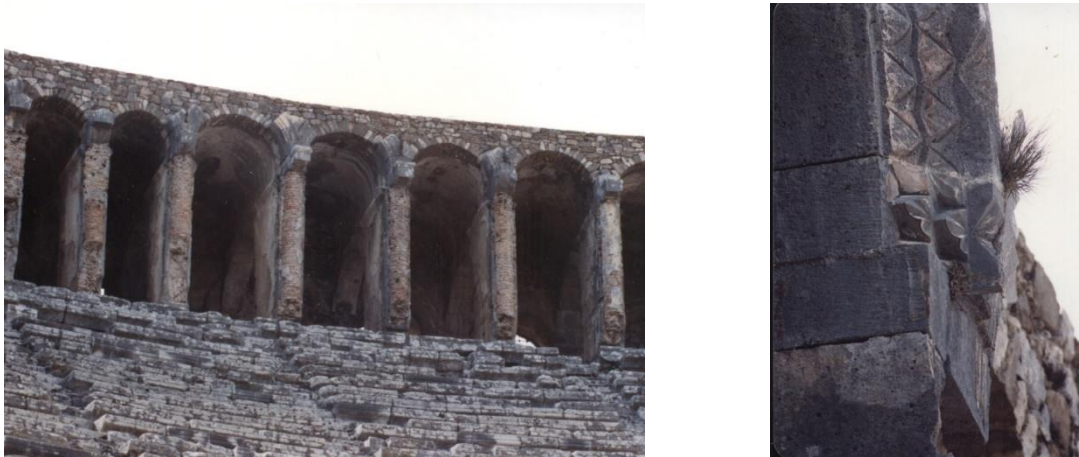
Figure 6. Arcades behind the cruise terrace and Seljuklu Muqarnasları in Arcade (O.N. Dülgerler's archive)

Inside the theatre, behind the gallery and above in some parts of the arcade surrounding the theatre, broken and missing parts of the stone arcade column was completed in accordance with the original shapes by using brick material (Akurgal, 1983), (Figure 6).

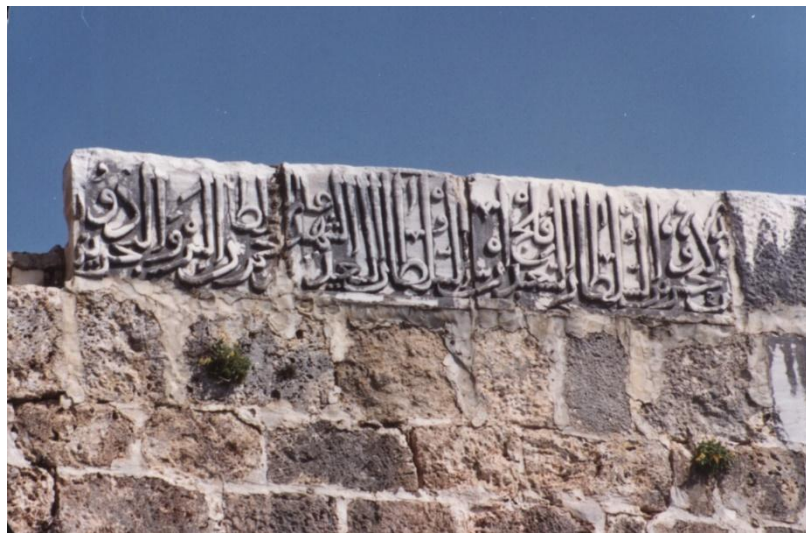
Figure 9: Arabic inscription of the bridge (O.N. Dülgerler arşivi)

Another case of the Anatolian Seljuks period traces of restoration is the bridge of Sultan Alaaddin which is called Belkıs on Köprüçay, on the Alanya road. This bridge is located 40 km east of Antalya. It is understood from the 60 cm high 6.00 m long Arabic Tablet on the upstream side of the bridge that it was built at the reign of Sultan Alaaddin Kayqubadh I (Figure 9).

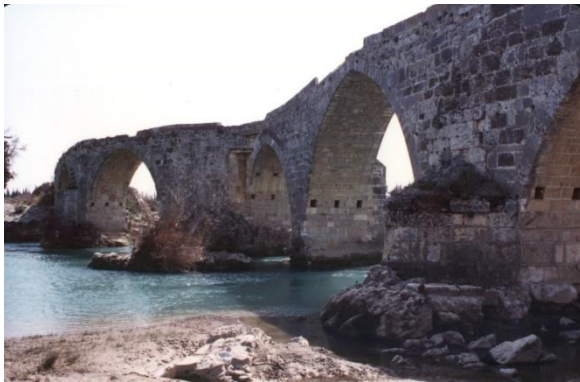
Figure 10. Overview of the Bridge

However, since some parts of the inscription are fragmented, the date of construction is unknown. This bridge is made of cut stone, with different aperture, extending along a broken line of 116 meters (Figure 10). The largest arch opening is approximately 22 meters and consists of seven eyes (Tunç, 1978; Çulpan, 2002, İltir 1978). The bridge was built by rebuilding the feet of an ancient bridge that was previously in the same place but was destroyed later. The feet of the bridge from the Roman period can be noticed even today at both sides and in the middle. (Figure 11).

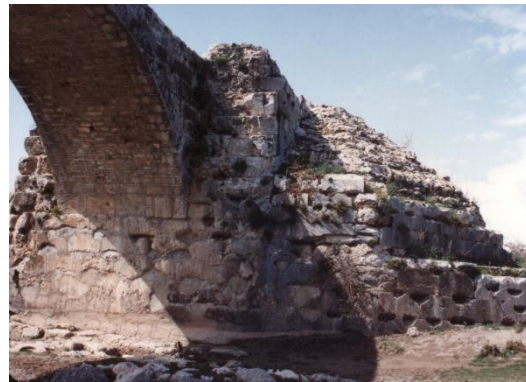
Figure 11. One of the feet of the bridge from the Roman era
