Letter to Editor

Central Venous Line Placement and Ultrasound Probe Damage: A Word of Caution

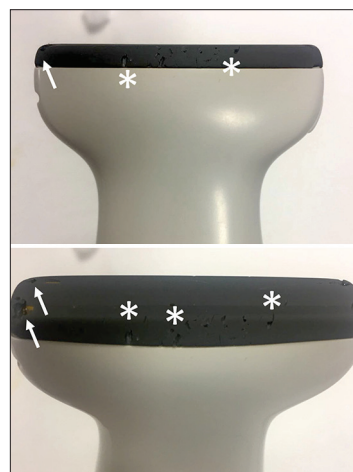
Figure 1: Ultrasound damaged probe

The image [Figure 1] shows a linear US probe used for CVC placement in at least three-thousand procedures, mostly by resident anesthesiologists. The most damaged areas are located on the short side of the probe (arrows) and on the median point of the long sides (asterisks). The supposed mechanism of damage is the repetitive contact of the sharp needle tip with the softer probe material during “in-plane” approach (arrows) and “out-of-plane” approach (asterisks). We have to assume damage to the sterile plastic sheath casting doubts about sterility and asepsis of the procedure. Caution has to be made every time an US-guided approach is used, and needle contact with the skin has to happen under direct vision, to avoid such complications.
