Article

Flexural Response of CFRP-Strengthened Steel Beams with Initial Bond Defects

ENGINEERING JOURNAL Volume 24 Issue 1

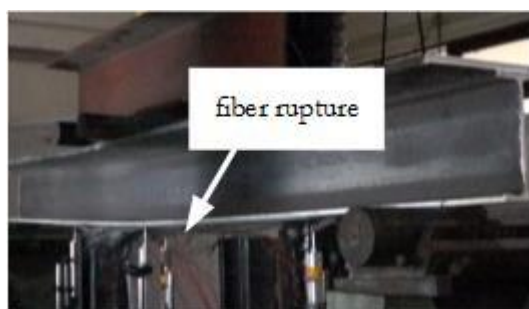
(a) Fiber rupture (beam BM120-0)

Fig. 9. Failure modes of CFRP-strengthened steel beams.

A video camera recording in slow-motion at 1,000 frames per second was used to capture the time when failure occurred in the FRP-strengthened steel beams. The fiber rupture occurred in strengthened beams with no bond defect, while the intermediate debonding occurred in strengthened beams with an initial bond. Fig. 9(a) shows the failure of beam BM120-0 which is a typical fiber rupture (FR) failure. Some broken carbon fiber pieces detached from the FRP plate as depicted in

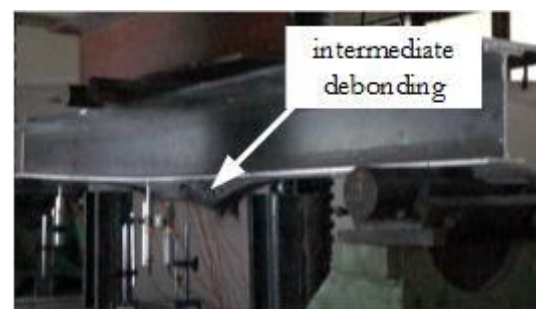
(b) Intermediate debonding (beam BM150-100)

Fig. 10(a). Figure 9(b) shows the failure of beam BM150-100 which is a typical intermediate debonding (ID) failure. There is no evidence of broken carbon fiber pieces detached from the FRP plate. Some portions of the FRP plate were adhered at the lower surface of bottom flange, as shown in Fig. 10(b).

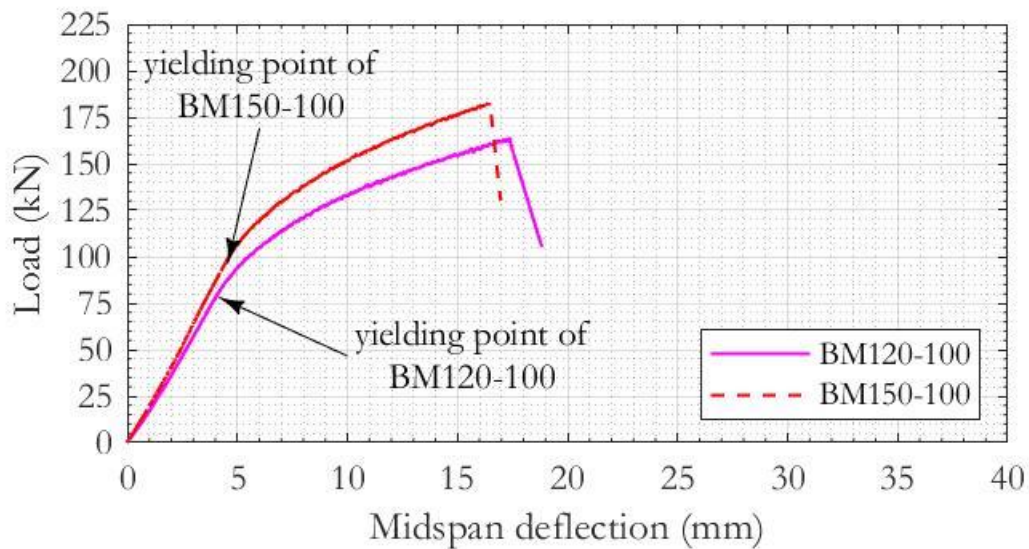
Fig. 14. Effect of FRP bond length on load-deflection curve.

Figure 14 compares the load-deflection relationships of CFRP-strengthened steel beams using different plate lengths. It can be seen that strength and stiffness of the strengthened beam increased as FRP length increased. In this study, an increase in FRP length of 25% increased the maximum load capacity by 11%, while it decreased the ductility index by 6%.
