# Post-operative Effects on Silver Coated Tumor Endoprosthesis and Biofilm Prophylaxis Systems

**Abstract.** Despite the high state of the art in limb replacement and the reconstructive tumor surgery, failures cannot be excluded. Investigations on post-operative effects on explanted silver coated modules of MUTARS<sup>®</sup> prostheses have disclosed changes in the silver surface. Both, the silver coatings and the perioperative lavage with antiseptics reduce efficiently the risks of infections.

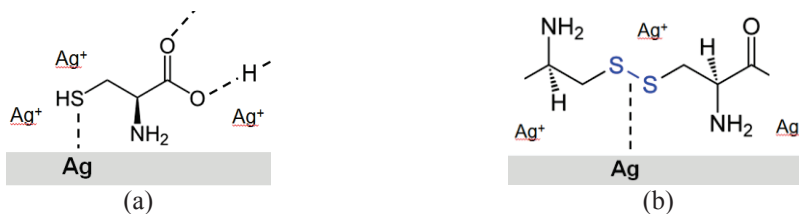
The contact and the interaction of the silver surface with soft tissue and interstitial liquid cause the adhesion of proteins. Spreading and denaturation takes place [13]. Enzymes, ROS (*reactive oxygen species*), catalytic effects of silver, and  $\text{Ag}^+$  ions induce the degradation of proteins by cleavage such as  $\alpha$ ,  $\beta$ -elimination followed by forming adherent chelate complexes. The interaction with cysteine sequences and with protein disulfide bridges generate sulfur and nitrogen containing surface compounds (Fig. 3a, b) which degrade subsequently to the black colored, insoluble  $\text{Ag}_2\text{S}$ .

**FIGURE 3.** Possible interactions of the silver surface with the HS function of cysteine sequences of proteins (a) and the disulfide bridges of cystine segments (b)
