Water governance at Loch Leven, Scotland.

Linda May, Centre for Ecology & Hydrology

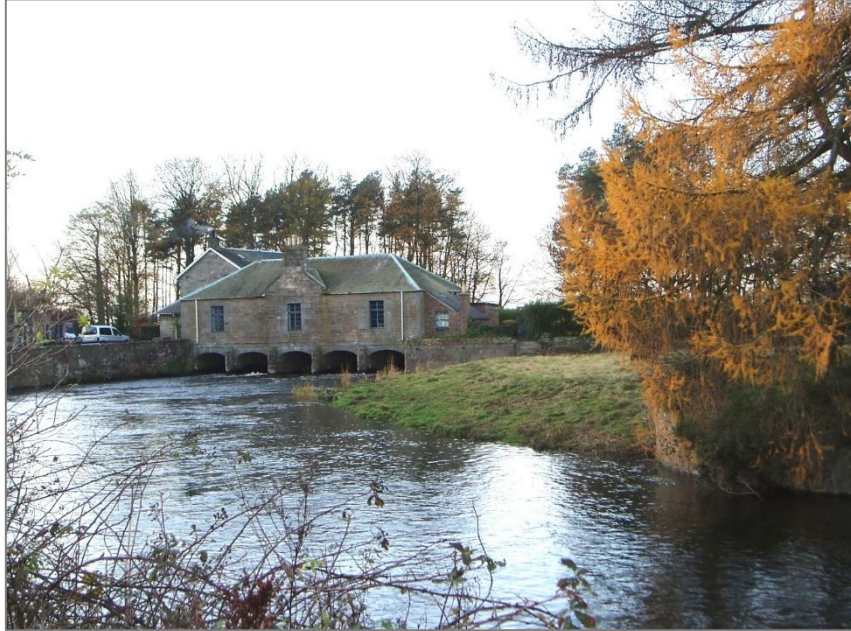
Figure 1 Sluice gates on the outflow from Loch Leven. (Photo: Linda May)

Building and land drainage works began in 1831. These lowered the level of the loch, installed sluice gates on the outflow and straightened the outflow over the first 5.2 km of its length (to form the 'Cut'). Five sluice gates were installed, opened and closed by a mechanical device with the number of screw turns being recorded to calculate the change in the size of the opening; later this was measured using a Vernier gauge. Under normal conditions, only four of the gates are used to discharge water. The centre gate remains shut and a measurement of flow is made behind it. A spillway was constructed at a level of 1.37m above the sluice gate sills.

The total cost of these 'improvements' was about £40,000 at the time, a final figure that was more than double the original estimate (Munro, 1994). This is equivalent to a present day value of about £4.2M. Although many of the mills and industries have now closed, the sluice gates (Figure 1) still regulate the outflow from Loch Leven. As such, the loch is, effectively, a reservoir that provides a regular water supply of about $5,000 \text{ m}^3\text{s}^{-1}$ to downstream industrial users. The discharge from the loch and the loch level are managed by the River Leven Trust.

Five sluice gates, each 1.372 m deep and 2.718 m wide, were installed on the outflow from the loch. These gates are opened and closed manually using a screw lifting gear. Between 1850 and 1977, measurement of the sluice gate opening was recorded by a mechanical device that registered the number of turns of the screw (1 turn = 3.2 mm). In 1977, this mechanism was replaced by a Vernier gauge. Under normal conditions, the centre gate is kept closed. Prior to 1977, the water level behind the centre gate was measured at weekly intervals by manually reading a gauge board. Since then, water level has been measured by an electronic water level recorder.

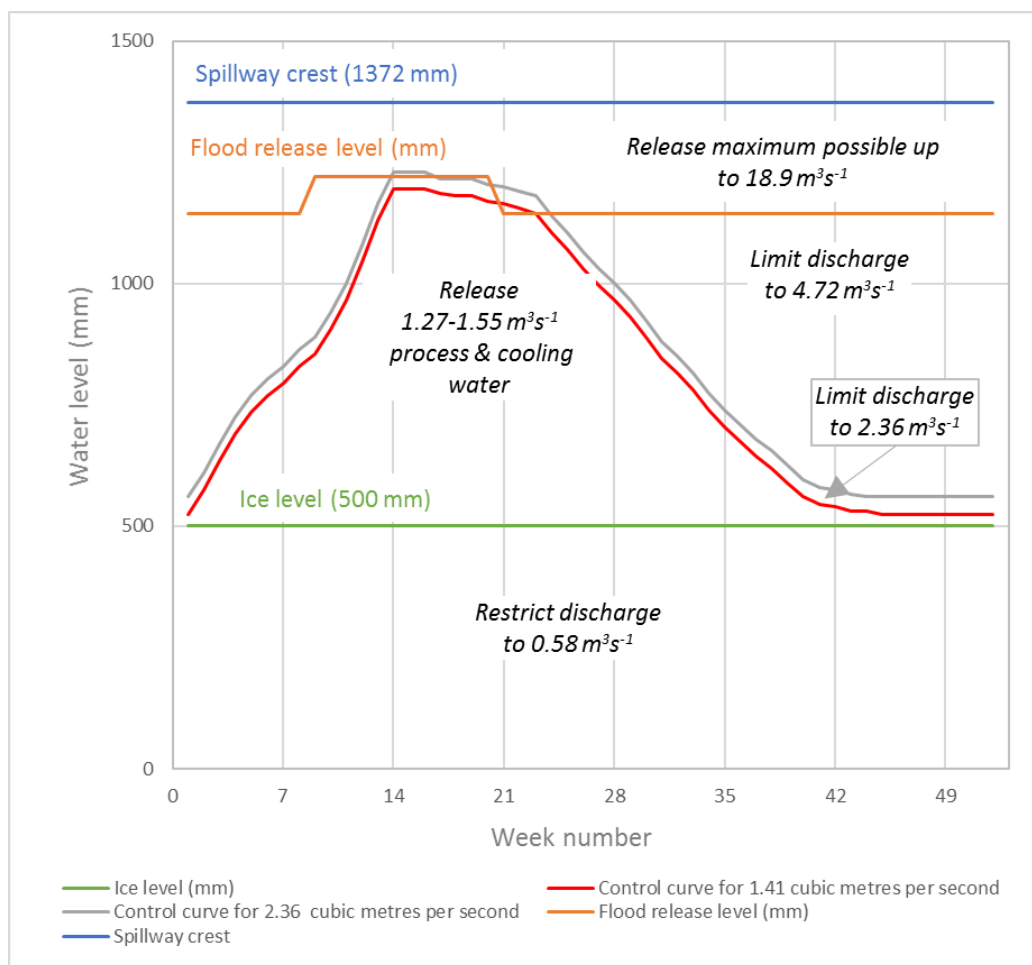
Figure 5 New operating rules suggested by Binnie and Partners (1982).

These new rules are illustrated pictorially in Figure 5.

1. If the loch is below the ice level, restrict discharge to $0.58 \text{ m}^3\text{s}^{-1}$.
2. If the loch is between the ice level and the control curve for $1.4 \text{ m}^3\text{s}^{-1}$ limit the discharge to $1.4 \text{ m}^3\text{s}^{-1}$, except between 1 May and 30 June (when discharge should be reduced by 10%, to $1.27 \text{ m}^3\text{s}^{-1}$) and between 1 July and 15 September (when discharge should be increased by 10%, to $1.55 \text{ m}^3\text{s}^{-1}$).

3. If the loch level is between the control curves for $1.41 \text{ m}^3\text{s}^{-1}$ and $2.36 \text{ m}^3\text{s}^{-1}$, limit the discharge to $2.36 \text{ m}^3\text{s}^{-1}$.
4. If the loch level is between the control curve for $2.36 \text{ m}^3\text{s}^{-1}$ and the flood release level, limit the discharge to $4.72 \text{ m}^3\text{s}^{-1}$.
5. If the loch level is above the flood release level, the discharge should be the maximum possible up to $18.9 \text{ m}^3\text{s}^{-1}$.
6. When snow and ice are present, the control curve and flood release levels should be reduced by 300 mm for every 25 mm of water represented by the snow and ice.
