Special based isolation system for low-rise RC building

N H Hamid ^{*1}, I F Azmi ², P L Y Tiong ³, H Awang ⁴

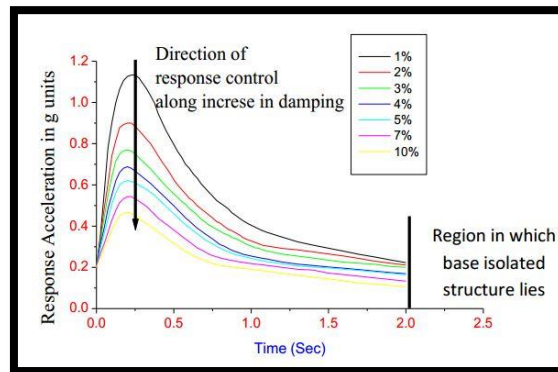
Figure 1. Concept of Base Isolation and Dampers [3]

demolishing. The idea of base isolation system is to reduce the earthquake forces on structure by isolating the structure from damaging effect of ground movement and shift the fundamental period of the structure out of the range of dominant earthquake energy frequencies and increasing the energy absorbing capability[1][2][3]. This concept explained as in figure 1 **Figure 1**. This technique contrasts with conventional design that rely on inelastic structure to dissipate the earthquake energy.

Base isolation proven as the excellent mechanism to cater the earthquake vibration especially at the medium to high seismic region due to the function of base isolation that can increase the natural period of the rigid structures due to their flexibility[1][4][5][6]. The base isolation consists of alternative layers of rubber and steel. A strong bond between the rubber and steel is critically important to the correct functioning of the bearing. The natural rubber is specially formulated to give the required damping. Researchers and engineers proved Base Isolation System is the best way to control the earthquake vibration toward the buildings.

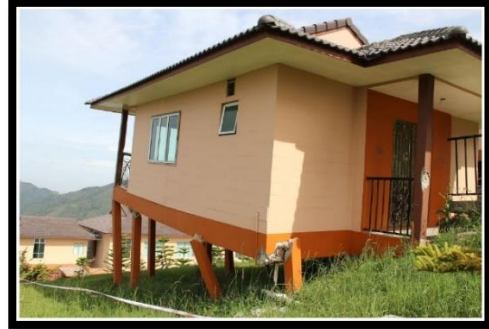
Figure 3. Properties damaged by the earthquake

and Figure 4 [8]. Most of people lost their homes, farms, and plantation as well as disrupted water supply. Typical damages reported were brick wall, shear failure cracks, cracks on columns and beams, roof failure, failure of supporting columns or tilts, concrete spalling, and shattered windows.

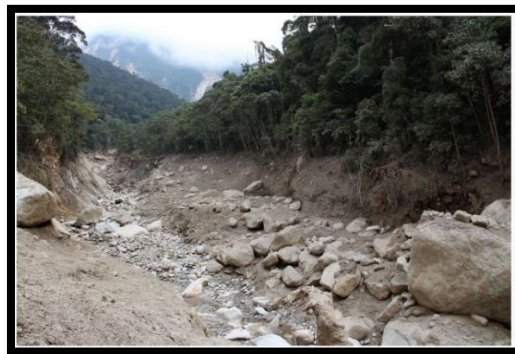
Figure 4. A landslide caused by the magnitude 6.0 earthquake

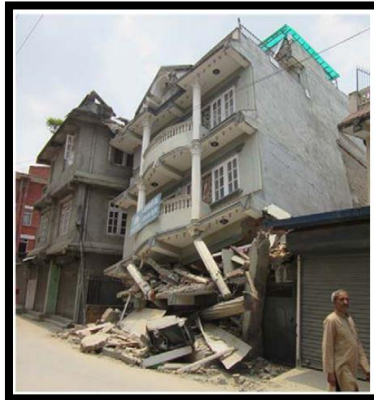
Figure 7. Low rise RC frame building due to the 2015 Nepal earthquake [13]

The earthquake had a significant impact on housing, institutional facilities, heritage buildings, schools, hospitals, and lifelines. About 98% of property in Nepal are low-rise buildings that were constructed by owner-builders that only follow the advice from the local craftsman without any consideration of engineering factors and seismic activities as in Figure 7. They are used as residential buildings for extended families, which is a common housing pattern in Nepal. The space at the ground floor level in these buildings is often used for commercial purposes (small retail stores) as in Figure 8. We can conclude that low-rise buildings in moderate to high seismic regions can be affected by earthquake excitation and need to be repaired by installing the base isolation system. The old and traditional ways of construction are not reliable and increase fatalities.

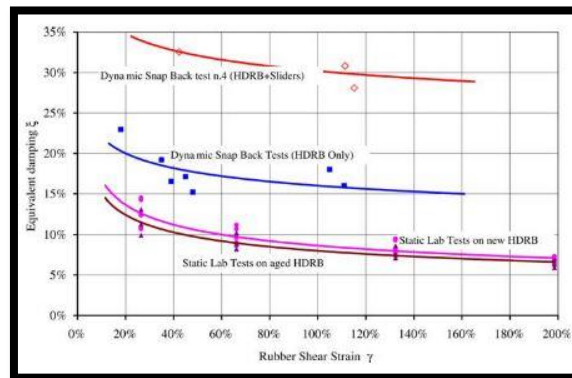
Figure 12. Experimental evaluation of equivalent damping

The tests on the hybrid system gave an equivalent damping ratio ξ_{eq} of about 30% for the first and second couple of peaks. The HDRB system gave an equivalent damping ratio ξ_{eq} about 15% as shown in Figure 12. It shows that the hybrid system (HDRB & Sliding bearing) provide double damping amount compared to the HDRB system only. Figure 13 shows base and top-floor accelerations of the HDRB system and the hybrid structure. It reveals higher values of accelerations for the HDRB system. The first period in the test direction identified during the release is about 1.47s for the HDRB system and 2.05s for the hybrid.

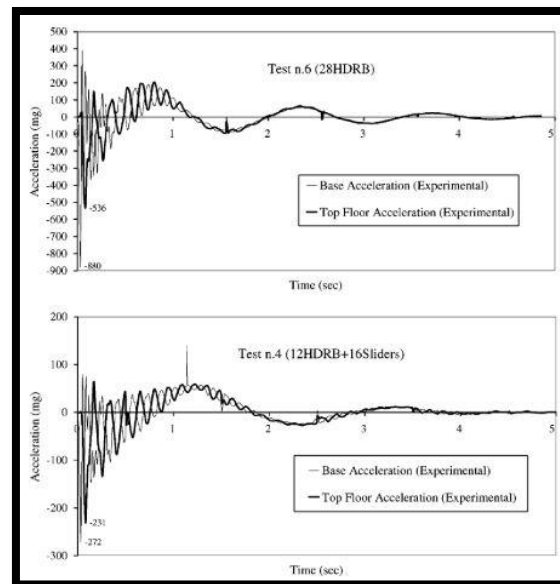
Figure 13. Floors acceleration histories during free vibrations
