Structural diagnosis of a concrete dam with cracking and high non-recoverable displacements

Abstract: Expansions in concrete dams may be caused by chemical or physical sources; however in certain occasions the evidences observed in the dam may not be attributed to a single cause. Mequinenza is an example of a concrete dam affected by expansions and high non-recoverable displacements that cannot be explained by the most frequent pathologies. This paper presents new hypotheses that could justify such behavior by assuming the superposition of a global phenomenon of water induced expansion in concrete in the entire dam and a localized effect consisting in the opening of cracks in the construction joints located in one of the blocks. This is validated by conducting numerical analyses through 2D finite element models that consider the nonlinear behavior of the construction joints and use zero-thickness interface elements to simulate the potential cracking planes in the dam. The results confirmed the diagnosis proposed and the capability of the model to reproduce the behavior of the dam, revealing the significant contribution of the opening of the cracks to the non-recoverable displaceme

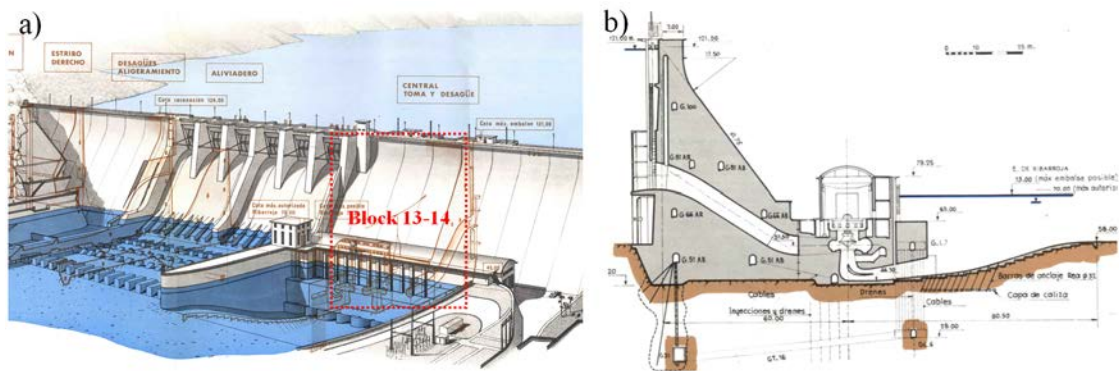
Mequinenza dam is a gravity dam located in the northeast of Spain at the Ebro River, which is the second largest river in the country. The dam presents a straight form in the ground plan with a crest length of 461 m and a height of 79 m. The dam is divided in blocks that are, in general, from 14 m to 21 m wide and exhibits a vast network of longitudinal galleries. Fig. 1a shows the view of the dam from the downstream area and highlights the location of block 13-14 (between vertical joints 13 and 14). This block presents some particularities with regards to the others since it contains the intake pipes leading to the turbines as shown in the cross-section of Figure 1b. The width of this block is 70 m, which is from 3 to 5 times wider than the rest of the blocks and the concrete employed for its construction contains higher content of cement than the other blocks.

Fig. 1. a) View of the dam from downstream face and b) cross-section of block 13-14 (reprinted from ENHER 1973, with permission).

The hypothesis of a superposition of a global effect in the entire dam and a localized effect in block 13-14 is in line with the horizontal displacements towards the downstream face observed in the dam and shown in Figure 1. In order to verify this, block 13-14 of Mequinenza dam was modeled with finite elements (FEM).

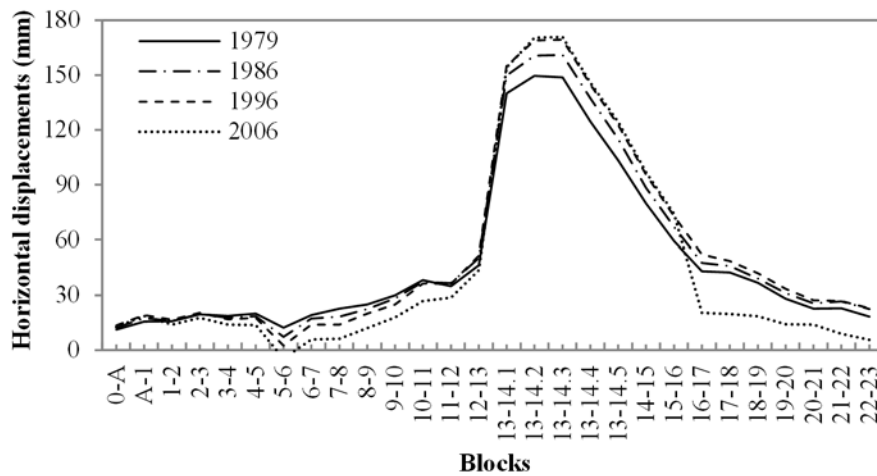
During the filling of the reservoir, horizontal displacements towards downstream were detected, particularly in block 13-14. Fig. 2 shows the evolution of horizontal displacements registered by the measurement points located at the crest in the years 1979, 1986, 1996 and 2006. The registered data indicates that the main displacements in the dam occurred before 1979. Nevertheless, it cannot be stated that they have stabilized despite that the displacements become smaller in subsequent years.

Fig. 2. Horizontal displacements at the crest of the dam.

Furthermore, the evolution of horizontal displacements in Fig. 2 reveals a distinct behavior in the block 13-14. This particular block exhibits horizontal displacements that are almost 10 times bigger than the rest of the blocks, even though certain dragging movements may also be observed in the adjacent blocks. In terms of vertical displacements, a similar response was detected with regards to block 13-14, which presented considerable displacements in the early years that decreased with time.

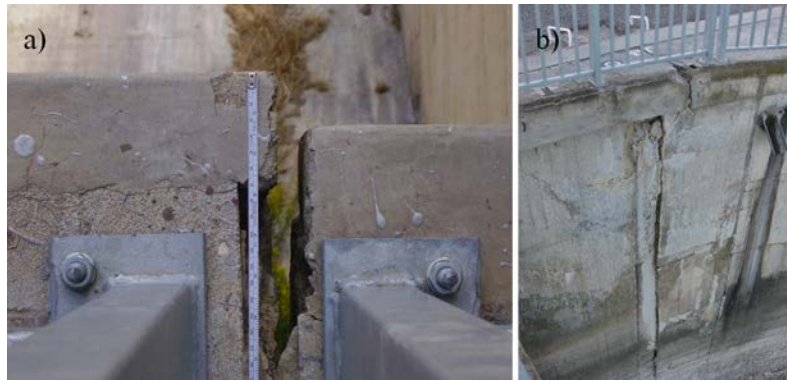
Fig. 3a shows the relative displacement between block 13-14 and the adjacent block to the right in the downstream face in 2006. This relative displacement reaches 4.0 cm, whereas in the upstream face the value decreases up to 2.0 cm approximately. Fig. 3b corresponds to the state of the joint 13 in the upstream face in 2009.

Fig. 3. a) Relative displacement in block 13-14 (downstream face) and b) joint 13 in the upstream face.

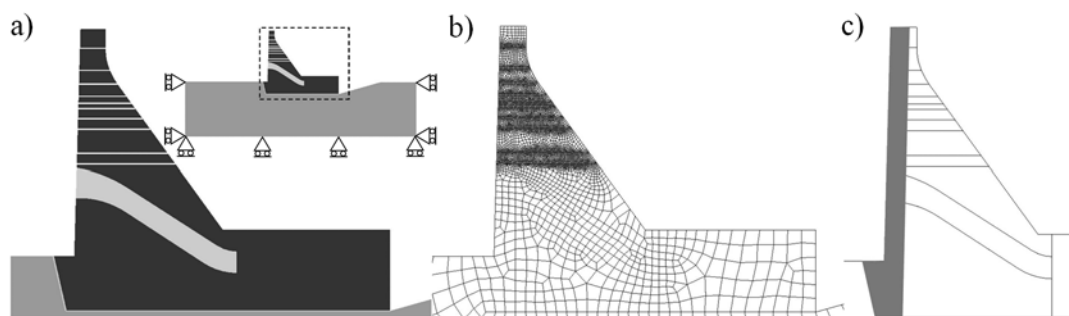
Fig. 4a shows the geometry of block 13-14, which was defined according to the information provided by the managing organism and includes the intake pipe and the horizontal construction joints (see grey horizontal lines). The location of the potential cracking planes was defined based on a detail survey of the cracking in the upstream face conducted in the late 1960s (see Table 1) and they are represented by zero-thickness interface elements. Fig. 4b presents the finite element mesh created for the modeling of block 13-14, with a higher density around the joints and in the area where the expansion occurs.

Fig. 4. a) Discretized geometry of block 13-14, b) detail of the FE mesh of block 13-14 and c) area where imposed deformations are applied (grey area).

The actions considered in the modeling were the self-weight, the hydrostatic pressure, the uplift pressure and the imposed deformation derived from the expansion of concrete. In the case of the imposed deformations, these were assumed to start in the upstream face and progress up to a depth of 6.1 m, where the drainage is located, as shown in Fig. 4c (see grey area). In terms of the boundary conditions of the soil, the horizontal displacement is restrained in the sides and the vertical displacement is restrained at the bottom as indicated in Fig. 4a.

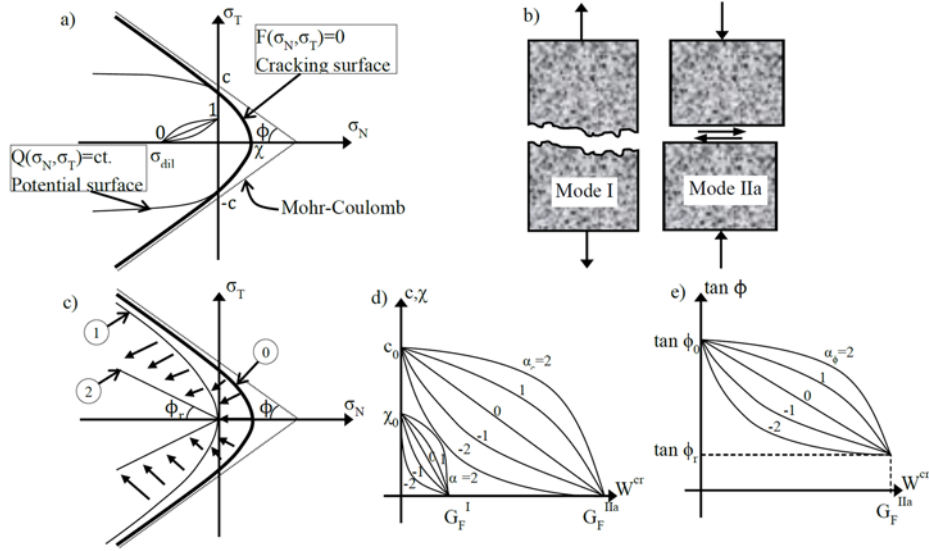
The main characteristics of the plastic model are represented in Fig. 5. The initial loading (failure) surface $F = 0$ is given as a three-parameter hyperbola (see Eq. (1)).

where tensile strength χ (the vertex of the hyperbola), asymptotic cohesion c and asymptotic friction angle $\tan \phi$ are model parameters (see Fig. 5a). The model assumes that the crack appears when the stress in the interface plane reaches the condition of $F(\sigma_N, \sigma_T) = 0$, where σ_N is the normal stress at the interface and σ_T is the shear stress at the interface.

Fig. 5. Crack laws: a) hyperbolic cracking surface F and plastic potential Q ; b) fundamental modes of fracture; c) evolution of cracking surface; d) softening laws for χ and c ; e) softening law for $\tan \phi$ (reprinted from Carol et al. 2001, with permission).

As the cracks appear, the loading surface begins to shrink due to the decrease in the main parameters according to evolution laws based on the work dissipated in fracture process (W^{cr}). In order to control the evolution of F , the model has two parameters that represent the classic energy of fracture in mode I, indicated as GF^I (pure tension), and a second fracture energy under mode IIa defined under shear and high compression without dilatancy, denoted as GF^{IIa} (schematically shown in Fig. 5b).

Under pure tension the final loading surface is given by a hyperbola with a vertex that is the origin in the stress space (curve "1" in Fig. 5c). Under a shear/compression load, the final state, reached when $c = 0$ and $\tan \phi = \tan \phi_r$ ($\tan \phi_r$ represents the residual internal friction angle), is defined by a pair of straight lines representing the pure residual friction state (curve "2" in Fig. 5c). Additional parameters α_x , α_c , α_ϕ control the softening curves evolution (for $\alpha_x = \alpha_c = \alpha_\phi = 0$, the decrease is linear, Fig. 5d and 5e). The model is associated in tension $F=Q$, but not in compression. A dilatancy law is defined with a progressive reduction of the dilatancy with the increase of the compression level $\sigma \rightarrow \sigma_{dil}$, which is an additional parameter of the model (Fig. 5a), and interface degradation $c \rightarrow 0$. A more detailed description of the interface law may be found in (Carol et al., 1997; Carol et al., 2001; López et al. 2008a).

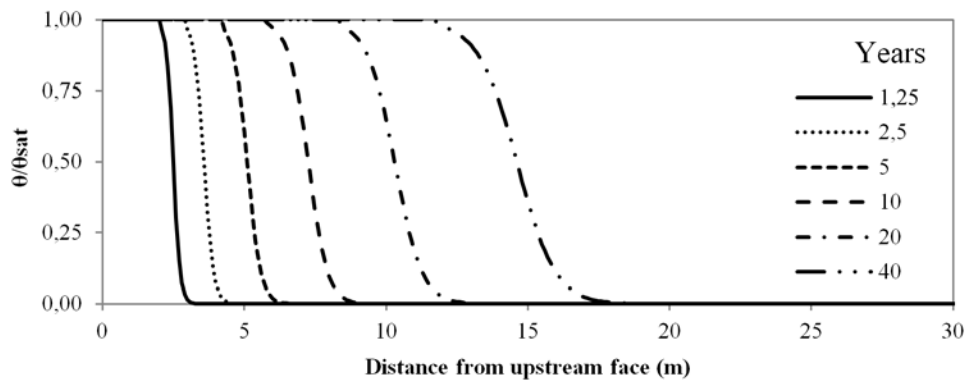
As an example, the water infiltration model is applied to simulate the infiltration in a generic cross-section. This is represented in Fig. 6 in terms of water gain (θ/θ_{sat}) against distance from the upstream face (or depth into the dam) for a level of the cross-section of the dam located 20.0 m below the reservoir level. Considering the relation established in Equation 4, the figure shows the shape of the evolution of the volume variation with time from the upstream face towards the inside of the dam. Furthermore, the results indicate that the areas close to the upstream face are saturated, whereas as the distance increases the degree of saturation decreases. The saturated areas remained at a distance from the upstream face below to 10.0 m during the 20 years after the construction, however from that moment on the saturated areas increased towards the inside of the dam.

Fig. 6. Horizontal infiltration for a section located 20 m below the reservoir level.

In the results presented in this section, the expansions are imposed considering the water infiltration process presented in Fig. 6. The deformations are applied assuming that the infiltration begins in the upstream face and progresses up to a distance of 6.1 m, where the drainage is located. The expansion is defined in the model as imposed deformations in each node of the mesh as if it was variation of temperature. The water infiltration model is applied in the following section to validate the diagnosis.

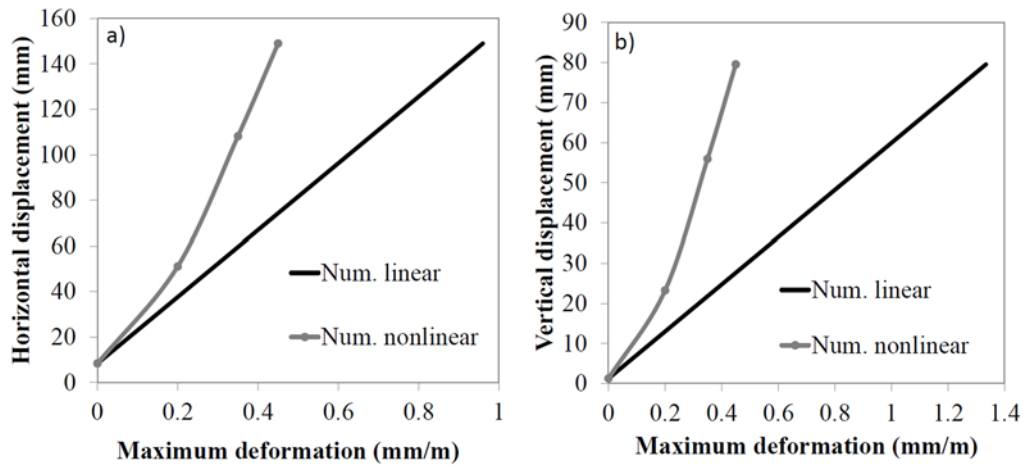
The influence of the imposed deformation due to the expansion is assessed by performing the analysis of the horizontal and vertical displacements at the crest of the dam for values of expansions ranging from 0 to 4.5 mm/m. The upper limit of 4.5 mm/m was set according to the deformations obtained from the samples in the studies described in previous sections. Furthermore, the influence of assuming a linear elastic behavior or a nonlinear behavior is also evaluated. In the case of the linear elastic case, the response is exclusively due to the deformation of the continuum. Fig. 7 shows the results yielded by the model.

Fig. 7. Influence of the expansion on: a) horizontal displacements and b) vertical displacements.

The results indicate that the horizontal and vertical displacements obtained with the nonlinear analysis increase at a higher rate with the value of imposed deformation than the values yielded by the linear elastic analysis. For example, the value of 0.35 mm/m yields values of horizontal and vertical displacements at the crest of the dam of 5.96 cm and 2.18 cm, respectively, when a linear behavior of the joints is assumed. Nevertheless, these values increase to 10.81 cm and 5.59 cm, respectively, when a nonlinear behavior is assumed. Notice that these values correspond to twice the value obtained with the linear elastic simulation. This highlights the significant contribution of cracking to the increase in the displacements at the crest of the dam.

The expansion generates compressions within the area where the expansion occurs and tensions in the adjacent area of the advancing front. Furthermore, the results indicate that the cracking in the joints appears at a certain distance from the upstream face (see Fig. 8a) and grow with time towards the downstream and the upstream faces (see Fig. 8b and 8c). Fig. 8d depicts the final deformed configuration that corresponds to horizontal and vertical displacements at the crest of the dam of 10.81 cm and 5.59 cm, respectively (as previously shown in Fig. 7).

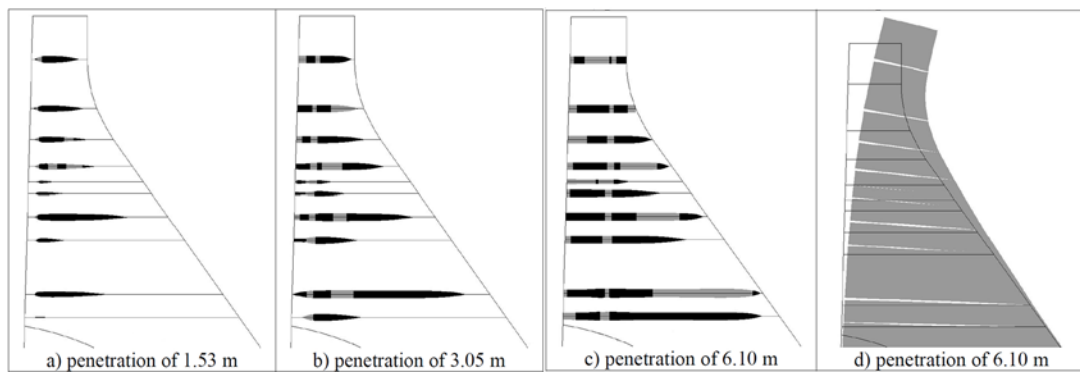
For this reason, the value of 0.35 mm/m is considered to study the evolution of the cracking in terms of energy dissipated during the fracture process in three different moments as shown in Figure 8. This amount of energy is represented by the thickness of the line in the joints depicted in Fig. 8a, 8b and 8c. Notice that the black stretches represent loaded areas of the joint where the crack is active, whereas the grey stretches correspond to elastic unloaded cracks.

Fig. 8. Evolution of the cracking in the joints.

The results yielded by the model regarding the progression of the cracking in the joints are consistent with an internal report from the managing organism dating back to 1969. This report states that “block 13-14 presents water infiltrations in the downstream face at level 112.0 m due to a horizontal crack from face to face of the dam” (see also Table 1). These results are a strong indication that the diagnosis hypotheses are valid and could explain the behavior observed in block 13-14.

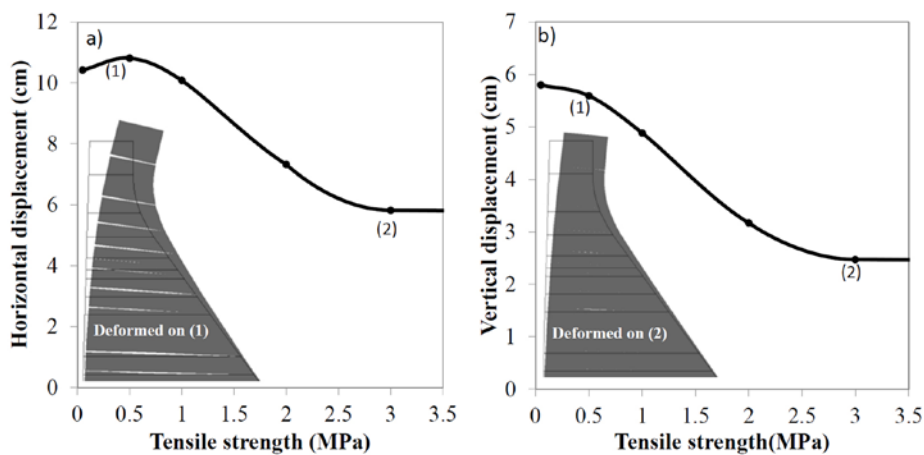
For the calculations in the previous section, the value adopted for the tensile strength of the joints was 0.5 MPa. In order to evaluate the influence of the tensile strength of the joints in the results, further analyses are conducted by taking values ranging from 0 to 3.0 MPa and keeping constant the value of the expansion (0.35 mm/m). Notice that Mequinenza dam was built in the mid-1960s and the tensile strength of the construction joints was most probably low (as it is indicated in the records of the dam), which leads to high values of the displacements. Fig. 9 shows the results of horizontal and vertical displacements yielded by the model at the crest of the dam in block 13-14.

Fig. 9. Influence of the tensile strength of the joints on: a) horizontal displacement and b) vertical displacements at the crest.

The curves reveal that for a tensile strength between 0 MPa and 1.0 MPa the displacements do not vary significantly, taking values close to 11 cm for horizontal displacements and between 5 and 6 cm for the vertical displacements. Conversely, for higher values of the tensile strength both horizontal and vertical displacements are considerably reduced, particularly when the tensile strength increases from 1.0 MPa to 2.5 MPa. For tensile strengths over 3.0 MPa the displacements are stabilized and take similar values to those obtained with the linear elastic simulation.

This difference in the displacements between the points (1) and (2) may be attributed to the different contribution of the cracks as shown in the graphs of the deformed mesh in Fig. 9a and 9b. For the tensile strength associated to case (1), the opening of the cracks contributes to the vertical and horizontal displacements, whereas for case (2) no cracking is observed and, therefore, the displacements correspond to the elastic situation.

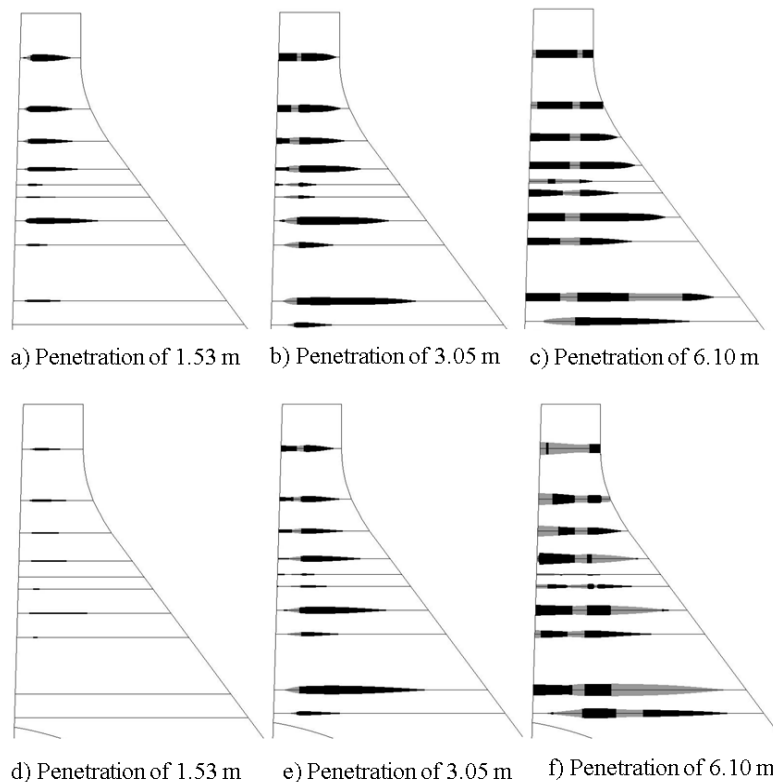
In order to determine the influence of the uplift pressure in the results of the model, a case was analyzed without taking into account this effect in the construction joints. For that, the values of expansion and tensile strength of the joints adopted were 0.35 mm/m and 0.5 MPa, respectively. Moreover, the effect of varying the fracture energy of the interface elements was also evaluated. For that, the calculations were conducted once more with a value of fracture energy five times bigger than in the previous cases ($5 \times GF^I$). Fig. 10 presents the evolution of the cracking obtained for both cases.

Fig. 10. Evolution of the cracking in the joints without considering the uplift pressure (a, b and c) and with a fracture energy $5 \times GF^I$ (d, e and f).

Fig. 10 indicates that the evolution of the cracking for both cases is similar to the case presented in Fig. 8. However, in terms of the horizontal and vertical displacements the values yielded by the model in these two cases are smaller than for the case presented in Fig. 8. If the uplift pressure is not considered in the modeling, the values decrease to 9.05 cm and 4.45 cm, respectively. When the uplift pressure is taken into account but the fracture energy is

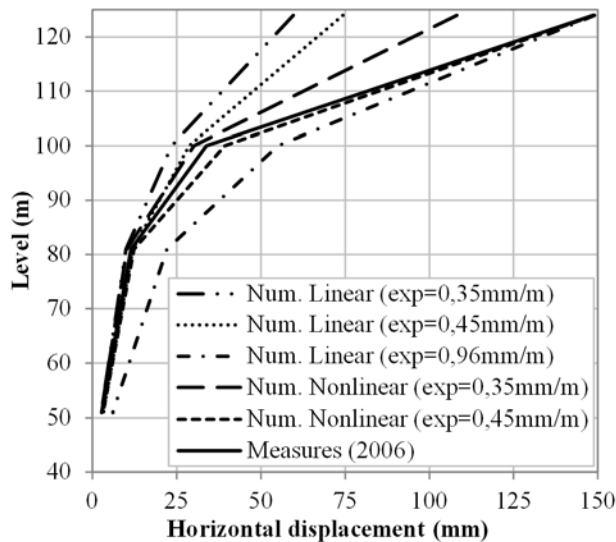
Fig. 11 shows the comparison of the horizontal displacements with the results of the model for different values of expansion (0.35 mm/m and 0.45 mm/m) and both linear and nonlinear analyses. The horizontal displacement is plotted against the level in meters. As a reference, the value 0.96 mm/m is also adopted for the linear assumption.

Fig.11. Horizontal displacements measured and calculated in various cases.

The four cases with 0.35 mm/m and 0.45 mm/m yield a good fit of the horizontal displacements up to the level 81 m. From that level upwards, the results of the model start to differ from the measurements registered, particularly for the linear analysis. Notice that in order to reach the values of displacement registered at the crest of the dam without assuming cracking an expansion of 0.96 mm/m is required, which is not realistic and significantly higher than the experimental values described in the section entitled *Previous studies*. Furthermore, this expansion yields value of displacement noticeably higher than the ones measured at the dam for levels below the crest.

Conversely, when a nonlinear approach is adopted and the cracking in the construction joints is considered in the calculations the fit of the results improves. In fact, the results show that the displacements registered in block 13-14 remain between the estimated displacements for 0.35 mm/m and 0.45 mm/m. Furthermore, the model is capable of reproducing the change in the curve at levels 80 m and 100 m, which is precisely due to the consideration of the opening of the cracks. It must be highlighted that the cases were analyzed taking into account ten potential cracking planes and assuming that there might be more cracks than the ones considered. This would represent a greater contribution of the opening to the cracks to the displacements for a similar degree of expansion.

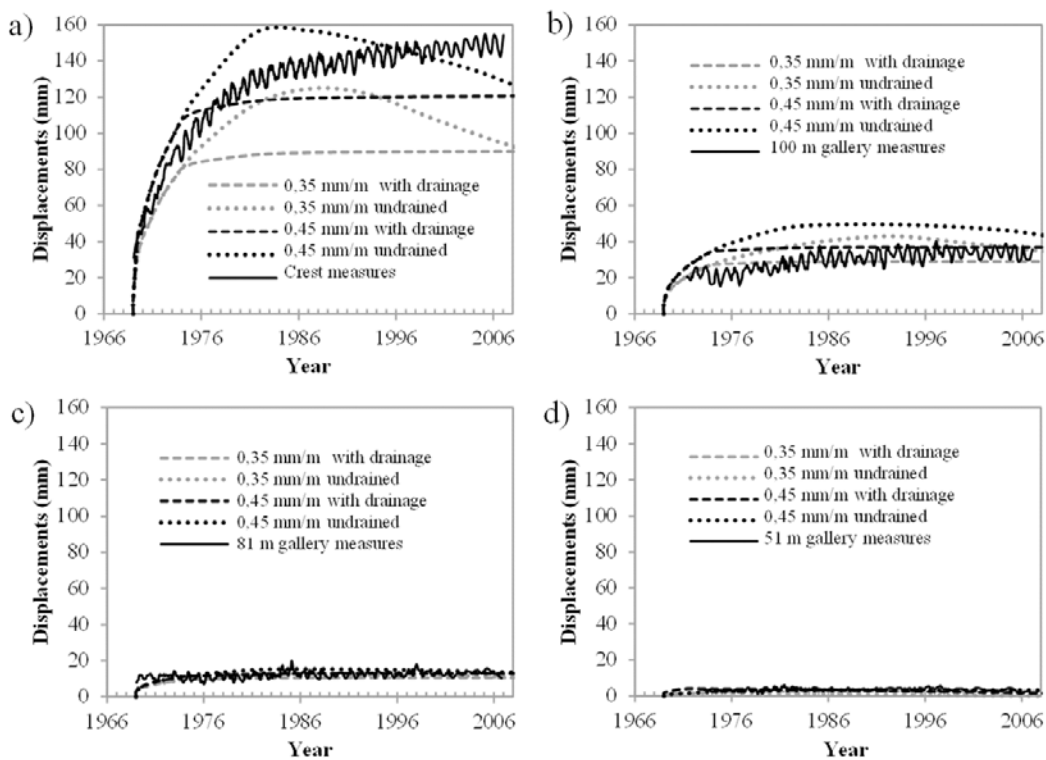
Fig. 12 presents four graphs with the evolution of the horizontal displacements for the described cases of expansion and drainage and the measurements registered at the dam. Each of these graphs corresponds to the measurements at a certain level of the dam. In this case, the displacements correspond to the measurements at crest of the dam (Fig. 12a), at the gallery 100 m (Fig. 12b), at the gallery 81 m (Fig. 12c) and at the gallery 51 m (Fig. 12d).

Fig. 12. Evolution through time of the horizontal displacements for Block 13-14: a) at the crest of the dam, b) at the gallery 100 m, c) at the gallery 81 m and d) at the gallery 51 m.

The general outcome indicates that the model is capable of reproducing the measurements registered in block 13-14 with the diagnosis hypotheses proposed. The accuracy of the estimation is particularly noticeable in Fig. 12b, 12c and 12c.

Regarding the drainage, the curves in Fig. 12a show that the displacements registered at the crest of the dam remain among the ideal drainage and no drainage situations, which is reasonable given that the drainage in the dam is not ideal and certain amount of water inside the dam might not be drained. In the case of the galleries (at the different levels), the differences of considering an ideal drainage or no drainage are minor if compared to the crest of the dam.
