Procedia Engineering 2 (2010) 3053–3058

Evaluation of pressure insoles during running

Rene El Kati^{a*}, Steph Forrester^a, Paul Fleming^a^aLoughborough University, Loughborough, Leicestershire, LE11 3TU, UK

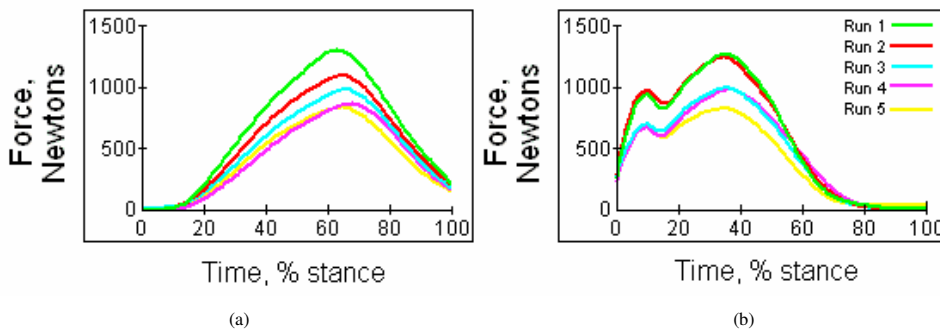
Fig. 2. During the 5 x 1.5 minute runs the output of the insoles decreased both in the forefoot (a) as in the rear foot (b)

The force curve of the pressure insoles with the step calibration show that with each run the output decreased substantially, with a 41% drop of the peak force between the first and the last run (Fig. 1). Similar differences were found for specific regions across the foot (Fig 2). Nevertheless the shape of the force curve seemed consistent for all the trials.

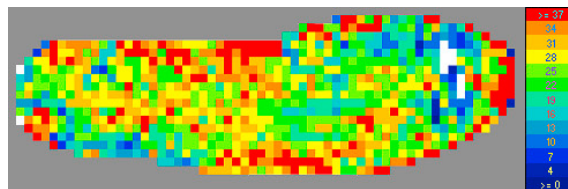
Fig. 3. Putting the insole in the airbladder at a constant pressure after the test showed that the cells did not degrade uniformly, there were also a couple of cells that failed to produce any output.

When the insoles were put in the air bladder after the test it appeared that the forefoot region had degraded more than mid- and rear foot as the output of those cells was less than in other regions under the same pressure (Fig 3). There were also a few cells that failed to produce any output.

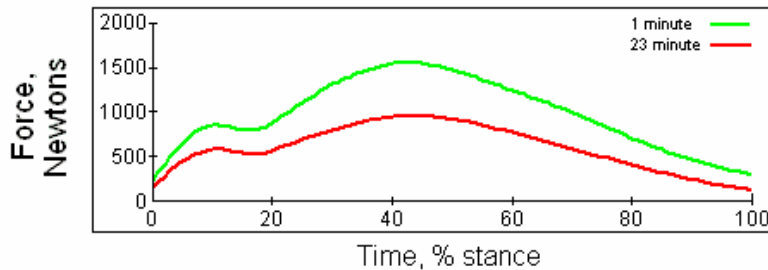
Fig. 4. A comparison of the output at 1 minute and at 23 minutes of the 23 minute shows a clear degradation of the pressure insole

The force curve of the pressure insoles with the step calibration show a similar decrease during the 23 minute run, with a maximal difference in peak force of 47% (Fig 4).
