10th CIRP Conference on Intelligent Computation in Manufacturing Engineering - CIRP ICME '16

## Eco-intelligent monitoring for fouling detection in clean-in-place

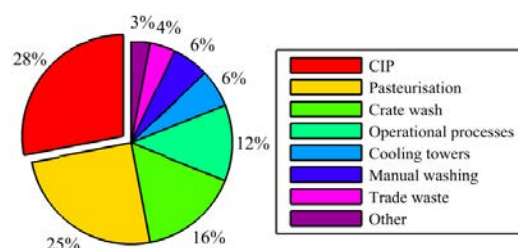
Fig. 1. Water use of a milk processor (4)

Furthermore it is estimated that between 9 and 30% of the site energy used by a food processing plant is for cleaning (3,4), as reported in Fig. 1, whilst between 7 and 33% of a production site's water is utilised by the cleaning process (5,6). The usual procedure for cleaning equipment in the food industry is the Clean-in-Place (CIP) system that avoids the need for equipment disassembly.

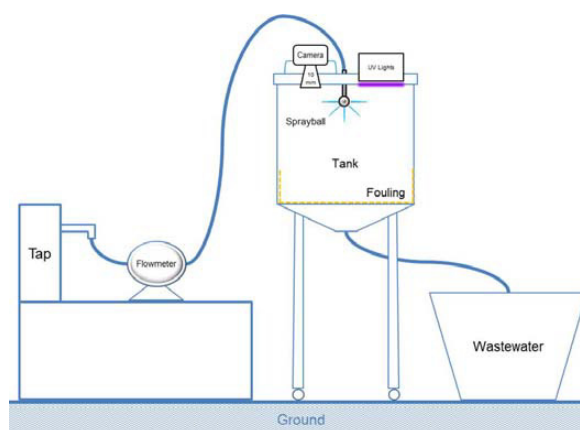
Fig.2. Experimental setup general scheme

A stainless steel brewing tank, diameter 62 cm and a usable volume of 100 litres (Fig. 2) endowed with exit tap was used for the design and implementation of the proposed CIP monitoring system. The lid was modified in order to allow the installation of the sprayball, the camera and the UV lights set.

The purpose of the experimental campaign is to reproduce a CIP system in laboratory scale, in order to verify the capability of a monitoring system to detect surface fouling within the tank.

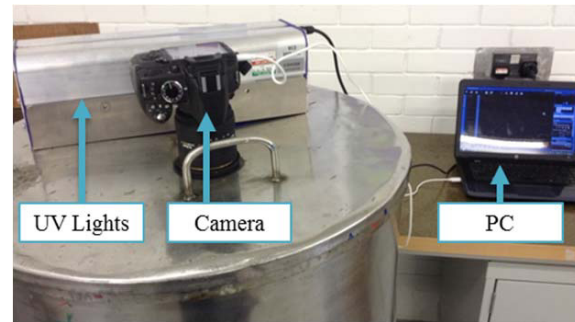
Fig. 4. Image acquisition system

For the acquisition of images, a Nikon D3100 digital camera and a set of 18 W 370 nm fluorescent UV lights were installed in the lid of the tank (Fig. 4)

The digital camera was placed with a 7° inclination angle to improve the field of view within the tank for its given geometry.

In order to maximise the tank surface included in a single image, a wide angle Sigma 10-20 mm zoom was used on the digital camera. Considering that the UV light set is the only source of light in the tank, it was not necessary to apply a UV filter on the lens. The campaign of experimental tests was carried out using a time-lapse technique.

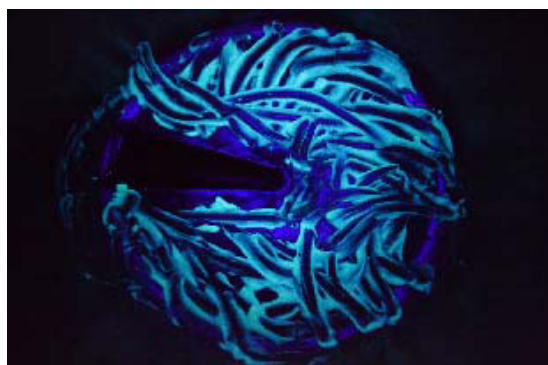
Fig. 5. RGB image acquired

The RGB image appears as a 4608 x 3072 x 3 elements matrix, where the first two dimensions (4608 x 3072) represent the image resolution, and the third dimension (3) is represented by the three colours channels red, green and blue respectively. An example of RGB image is reported in Fig 5.

Due to the reaction to the UV light, in the RGB image, the fouling appears as a series of cyan-like coloured stains (Fig. 5), while the tank surface is blue-purple. In order to isolate the fouling image, it was necessary to isolate the green channel (G) of the image, as reported in the image below.

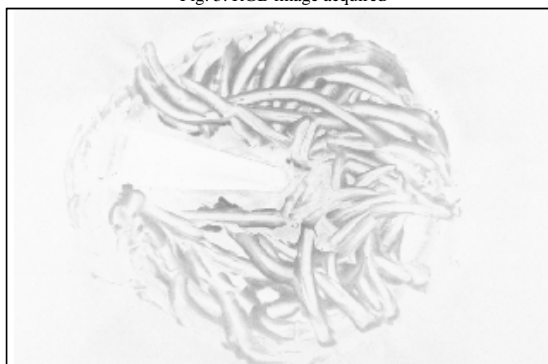
Fig. 6. Green channel grayscale representation

After this transformation, the green channel image corresponds to a 4608x3072 matrix whose elements values range from 0 (black) to 255 (white) and it appears as a grayscale image (see Fig. 6). The RGB to grayscale transformation allows the visualisation of the fouling on the tank surface.

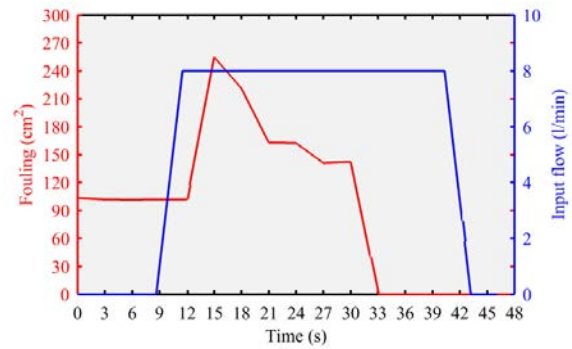
Fig. 8. Fouling removal in test R03

Fig. 8 illustrates the results of the test R03. As soon as the washing cycle starts (12-15 s), the apparent surface fouling value increases, this is due to the water flow which removes part of the fouling allowing it to float on the water surface since the inlet flow (8.0 l/min) is higher than the drain flow (2.0 l/min). As the washing cycle continues, the amount of surface fouling decreases as it is drained, and after 33 seconds, the tank results appear clean according to the system sensitivity.

The experimental and the image acquisition parameters are reported in Table 2. Water flow was set to 8.0 l/min during the experiment with the exit tap of the tank wide open during the whole washing cycle.

An initial variation in the amount of fouling can be seen in the first 12 seconds of the test, this is due to the low viscosity of the Riboflavin solution.

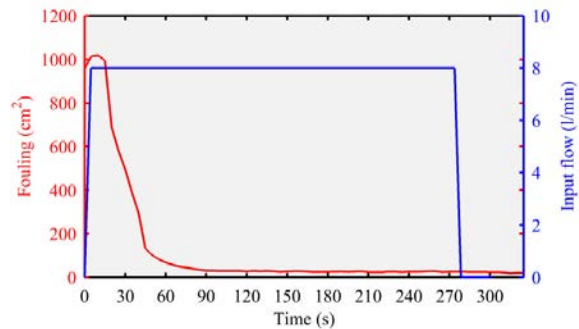
Fig. 9. Fouling removal in test Y03

The experimental and the image acquisition parameters are reported in Table 3. Water flow was set to 8.0 l/min during the experiment with the exit tap of the tank wide open during the whole cycle. Fig. 9 illustrates the results of the test Y03.

As soon as the washing cycle starts (8-10 s), the apparent surface fouling value increases, this is due to the water flow which removes part of the fouling allowing it to float on the water surface since the inlet flow (8 l/min) is higher than the drain flow (2.0 l/min). The asymptotic trend of the fouling around 50 cm<sup>2</sup> visible toward the end of the test highlights that the cleaning process was not completely successful. This was attributed to the irregular tank bottom surface which presents some crevices in which the residual yoghurt is not removed by the spray ball.

Moreover the yogurt has a higher viscosity (1100 mPa·s) and it makes its removal more difficult when constrained in crevices and cracks.

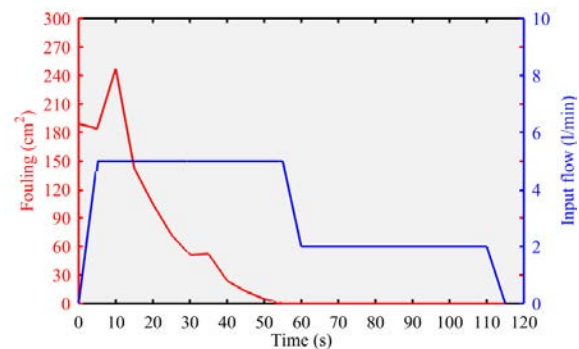
Fig. 10. Fouling removal in test I02

Fig. 10 illustrates the results of the test I02. In the first 10 seconds of the washing cycle the apparent surface fouling value rapidly increases, again due to the water flow which removes part of the fouling allowing it to float on the water surface since the inlet flow (5.0 l/min) is higher than the drain

flow (2.0 l/min). As the washing cycle continues, the fouling amount decreases until it reaches zero shortly before 60 seconds. In this case, the tank results clean to the sensitivity of the system.

The experimental and the image acquisition parameters are reported in Table 4. Water flow was set to 5.0 l/min for 70 seconds then decreased to 2.0 l/min for the rest of the test. During the experiment with the exit tap of the tank wide open during the whole washing cycle.
