Predicting In-situ Heat Pump Performance: An Investigation into a Single Ground-Source Heat Pump system in the context of 10 similar systems.

A. Stafford^{a*} and D. Lilley^b

^aCentre for the Built Environment, Leeds Metropolitan University, Northern Terrace,
Queen Square Court, Leeds LS2 8AG

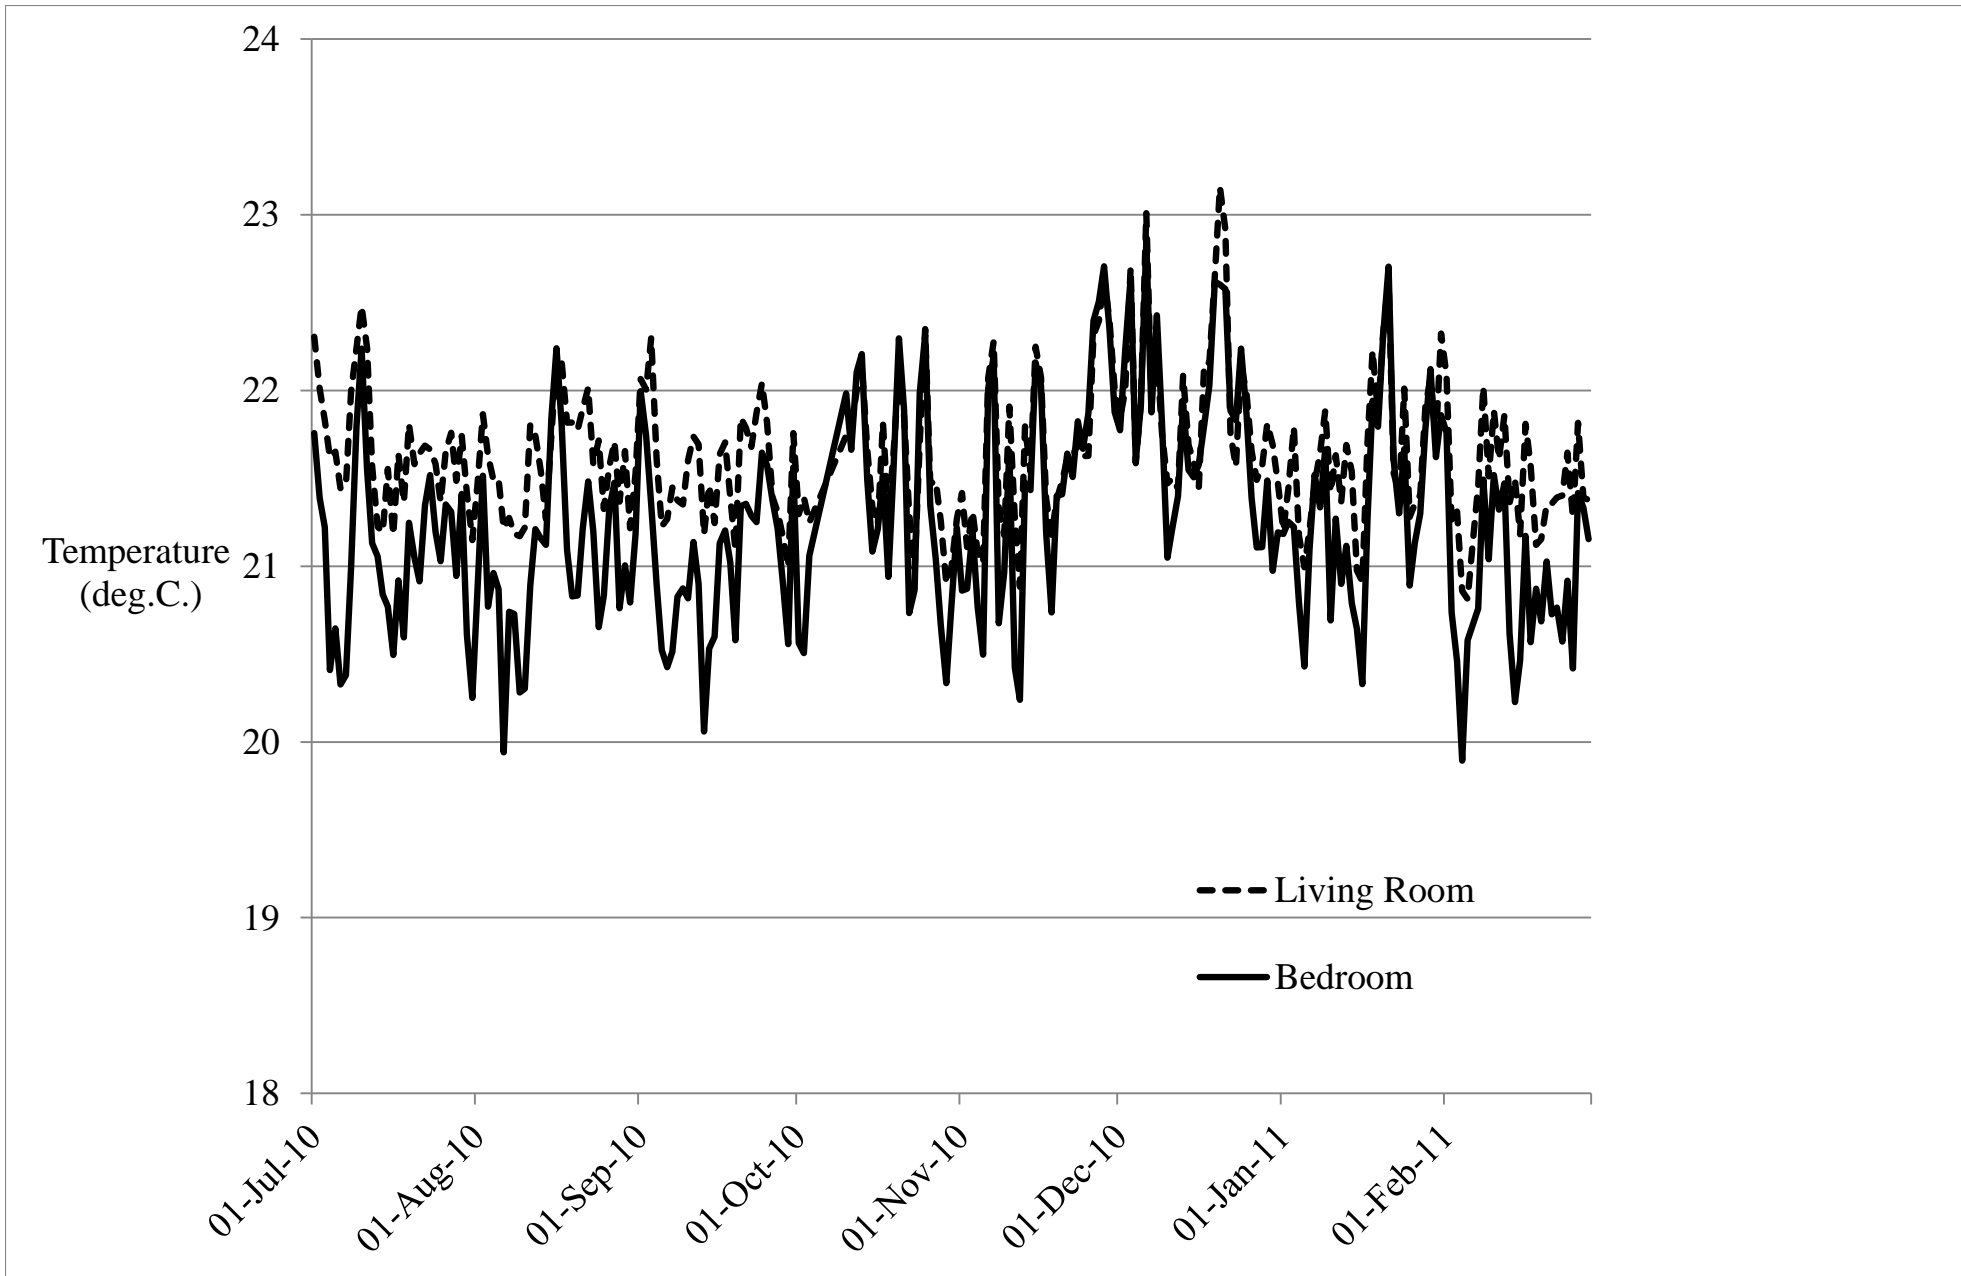
Fig 4: Daily Average Living Room and Bedroom Temperatures for system A (July 10 to February 11). (Daily average calculated as a mean from data sampled at 10 minute intervals).

Taking a simple view we might expect to see either fairly high internal dwelling temperatures, or low ground-loop temperatures, leading to relatively high electricity usage and lower efficiency during the heating season. Internal temperatures in the system A dwelling were measured in four locations (living room, bedroom, kitchen and bathroom) and found to be reasonably consistent and stable throughout the dwelling. Fig 4 shows living room and bedroom temperatures only for the sake of clarity, but kitchen and bathroom temperatures followed the living room temperature closely. The somewhat lower and less stable bedroom temperatures, during all of the year except for the coldest period in late November and December may be explained by the window-opening behaviour discussed in section 2.7.

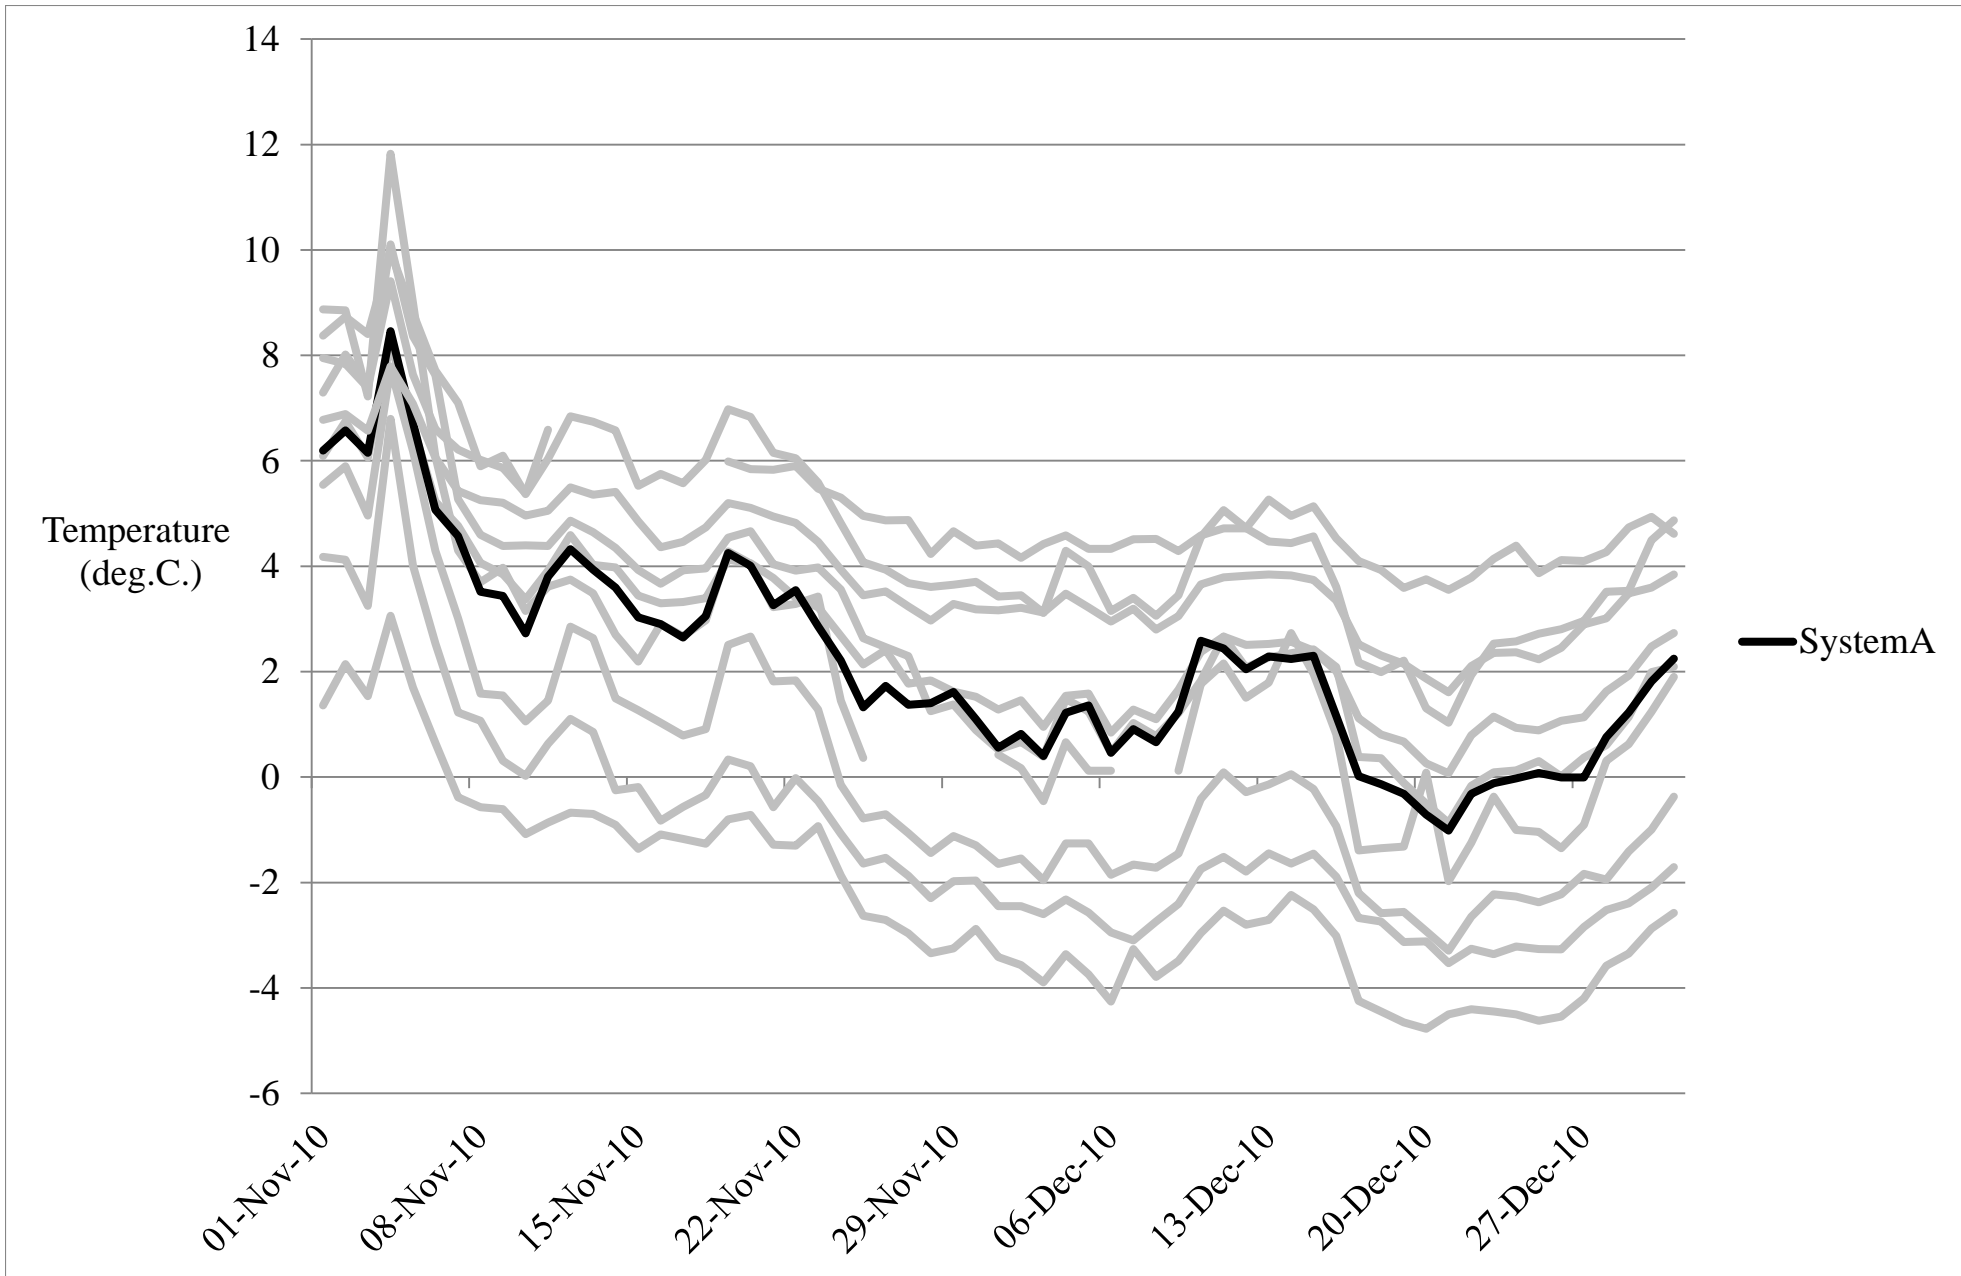
Fig 6: Daily Average Temperature of fluid from Ground Loop for all 10 systems (November/December 2010). (Daily average calculated as a mean from data sampled at 10 minute intervals).

Figs 5 and 6 track the living room temperatures and ground-loop fluid temperatures for all the systems. In the case of Fig 6 the plot is restricted to the months of November and December 2010. A full year plot would be misleading since during the warmer months, when the heat

pump is operating intermittently, the temperature measured may represent only that of stagnant fluid in the pipework.

Figs 5 and 6 show that in the context of the other systems, system A is around average for both internal temperature and ground-loop fluid temperature. We might therefore expect to see average performance during the winter months, when the efficiency is dominated by space-heating, but in fact the performance tends to be below average. Factors which may cause this apparent anomaly are discussed in the following sections.
