ANALYZING KINETICS OF DEFORMATION OF BOUNDARY ROCKS OF MINE WORKINGS

Purpose is to analyze nature of rock deformation and to estimate experimentally state of mine workings being supported under the conditions of areas disturbed by coal mining.

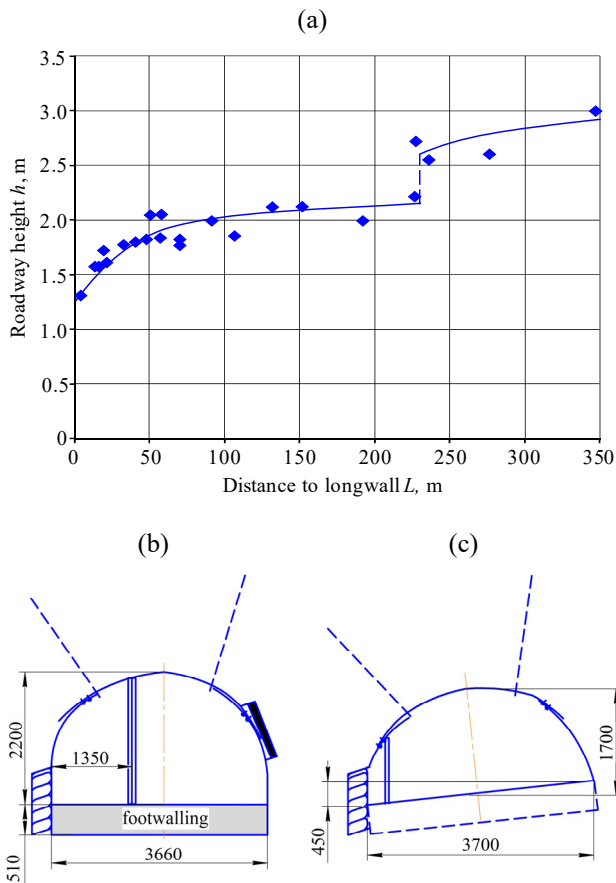
Figure 1. Graph of belt roadway height (h) of western longwall 12 (c_{18}) dependence upon distance to longwall L (a); drafts of the mine working cross-section at the distance of 229 (b) and 20 (c) meters

Instrumental observations in the ventilation raise have demonstrated that within mine workings, supported in front of the longwall, period of intensive shifts correlated with the period when the mine working gets to abutment pressure area. That coincides with common idea of deformation processes within mine workings being supported in a zone of longwall affect (Ma et al., 2018a; Ma et al., 2018b; Nehrii, Nehrii, & Piskurska, 2018). It is possible to determine general characteristic of the mine working deformation while analyzing its height variations depending upon distance to the longwall (Fig. 1a). Convergence intensification is observed at 80–60 m distance to the longwall; vertical convergence is more than 1 m. Drafts of the mine working cross-section show general deformation dynamics (Fig. 1b).

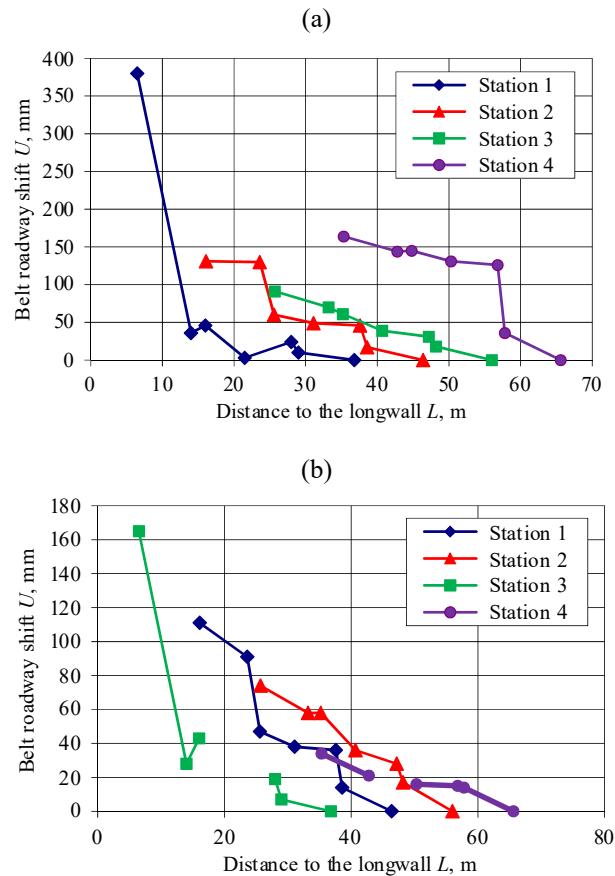
Figures 2. Graphs of belt roadway shift U (western longwall 12, seam c_{18}) depending upon distance to the longwall L : a – total vertical convergence; b – footwalling

Processing of the results of the measurements, concerning shears of the mine working boundary on benchmarks, helped obtain graphs of changes in total vertical shifts according to stations (Fig. 2a) as well as deformations of the floor rocks (Fig. 2b) within 65 – 6 m area in front of the longwall. Figure 3 demonstrates summary measurement results in the form of graphs illustrating dynamics of floor and roof shifts in a belt roadway of western longwall 12 (in terms of the Figure 3, measurement at 65 m to the longwall is taken as the defined zero).

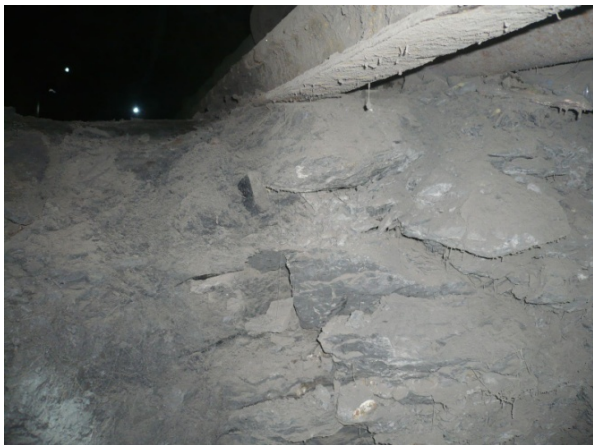
Figure 4. General view of floor rocks shear of a belt roadway of western longwall 12 of seam c_{18}

- during the whole operation period of the mine working, convergence of its floor and roof rock is 1.2 m on average;
- a value of a footwalling is up to 76% of total convergence;
- a velocity of the footwalling in the mine working within 6 – 65 m area in front of longwall was 3 mm/day on average;
- the floor rocks are represented as a discrete medium with small-section structure (Fig. 4).

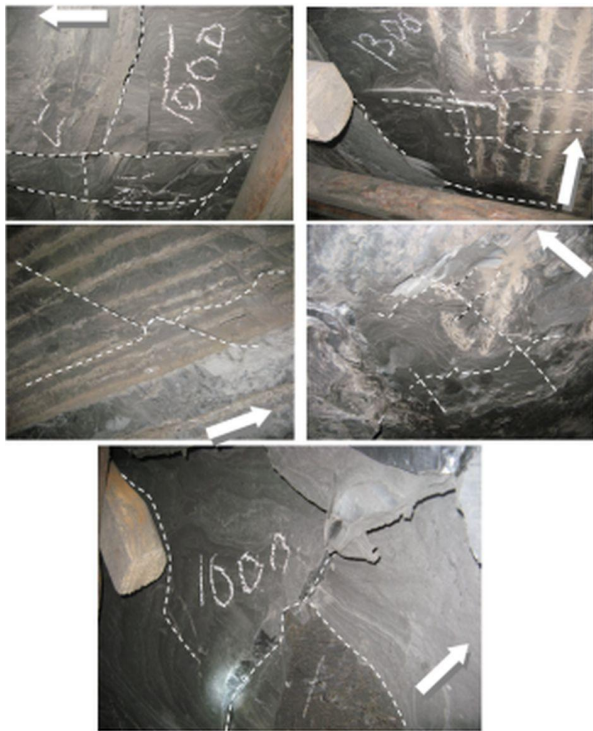
Figure 5. Photos of natural roof outcrops at the distance of 0.8 – 2.0 meters from the seam edge including fracture systems orientation as for the slope length

Boundaries of the caving zone were determined according to artificial roof fracturing resulting from mining processes. The parameters differed in face area width. Tight fractures were registered at the distance of 2 m from the seam edge. One and two fractured zones could be identified within the zone. One of the systems was at the distance of 0.8 m from the edge and fissures, parallel to the face length, prevailed. Sometimes, their angle to the longwall length was 45° . Distance of the two other systems was 0.8 – 2.0 m from the seam edge. Moreover, fissures form different systems cut each other at the angle being close to straight one (Fig. 5). Locally, three fracture systems were observed; however, they were of a random nature and not pronounced. Nevertheless, at the distance of less than 2 m from the seam, within the site of prop stay 3, fracture opening and intensive roof rock deformation were observed. The process was followed by relative shift of rock blocks, and rock inrushes between roof beams.

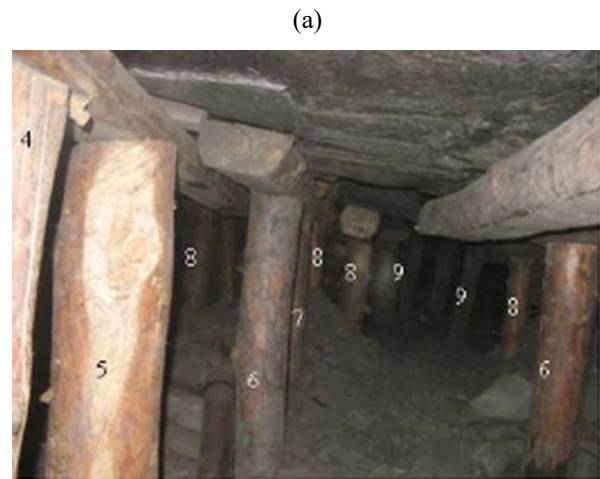
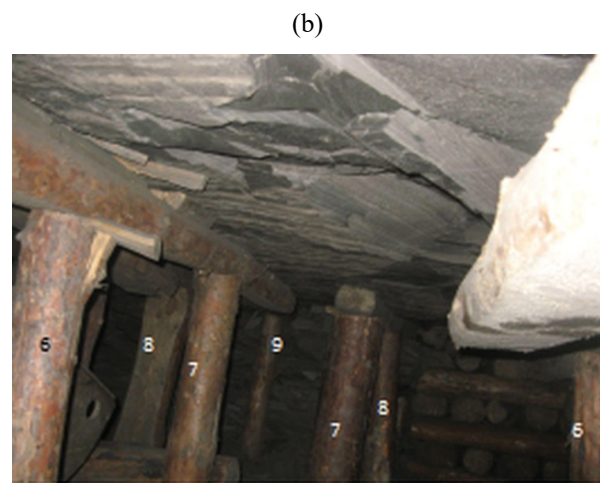
Figure 6. Photos of natural roof outcrops when distance from the seam edge is more than 2 m (photographing direction is from the seam to protective structure; numbers indicate stays across the width of the face area of terminal site)

Visual and instrumental observation of roof rocks condition within the terminal site of western longwall 11 of seam c_{18} (Fig. 6) have helped determine that the most dangerous inrush rock area is between 3rd and 9th prop stays of the face space, i.e. at the distance of more than 2.4 m from the seam edge.

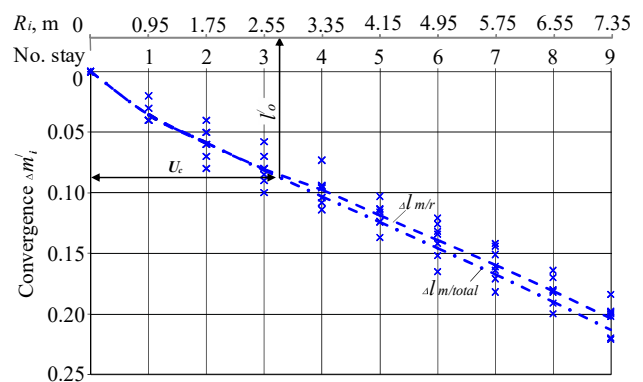
Figure 7. Graphs of total convergence $\Delta m/total$, and roof shifts $\Delta m/r$ across the width of the face space to determine roof rock cavity boundary

Height measurements of the face space on the individual supports stays made it possible to obtain dependences of total convergence of roof rocks and floor rocks, and floor rocks shift separately upon the distance from the seam edge (Fig. 7). Taking into the fact that critical shifts of the roof rocks U_c are 0.09 m (Nehrii, Sakhno, Nehrii, & Kolomiets, 2017), the closest boundary of a zone of their caving is at $l'_o = 2.7$ m distance from the edge (Fig. 7). That rock caving zone coincides with the face space area where the main operations are performed. Thus, it is the place where caving should be prevented. Moreover, it is possible to reduce the likelihood of staff injury if cavity boundary zone is transferred beyond face space area, i.e. to protective means. Then, taking into account the fact that flexibility of protective construction as well as support parameters of terminal site effects its roof rock shift value (Frith, Reed, & McKinnon, 2018), it is possible to transfer cavity area boundary from the seam beyond the face space at the expense of reduced flexibility of protective means and prevention from its forcing into floor rocks.
