## Shear strengthening masonry panels with sheet glass-fiber reinforced polymer

Stratford, T, Pascale, G, Manfroni, O & Bonfiglioli, B 2004, 'Shear strengthening masonry panels with sheet glass-fiber reinforced polymer' *Journal of Composites for Construction*, vol. 8, no. 5, pp. 434-443. DOI: 10.1061/(ASCE)1090-0268(2004)8:5(434)

# Shear strengthening masonry panels with sheet GFRP

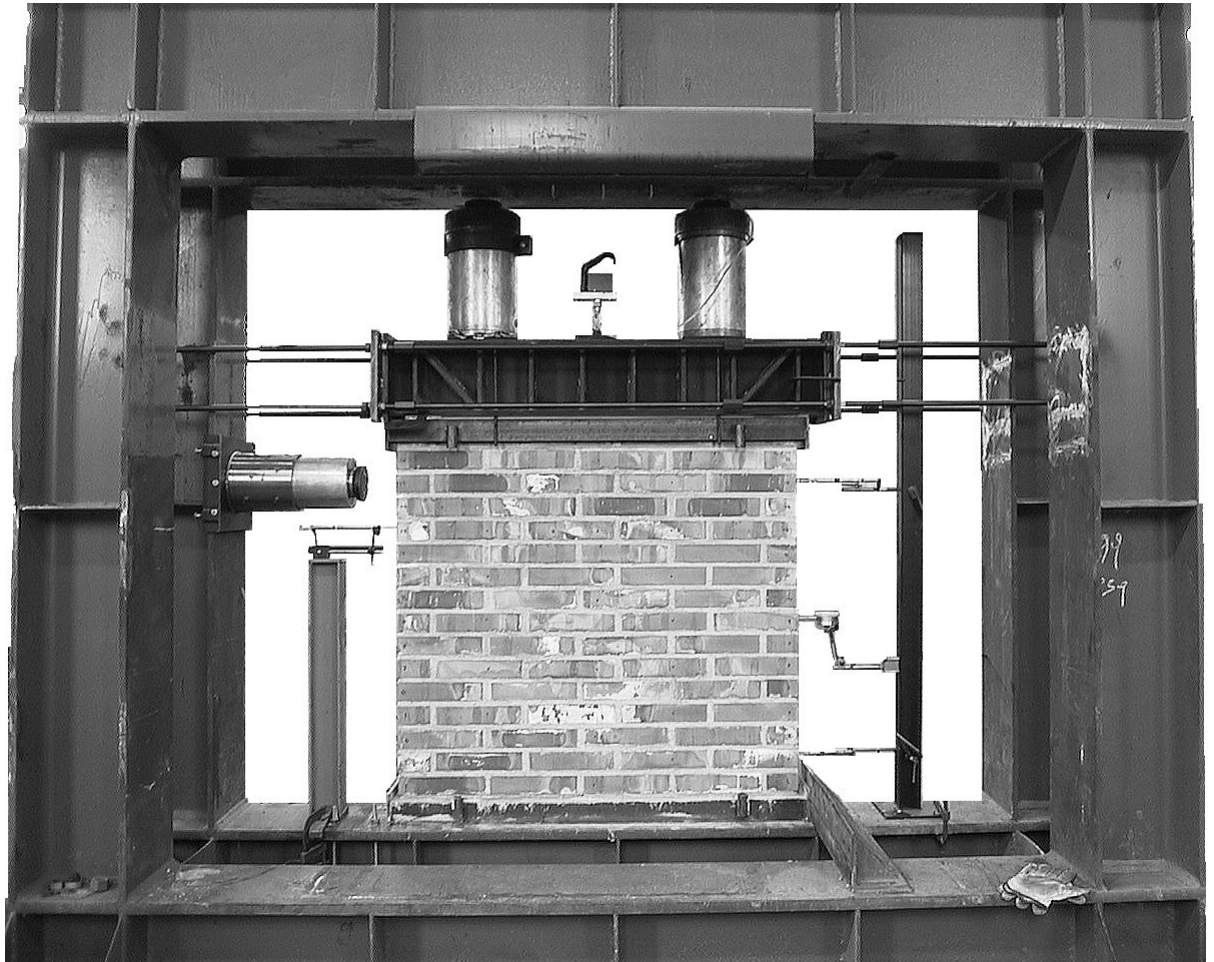
Figure 3 - The testing frame.

Figs. 3 & 4 show the testing arrangement. A combination of vertical compression (representing loads from the building above) and in-plane shear load was applied to each specimen.

The vertical prestress load was applied through two connected hydraulic jacks ( $N$ ). This load was distributed across the top of the specimen by a stiff steel reaction beam, which was restrained horizontally by steel bars. The load was transferred across a flat polytetrafluoroethylene (PTFE) bearing, into a steel cap beam on top of the wall. The bearing allowed the cap beam to slide horizontally relative to the reaction beam.

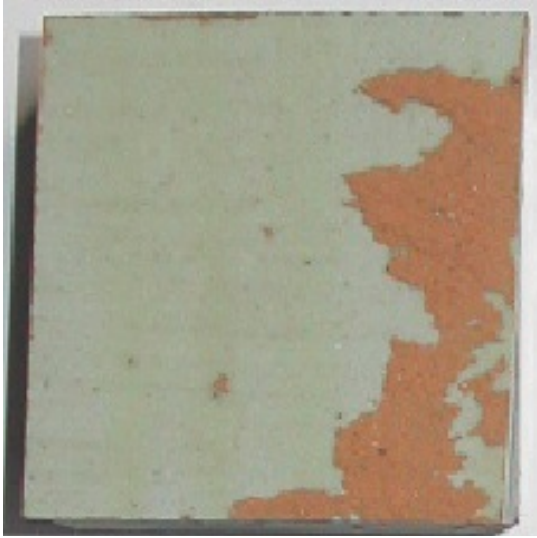
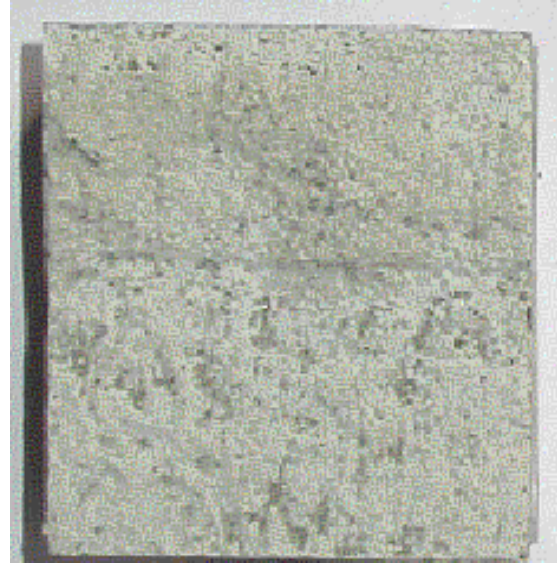
a) Clay

b) Concrete

Figure 5 - Interface failure in the small-scale pull-off specimens.

In addition, pull-off tests were conducted to characterize the interface between the masonry and the GFRP. The de-bonded surfaces of a clay and a concrete pull-off specimen are shown in Figs. 5a and 5b. There was good adhesion between the clay and the GFRP, with de-bonding occurring at the brick-adhesive interface or between the epoxy filler and adhesive layers at an average pull-off strength of 3.87 MPa. In the concrete specimen, failure was in the mortar rendering, with an average pull-off strength of only 0.59 MPa.

The very different characteristics of the concrete-GFRP and clay-GFRP interfaces observed in the pull-off tests (Fig. 5) have already been described, and these different responses are also apparent in Fig. 16. The strengthening is less effective for the concrete masonry, due to the inferior interface. Furthermore, the strengthening is less effective for Concrete 2 than Concrete 3, possibly due to imperfections in the masonry-GFRP interface.

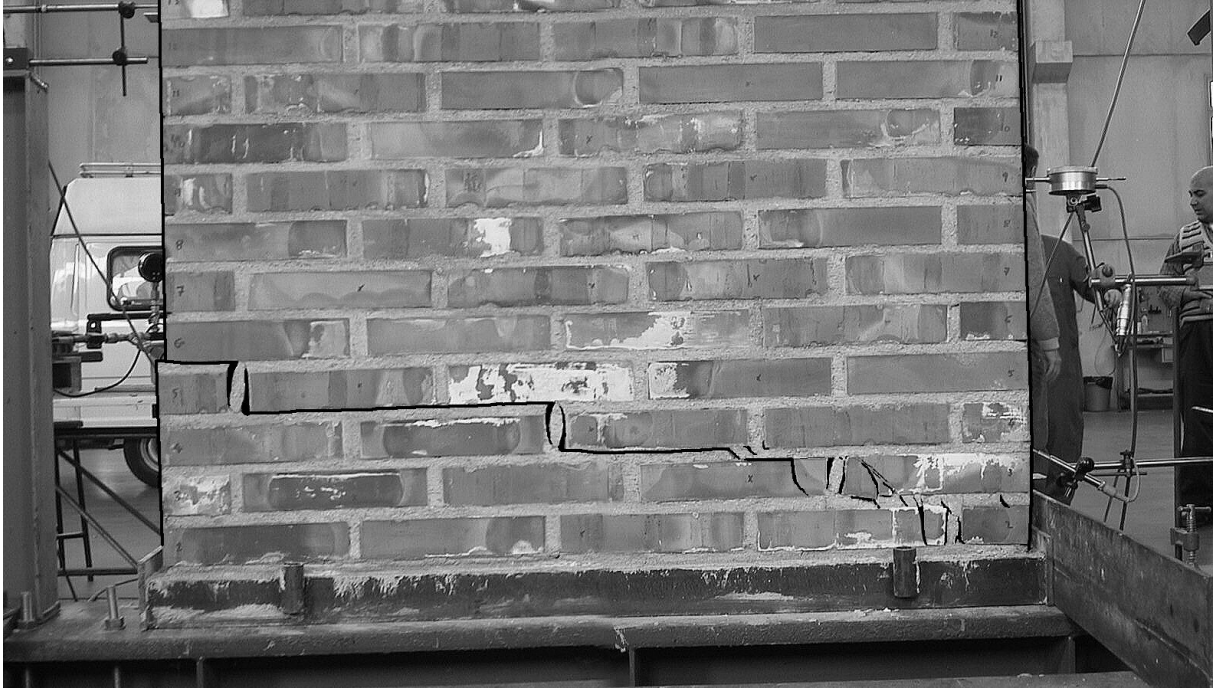
Figure 6 - Crack pattern in the unreinforced clay panel (clay 1).

Figs. 6 to 9 record the crack pattern in the exposed masonry face for one of each type of specimen tested. In all cases, except for the unreinforced clay specimen, the masonry panels failed by rapid propagation of a diagonal crack, which followed the mortar joints. The unreinforced clay wall failed along a near-horizontal crack at the base of the wall, dominated by sliding along the mortar-brick interface. This was due to the use of smooth clay bricks without any type of surface indentation.

Tensile and shear modes of joint failure mostly occurred at the brick-mortar interface rather than in the mortar itself, particularly in the smooth-surfaced clay bricks (this is apparent in Figs. 6 & 8). In a few places (for example, the top-left of Fig. 7), a tensile crack jumped across a brick, between two header joints. Compressive failure was by crushing of the mortar, as the compressive strength of the bricks was much higher than that of the mortar.

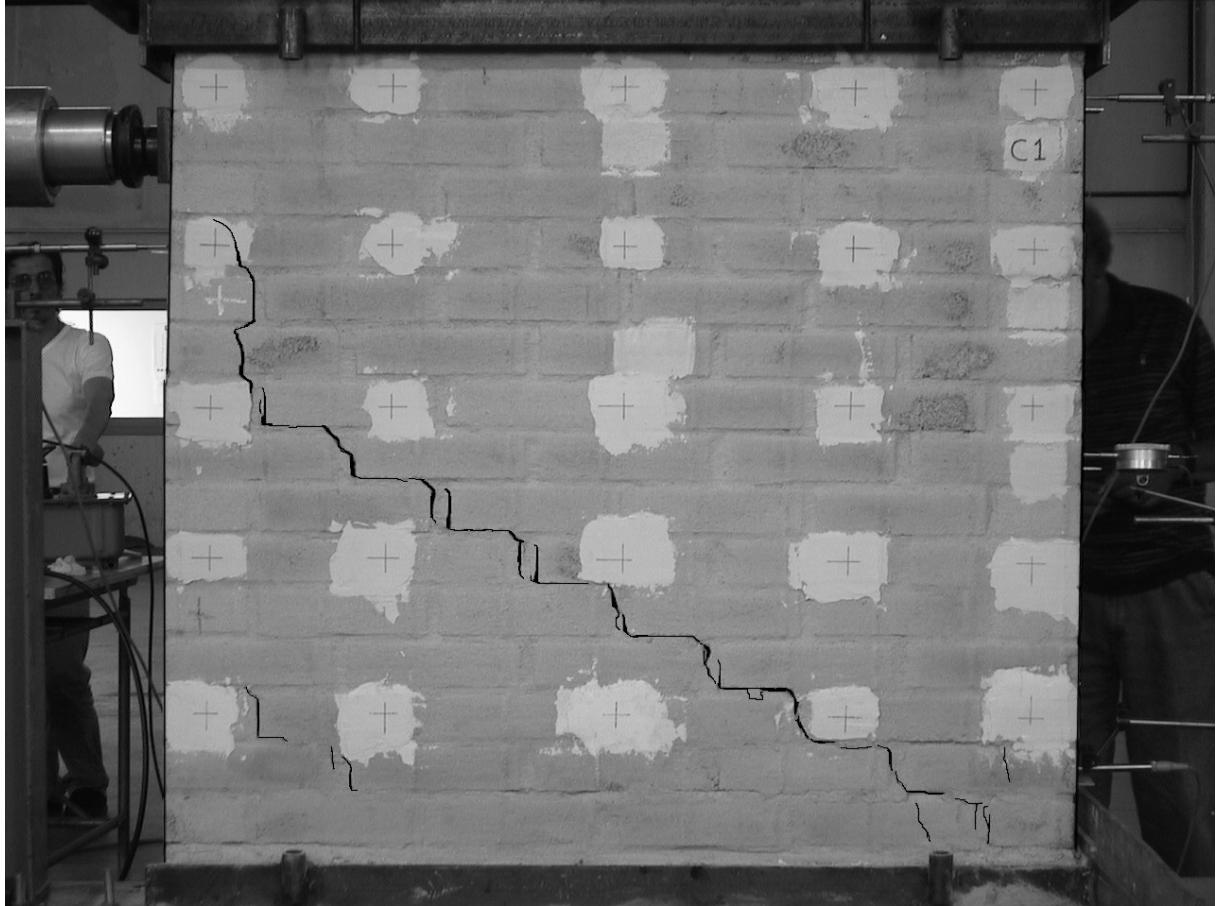
Figure 7 - Crack pattern in the unreinforced concrete panel (concrete 1).

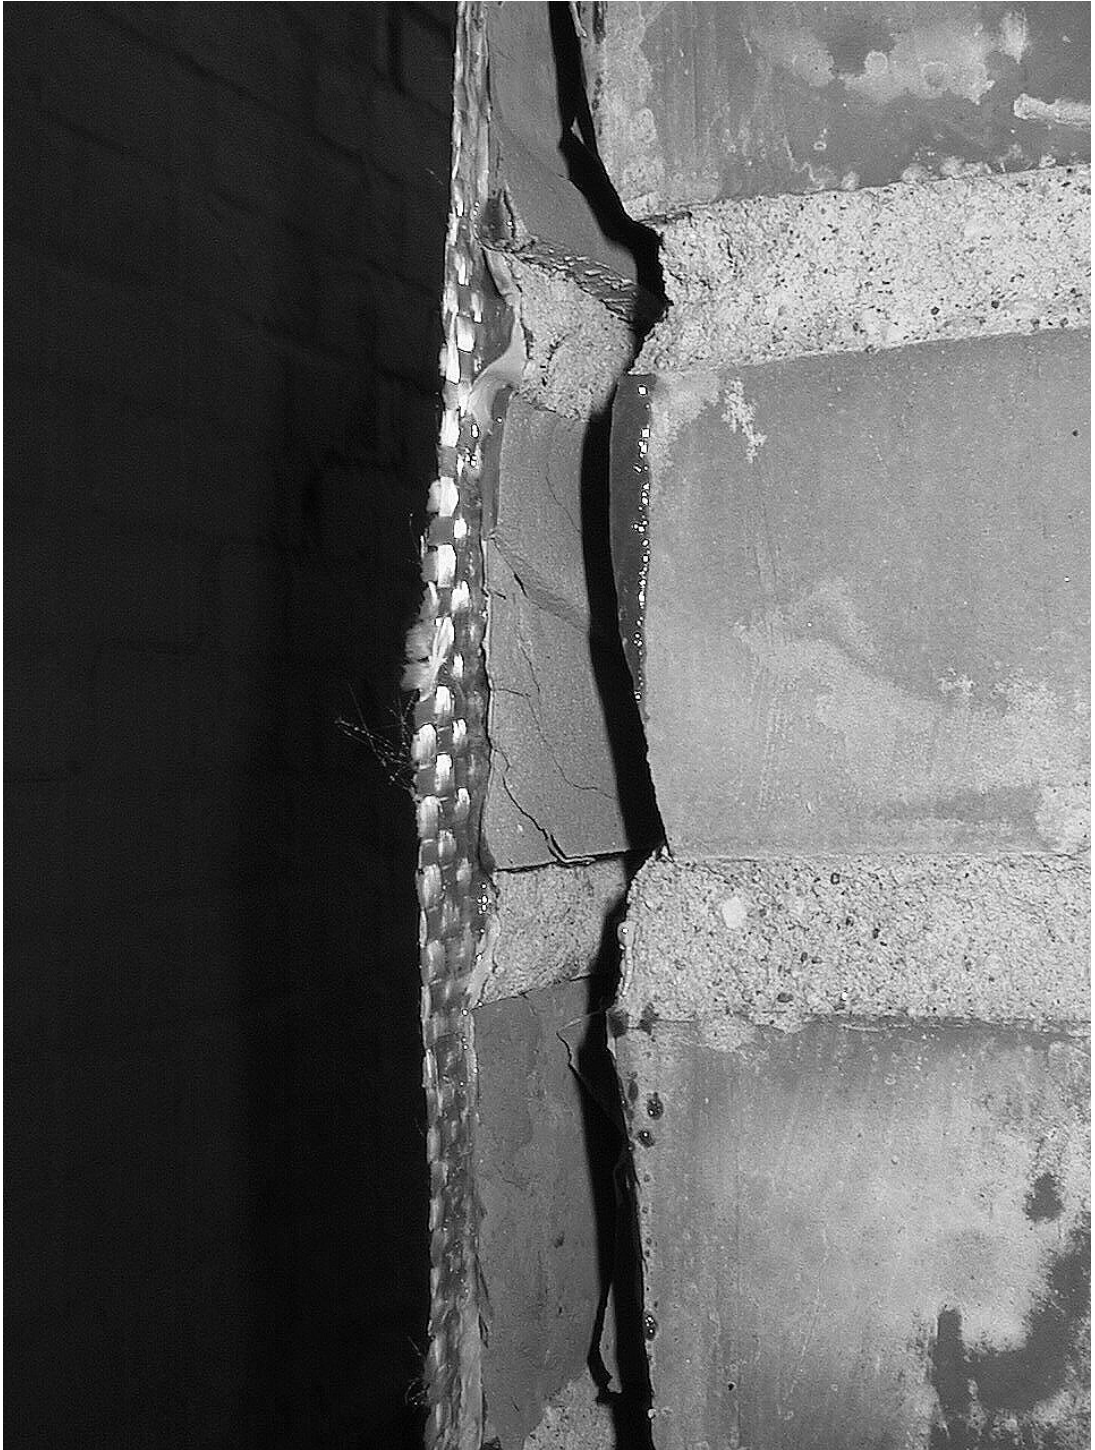
Figure 11 - Failure of the GFRP-masonry interface in a clay panel.

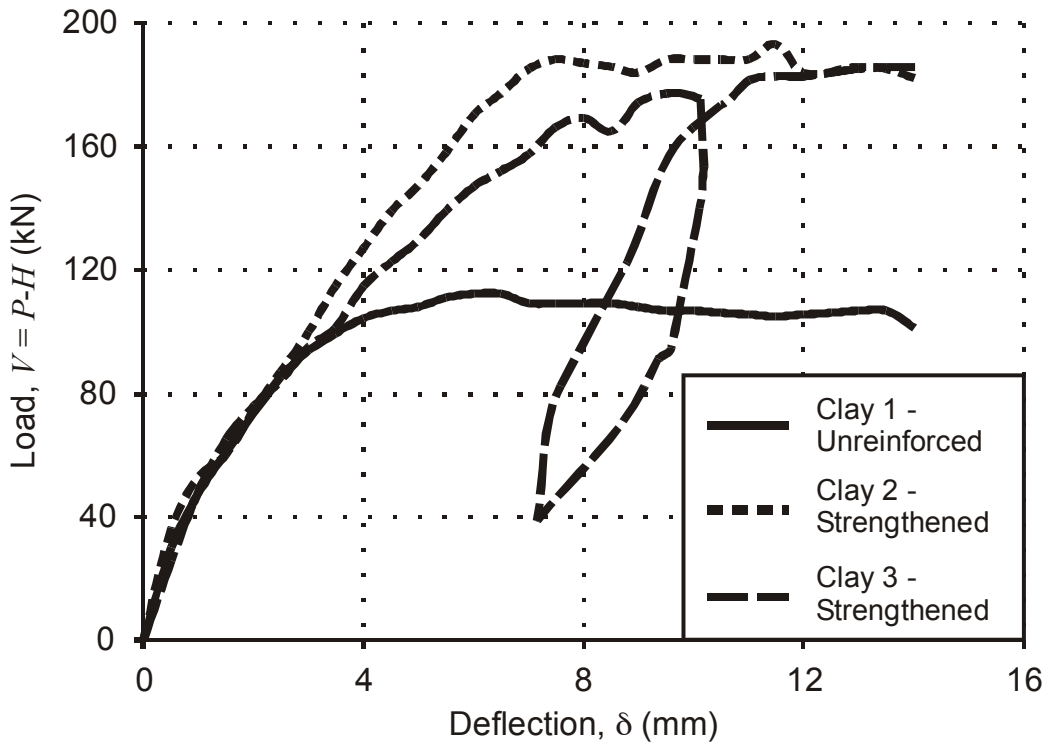
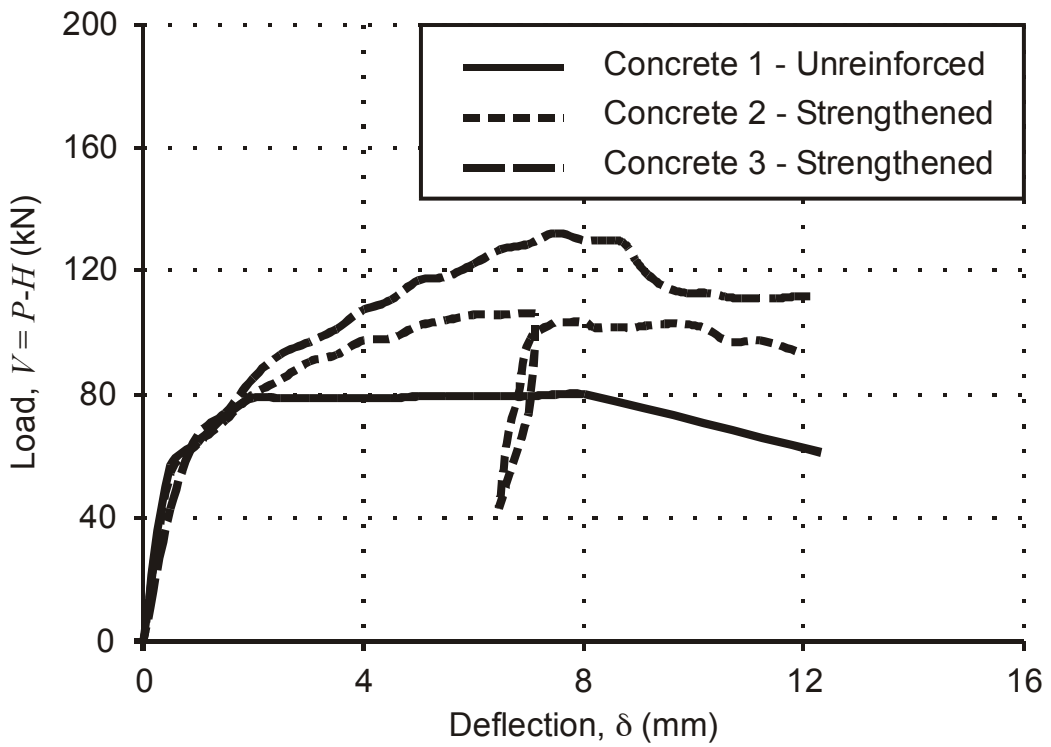
(a) Clay specimens

(b) Concrete specimens

Figure 12 - Load-deflection responses.

The load-deflection plots for the unreinforced masonry panels in Fig. 12 are typical for masonry loaded in shear (Barsotti & Ligarò, 1998). The masonry is initially uncracked and has a linear-elastic response. Progressive cracking follows, giving a second phase with a reduced stiffness. Finally, there is a frictional plateau.

The FRP must not fail before the masonry and so must have a deflection capacity greater than  $\delta_1$ , the deflection-capacity of the unreinforced masonry. (Figure 12 shows that  $\delta_1$  was 14 mm for clay or 12 mm for concrete in the present tests). Assuming the truss mechanism shown in Fig. 20, the strain in the FRP for a deflection of  $\delta_1$  is:

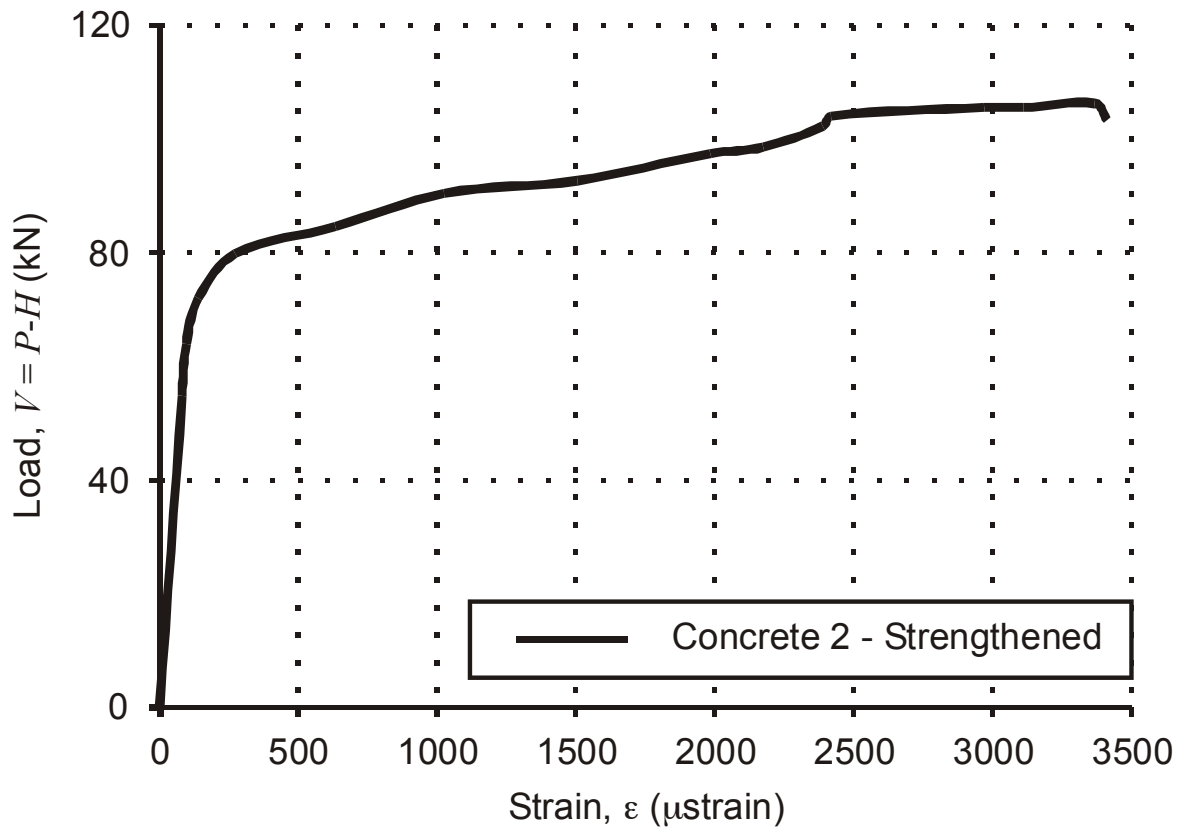
Figure 13 - Load-strain response.

Fig. 13 shows the load-strain response for sample concrete 2. The strain was measured towards the center of the wall, as shown in Fig. 4.

The load at which cracks first formed is most clearly shown by the load-strain plot in Fig. 13. The strain is a measure of local deformation, rather than the global deformation plotted in Fig. 12. These cracks propagate until the specimen is completely separated into two pieces.

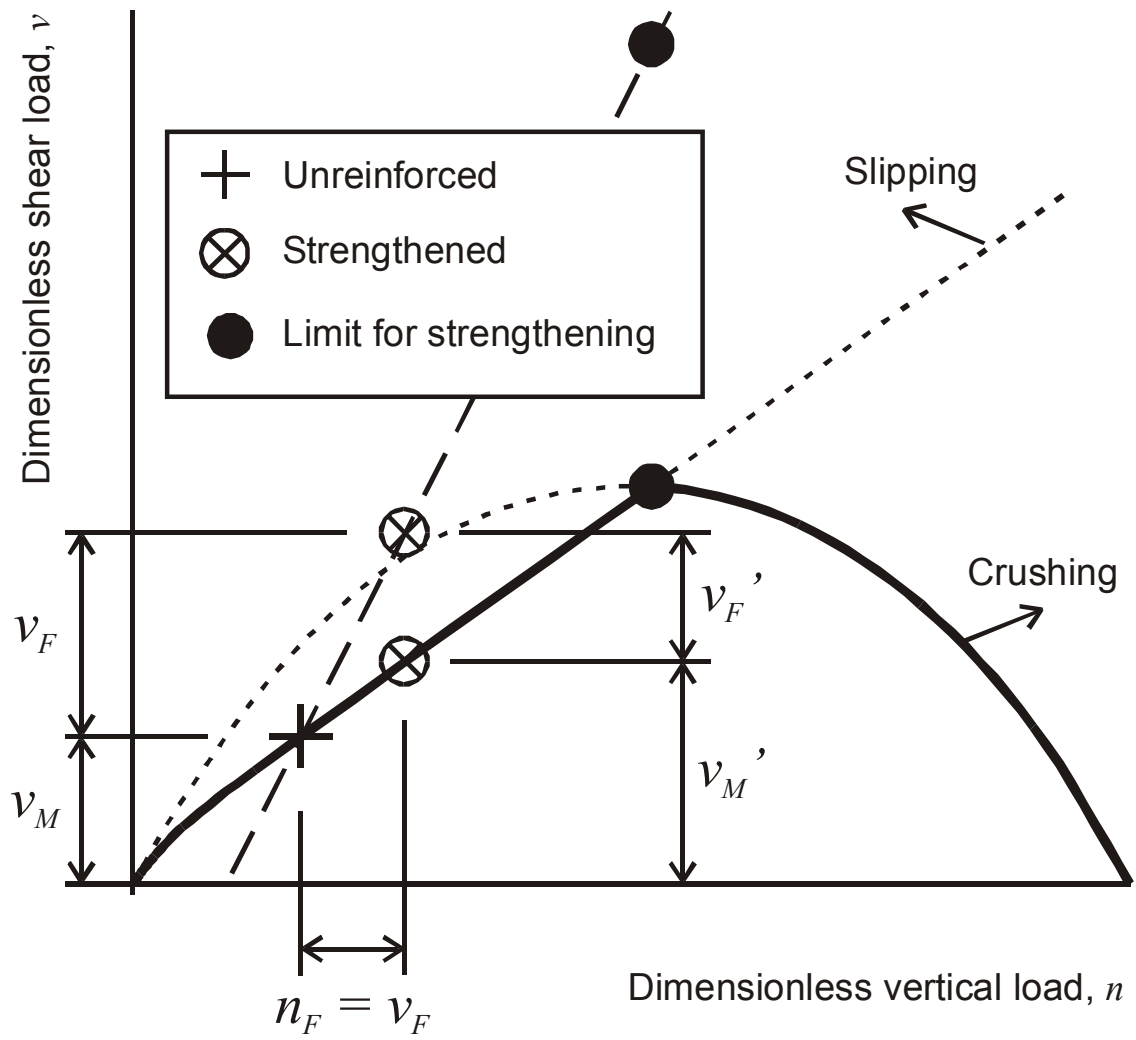
Figure 14 - Interaction diagram for masonry failure.

Interaction diagrams can be plotted showing these two limiting states and thus the domain of horizontal and vertical loads that can be carried by the masonry. Fig. 14 shows a typical interaction diagram, in which the non-dimensional vertical load,  $n = N/(\bar{\sigma} b t_M)$ , is plotted against the horizontal load,  $v = V/(\bar{\sigma} b t_M)$ .  $\bar{\sigma}$  is the compressive strength of the masonry,  $b$  is the breadth of the masonry specimen, and  $t_M$  is its thickness. The vertical load at which the mode of failure changes from slipping to crushing is dependent upon the ratio  $\eta = h/b$ , where  $h$  and  $b$  are the height and breadth of the panel.

If additional GFRP is applied to the masonry the vertical force will increase, until the point is reached on the interaction diagram where failure of the masonry joints changes from slipping to crushing (Fig. 14). Any further increase in the amount of GFRP will not be efficient, and thus there is an upper limit to the useful amount of GFRP that can be applied to masonry.

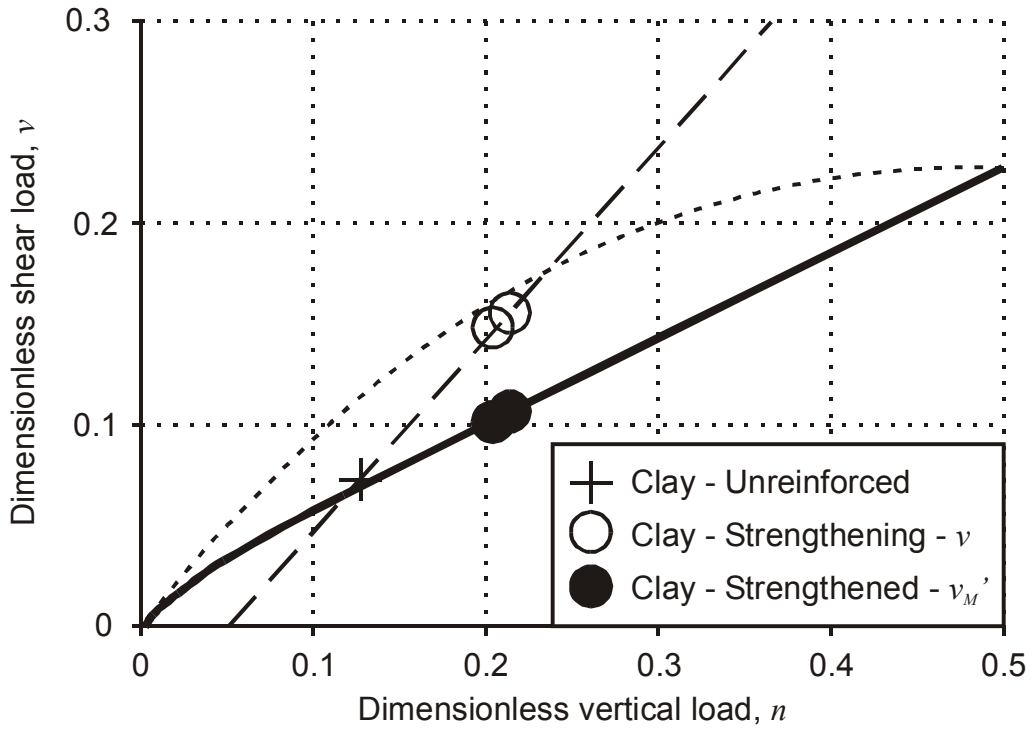
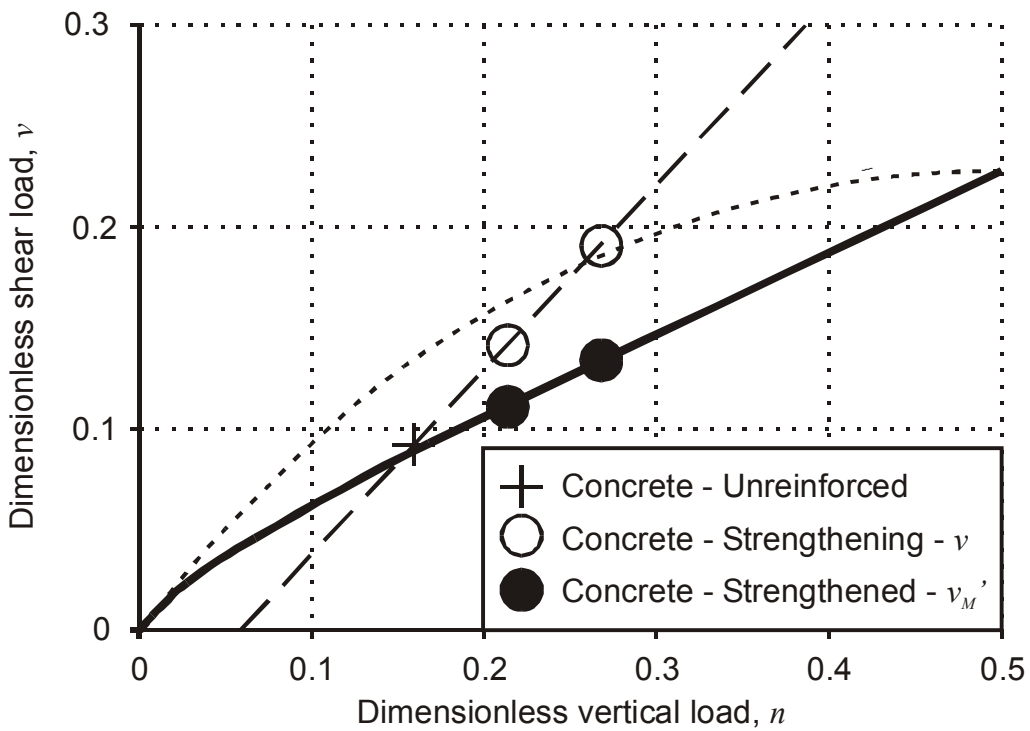
(a) Clay specimens

(b) Concrete specimens

Figure 15 - Interaction diagrams for failure of the clay and concrete specimens.

The work of Barsotti & Ligarò (1998) was used to construct the interaction diagrams for the clay and concrete walls tested in the present work (Fig. 15). The points representing failure of the unreinforced masonry specimens lie on the shear (slipping) failure limit, as observed during the tests.

The additional shear load carried by the masonry can be found using the interaction diagrams for failure of the masonry, as in Fig. 15.

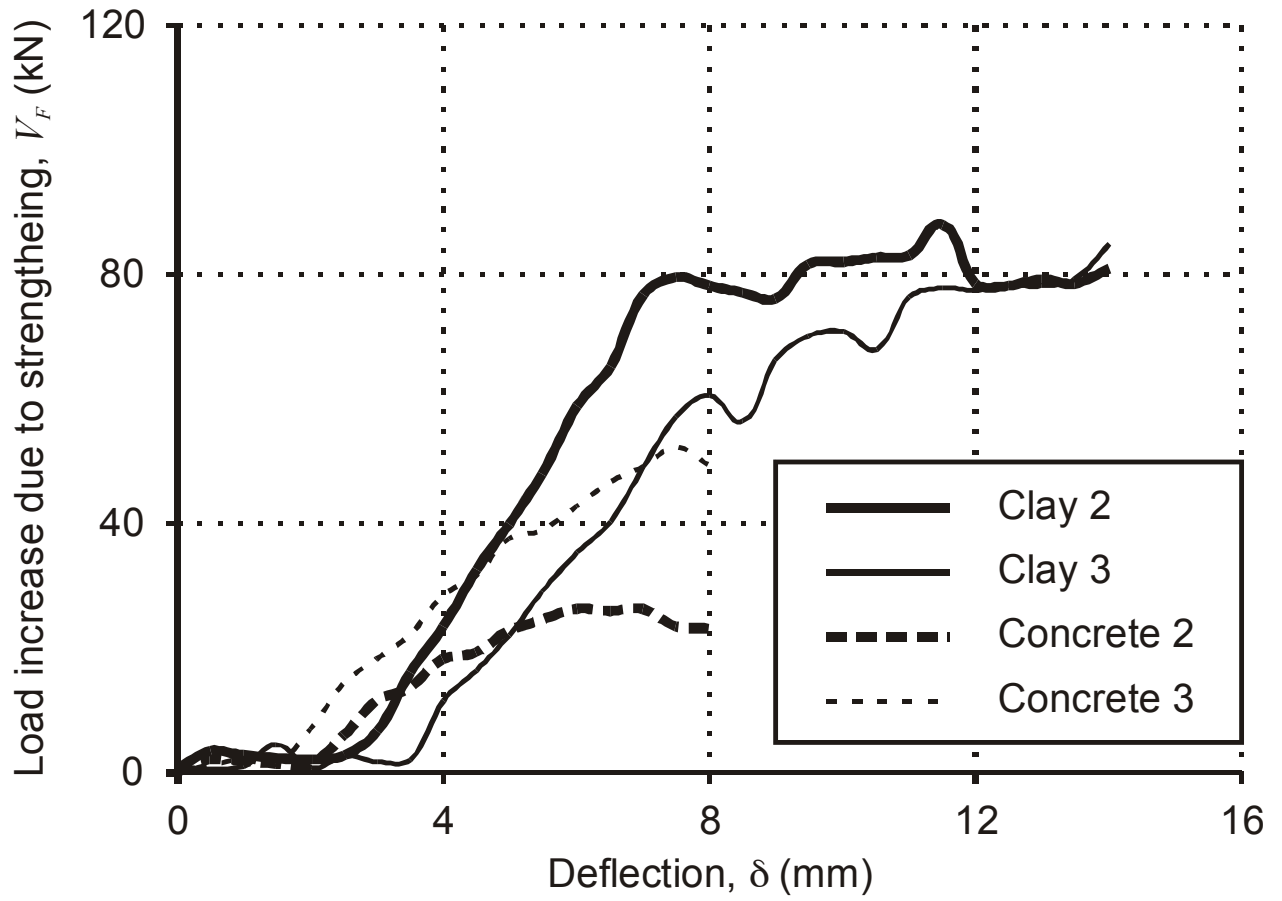
Figure 16 - Increase in load with deflection due to strengthening.

Fig. 16 plots the increase in load due to the GFRP (the difference between the strengthened and unreinforced load-deflection curves in Fig. 12). The mechanism by which the strengthened walls carry load changes with increasing deflection, giving three distinct parts, which are most apparent for the clay specimens. At small deflections, the GFRP is *fully-bonded* to the uncracked masonry and does not significantly increase the load carried by the wall. In the second mechanism, cracks form in the masonry and the GFRP debonds locally, accompanied by an approximately linear increase in load. Finally, a horizontal plateau indicates that the masonry is completely separated by a crack. These three mechanisms are illustrated in Fig. 17.

The spread of cracks across the masonry is accompanied by local de-bonding of the GFRP from the masonry, so that a band of de-bonded GFRP forms along a band roughly parallel to the cracks. The GFRP restrains the growth of cracks in the masonry, and thus the load carried by the strengthened specimens continues to increase with deflection (Fig. 16).

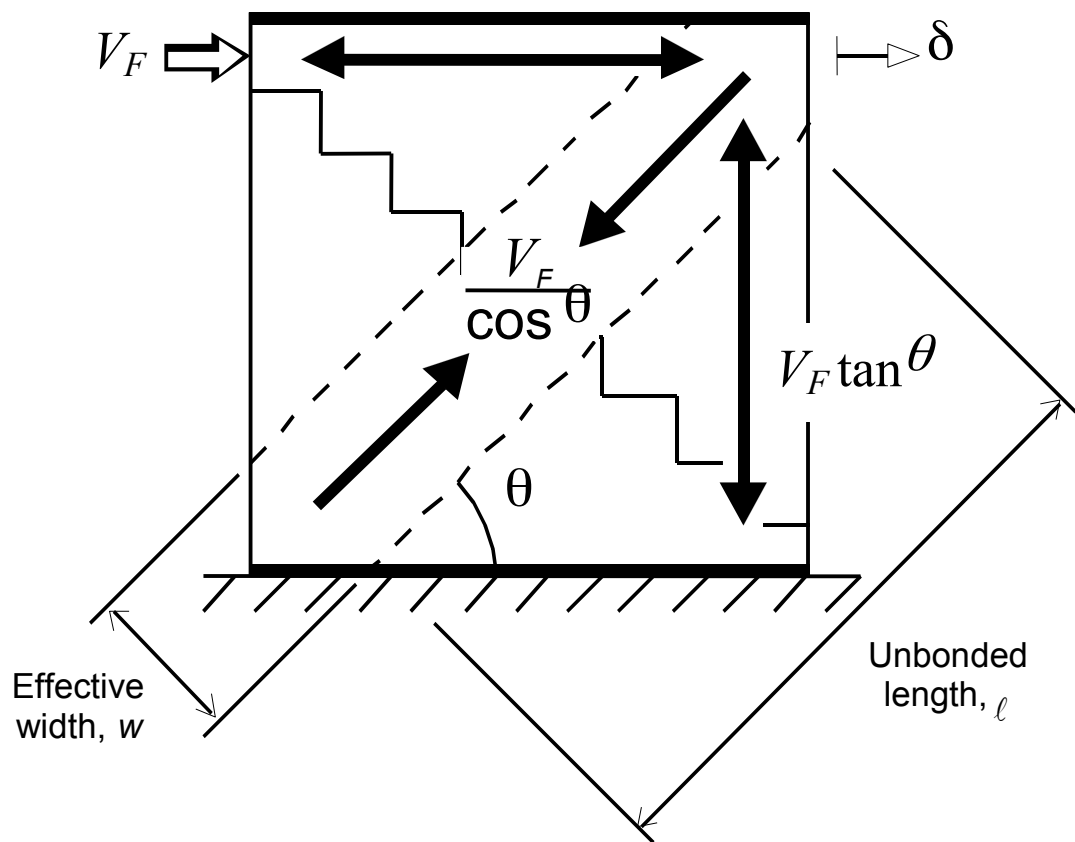
Figure 20 - Truss mechanism for carrying load through the de-bonded strengthening.

$V_{F1}'$  is the load carried through the FRP at failure of masonry. The FRP also increases the load carried through the masonry ( $V_M'$ ), due to confinement by the vertical compression shown in Fig. 20. This additional vertical compression is:
