AN IMPERIAL FRONTIER OF THE SASANIAN EMPIRE: FURTHER FIELDWORK AT THE GREAT WALL OF GORGAN

Source: *Iran*, Vol. 45 (2007), pp. 95-136

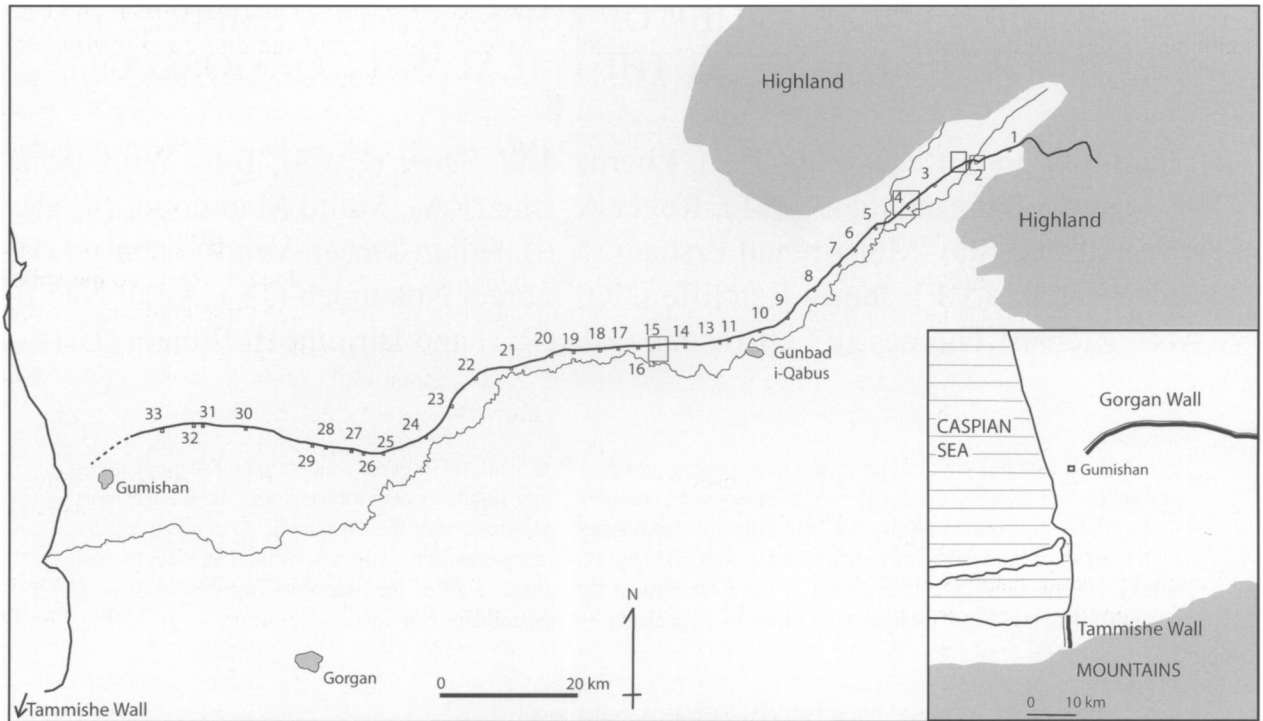
Fig. 1. The Gorgan Wall. Suggested sectors of the wall are as follows: east, from Fort 1–2; east central, from Fort 2–4; main, from Fort 5 west. The Digje canal is between Forts 16 and 17, and a possible canal is located by Fort 4.

more were noted, to make a total of five cross (or feeder) canals which apparently conducted water from the Gorgan River to the ditch on the north side of the Gorgan Wall (Fig. 1). The western-most feeder canal was recorded during the 2006 field season (having been

previously discovered by Hamid Omrani and his team). This feature, referred to as the Digje canal, was confirmed and mapped between Forts 16 and 17. This c. 12 m. wide canal forms a well-defined channel that led water from what is now a relict arm of the Gorgan

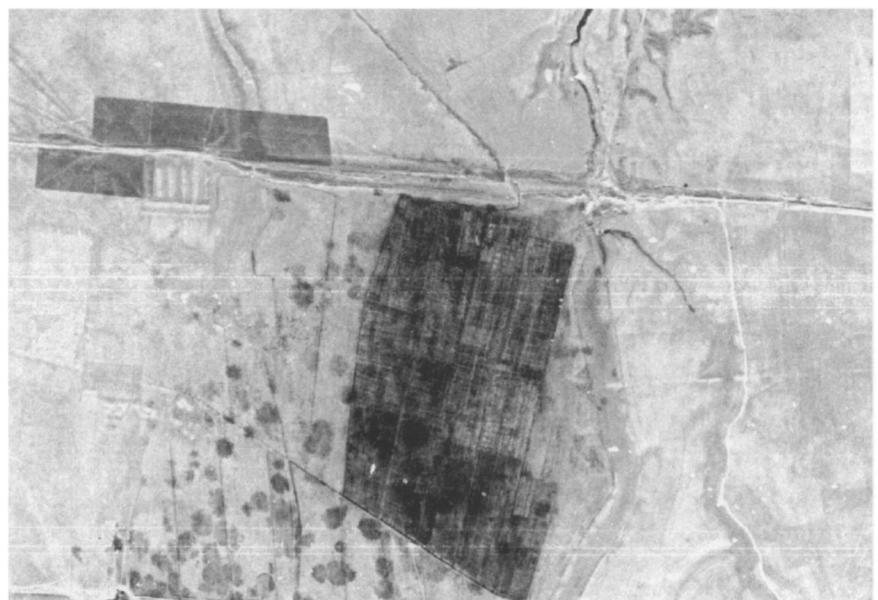
Fig. 2. Area of embanking along the wall (the alignment parallel to the top border) with Fort 15, the rectangular enclosure near the left margin, abutting the wall. Four parallel stripes are visible in the interior, at right angles to the wall. CORONA image by courtesy of US Geological Survey, with permission.

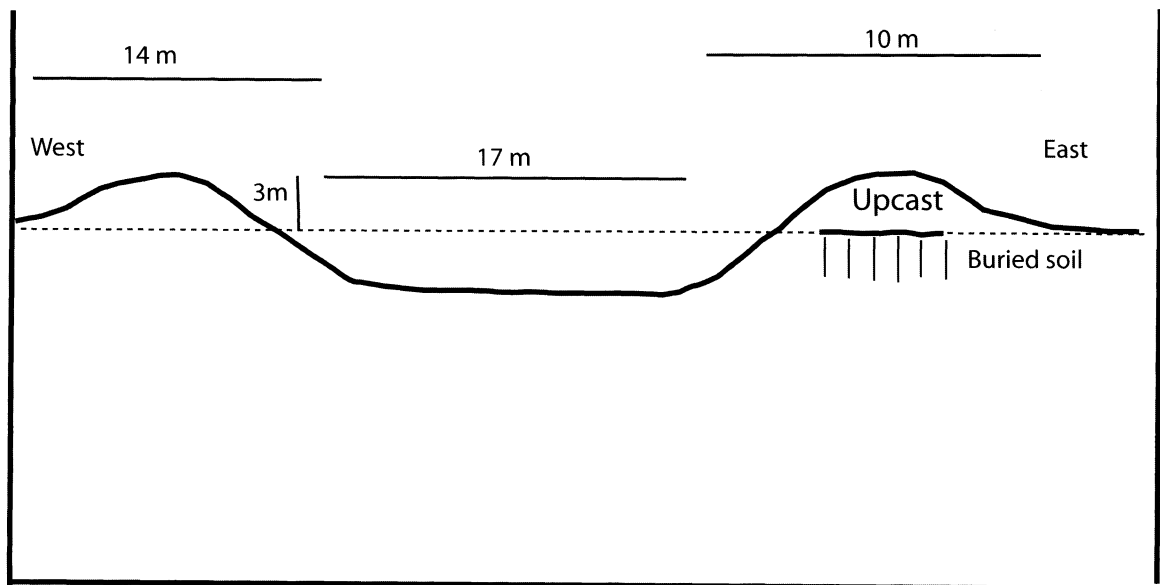
Fig. 3. Sketch section across Aghabad canal showing buried soil and upcast bank deposits.

Of the three well-defined feeder canals recorded in 2005, the central Aghabad canal (between Forts 8 and 9), was sampled by Morteza Fattahi for OSL dating.¹ This section, which was cut back and cleaned through the eastern bank of the canal (Figs 3–4), clearly demonstrated that during the original excavation of the canal considerable quantities of pale brown silt loam had been cast up over the original land surface. This buried soil, a slightly reddish brown loam with well developed calcium

carbonate concretions, represents the ancient soil that developed on the loess plain over many millennia. The presence of a clear bank of upcast silt over a pre-existing soil surface demonstrates that the feature was indeed a canal, although it is not clear whether the silts were from the original excavation of the canal, from subsequent cleanings or a combination of the two.

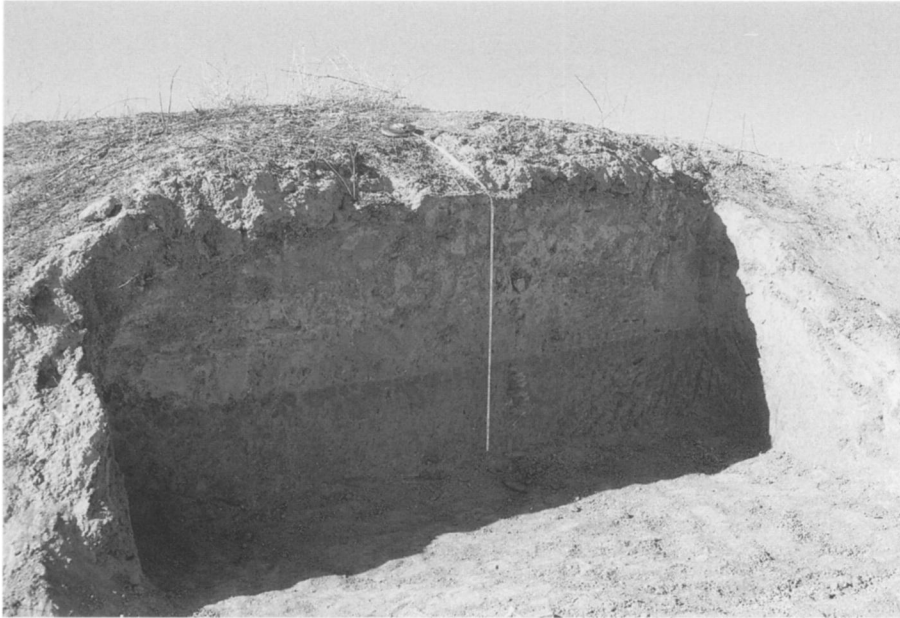
Fig. 4. Aghabad canal: the bank deposits overlying buried soil.

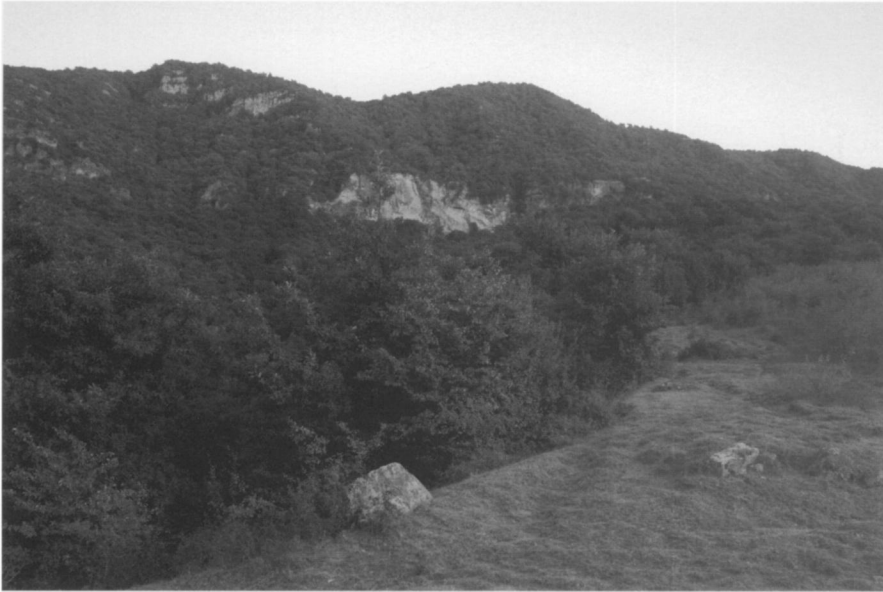
Fig. 5. The Great Wall of Gorgan, marked by a scatter of fragments of the typical bricks, follows the grass-covered ridge in the foreground, overlooking a deep valley to the left, and extends to the vicinity of the vertical rock face in the Elburz Mountains in the background (or possibly beyond).

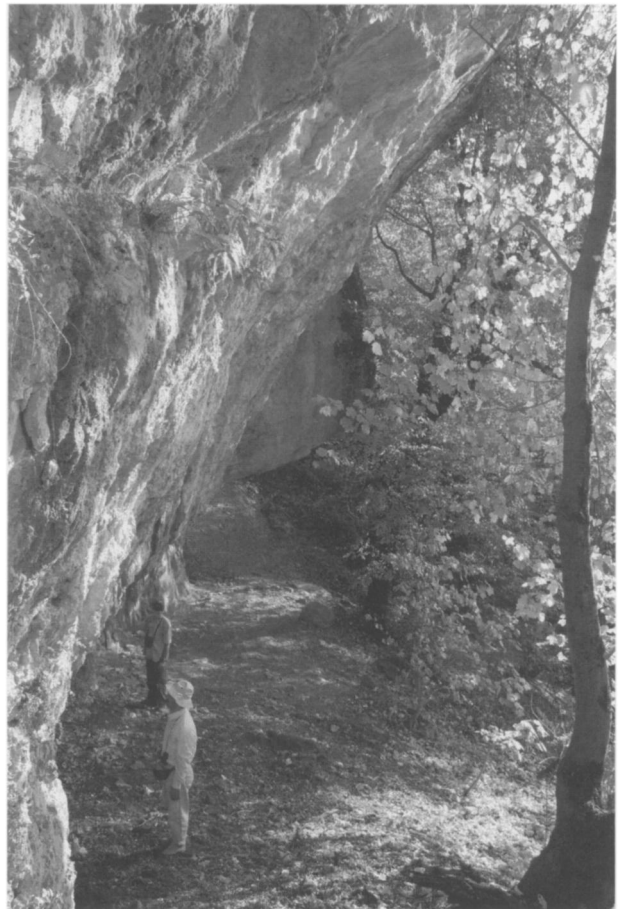
Fig. 6. The overhanging rock, marking a possible terminal of the wall (see Fig. 22), would have formed a substantial obstacle.

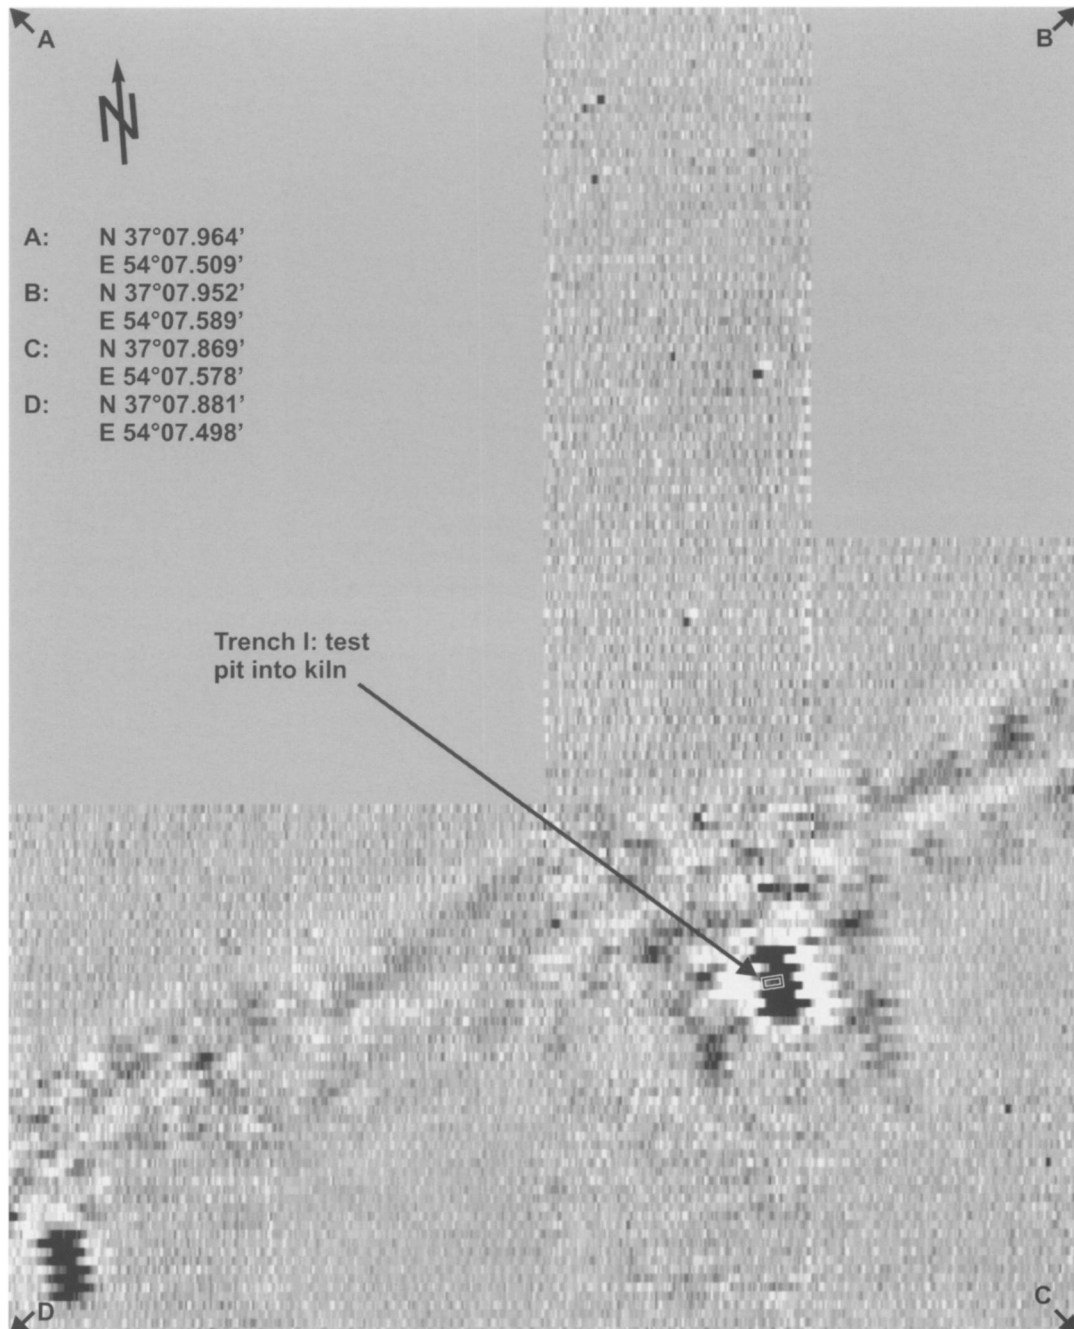
Fig. 7. Magnetometer survey of the Gorgan Wall and two associated kilns, c. 4.8 km. west of Fort 33, with the location of Trench I, by JR, SG and HO. The linear anomaly is likely to represent the Gorgan Wall robber trench and associated ditch, the two rectangular anomalies south of it are two kilns.

The westernmost known section of the Gorgan Wall is marked for some distance by a distinct robber trench, stretching up to 4.5 km. west of Fort 33. In order to test whether or not the wall continued and was detectable, we carried out a magnetometer survey (Fig. 7) in direct

continuation of the robber trench some 300 m. west of its visible terminal. The survey revealed a distinct linear anomaly, c. 18 m. wide, likely to have been caused by a combination of scattered brick fragments from the robbed-out wall, any remaining foundations of the wall and, probably, an associated ditch. Behind it, as in the

case of the survey of Fort 30 on the protected south side of the wall, we found two positive anomalies, whose rectangular shape, size and strength suggested two further brick kilns, c. 86 m. apart. The postulated continuation of the ditch could have provided the water necessary for brick making.

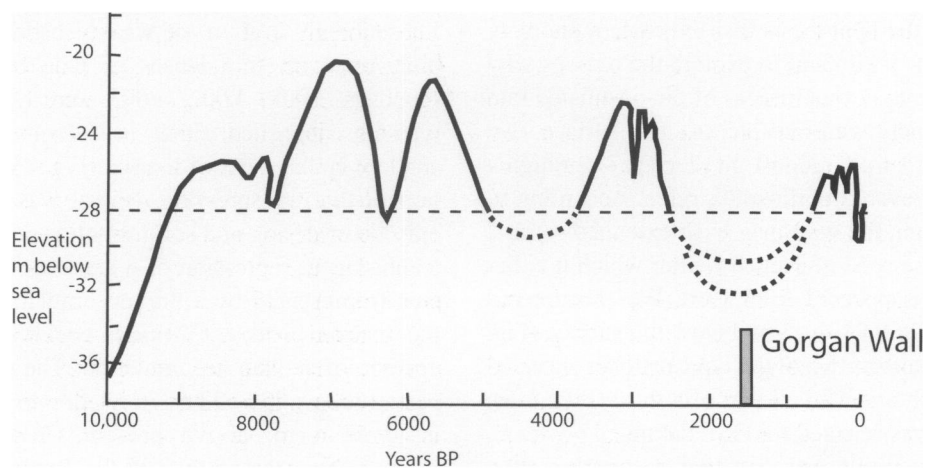
Fig. 10. Caspian Sea level curve with main phase of Gorgan Wall indicated (rectangle), based on Rythagov 1997: fig. 5.

correspond to this inundation were a series of transgressions that reached *c.* -22 m. between *c.* 500 years ago and the present day (Fig. 10). The shells from context I.004 have now yielded a radiocarbon date of A.D. 1344–1460 at 95.4% confidence level² for the initial transgression. Although this high sea stand corresponds chronologically to that of Rythagov, the elevation of the equivalent event along the Gorgan wall, at -22 m., is some 3 m. higher than Rythagov's estimate. Further dates and field studies are therefore required from the Gorgan Wall Project in order to sort out some of these contradictions.

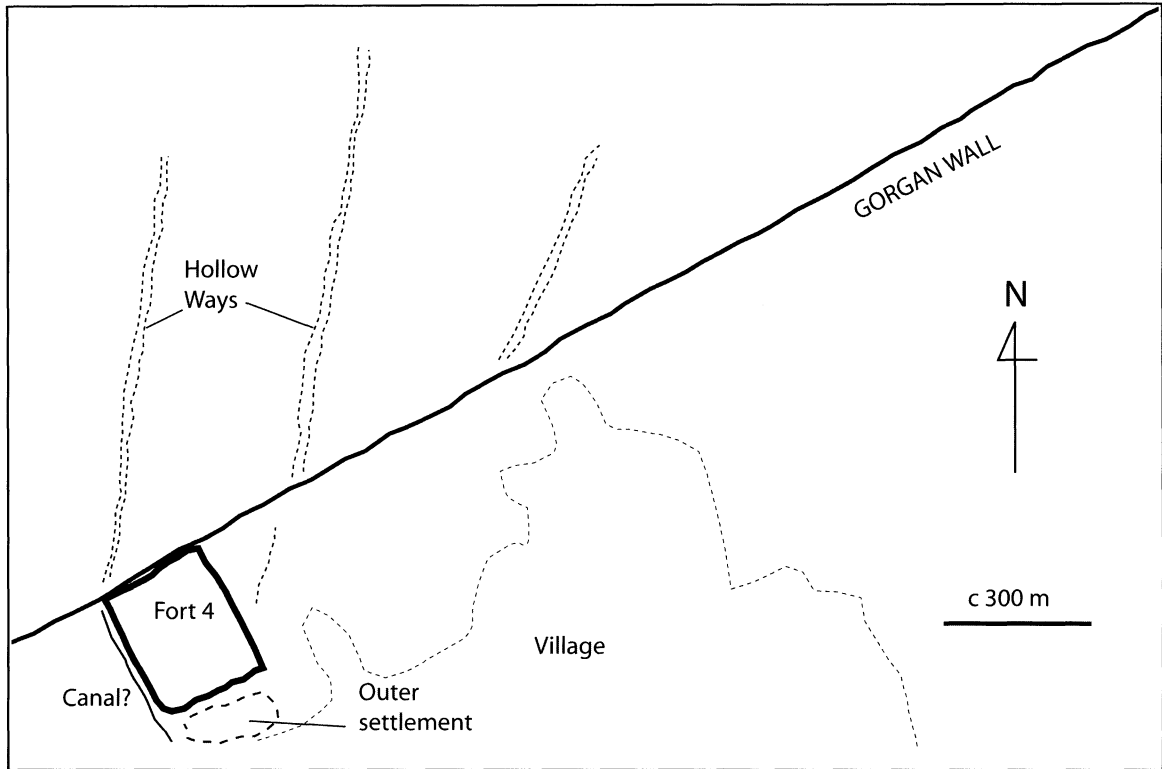
Fig. 11. Sketch map of Fort 4 and hollow ways.

As noted above, Fort 4 may have been associated with a cross canal that led water from the Gorgan River. Moreover, a high resolution Digital Globe image indicates that at the north-west corner of the fort a distinct “hollow way” can be traced leading northwards across the now cultivated steppe (Fig. 11). In addition, slightly less distinct

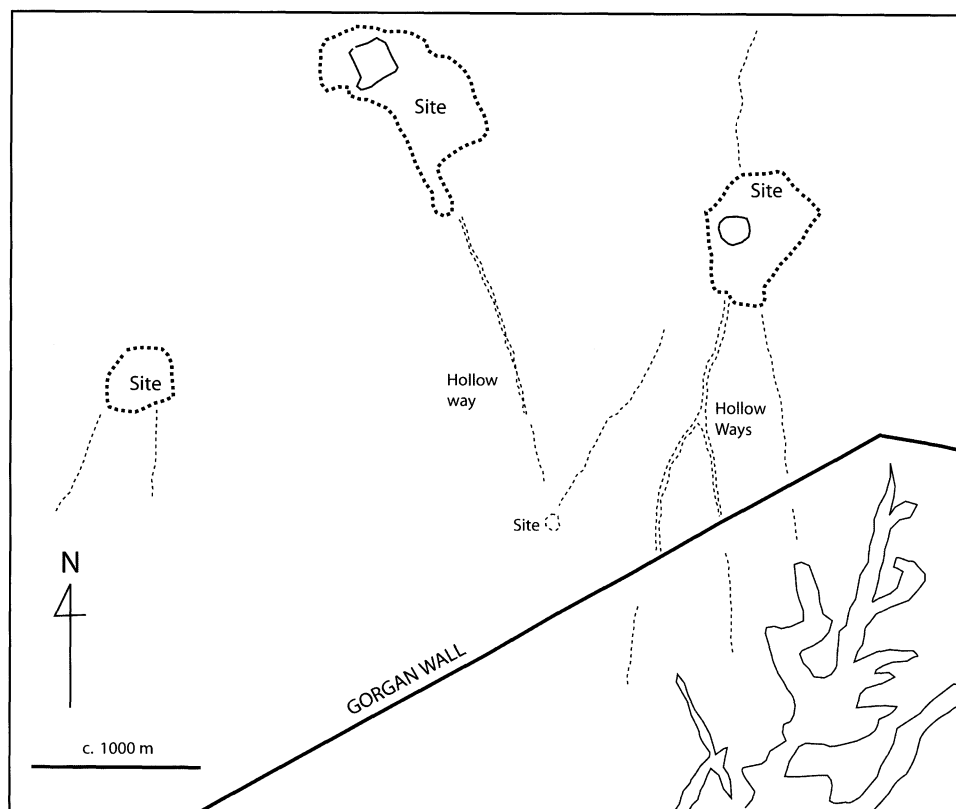
Fig. 12. Bend on wall between Forts 2 and 4 and sites with associated hollow ways.

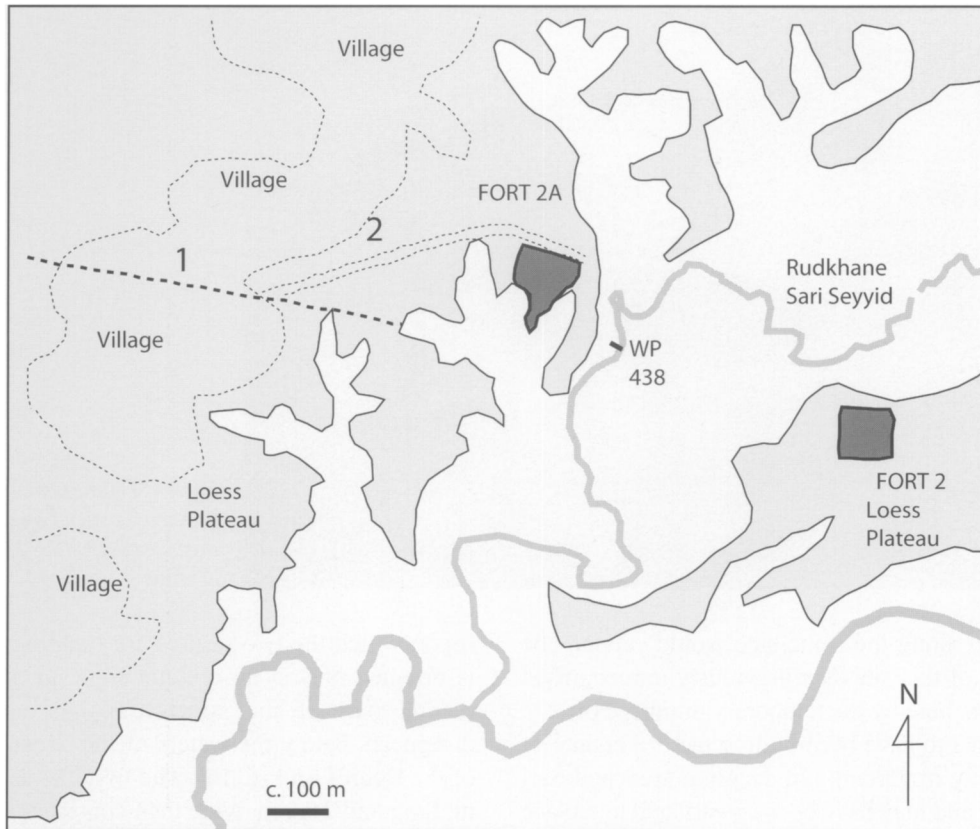
Fig. 13. Sketch map of Fort 2 area and associated sites.

In the floor of the valley of the Sari Seyyid River, an apparent part of the Gorgan Wall complex has been noted (by Hamid Omrani). This substantial feature of fired brick (Figs 13, “WP 438” and 14) is located in the bed of the flowing river. It consists of two lengths of wall or platform made of Gorgan Wall fired bricks. The first oriented at 233 degrees magnetic is at right angles to the main channel of the river, whereas the second

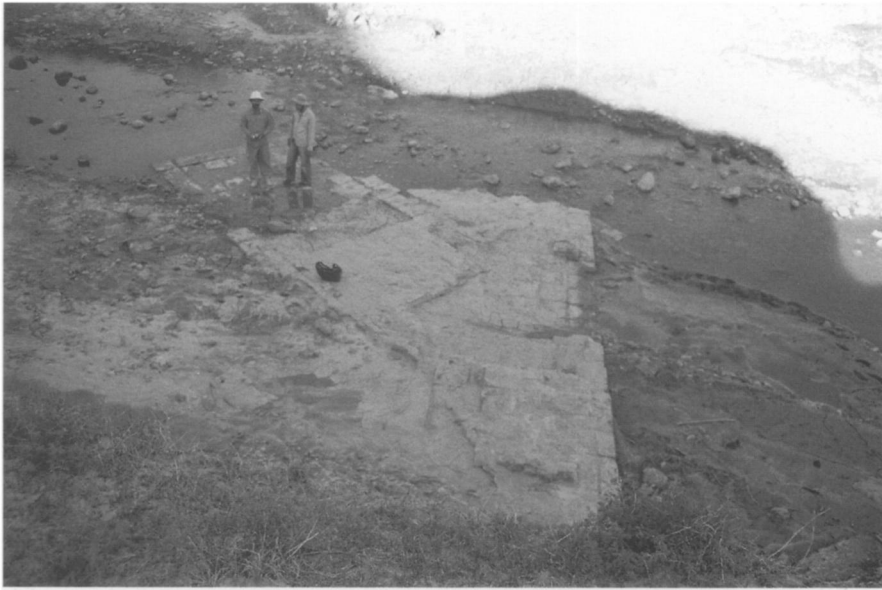
Fig. 14. Feature of Gorgan Wall bricks at east end of wall between Fort 2 and 2A. (See Fig. 13 for its location.)

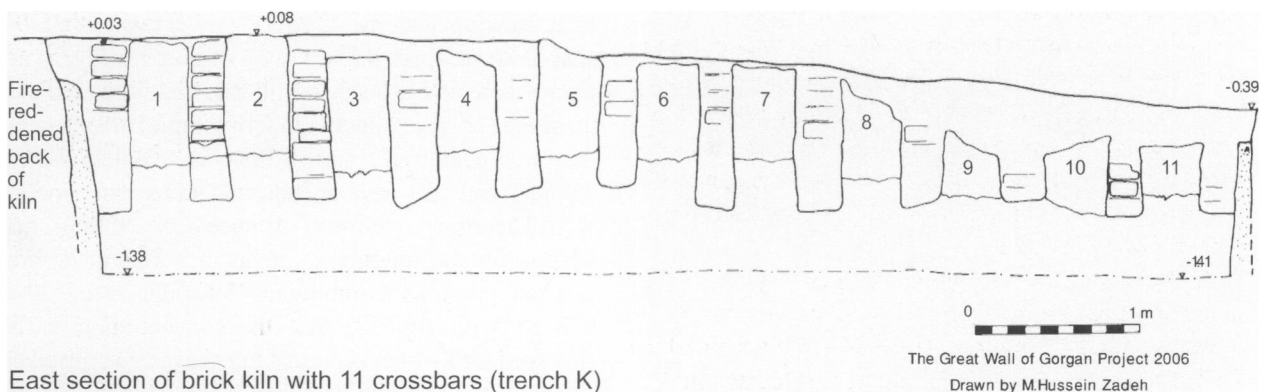
Fig. 15. Trench K: west-facing section of kiln cut by a recent drainage ditch, drawn by Maryam Hussein-Zadeh.

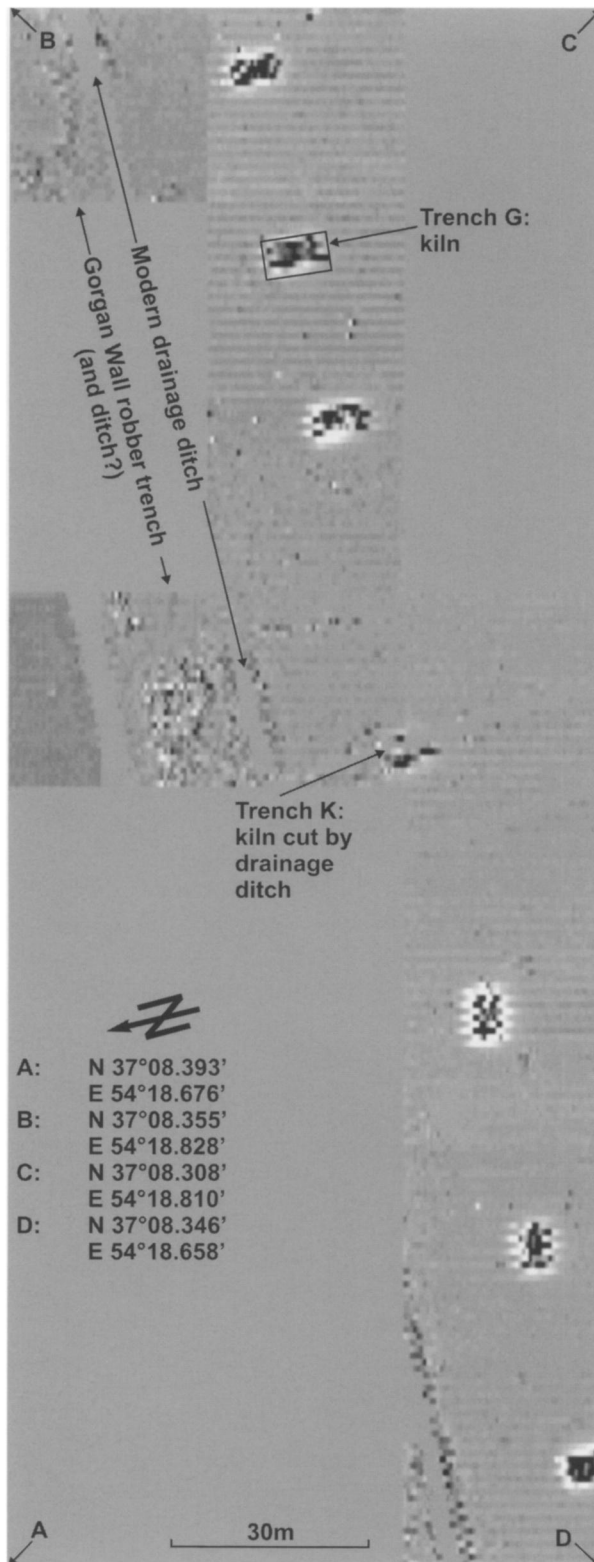
Fig. 16. Magnetometer survey of the Gorgan Wall and seven associated kilns, c. 1.3 km. west of Fort 30, with the location of Trenches G and K, by JR, SG and HO.

The survey identified a remarkable concentration of kilns south of the wall: three to the west and three to the east of the kiln cut by the drainage ditch, i.e. no less than seven within just 220 m. (centre to centre). Their distance to each other (on average 37 m.) and their orientation (some parallel or near parallel and some at a right angle to the wall) varied. However, as far as a survey allows us to tell, the centre points of all seem to be on the same alignment and all appear to be of similar dimensions. We cannot assume that a similar concentration of kilns existed at all sections of the wall. While suitable material was available at all sections, water may have been more of a problem, even though most sections seem to have been supplied by canals (Nokandeh *et al.* 2006). In the central section east of Gonbad, kilns have been identified in the Gorgan river valley, which may have produced bricks for the wall as well. Nevertheless, the discovery of yet two more kilns, spaced 86 m. apart, 4.8 km. west of Fort 33 (Fig. 7) at a point where no brick slag or mounds had suggested their presence (i.e. a genuinely random sample), may suggest that a comparatively narrow spacing of kilns was not atypical and that several thousand kilns may line the wall. The same, in terms of distance between kilns, may be true for the roughly contemporary Tammishe Wall and our previous assumption (Nokandeh *et al.* 2006: 153–55 with fig. 32) that the concentration in the surveyed area was exceptional may have been mistaken. The high number of kilns is somewhat surprising, as one would have thought that building fewer kilns and reusing them more often would have been more economic, even if it would have resulted in a slight increase in the average distance between production and construction site. It seems hard to explain why those

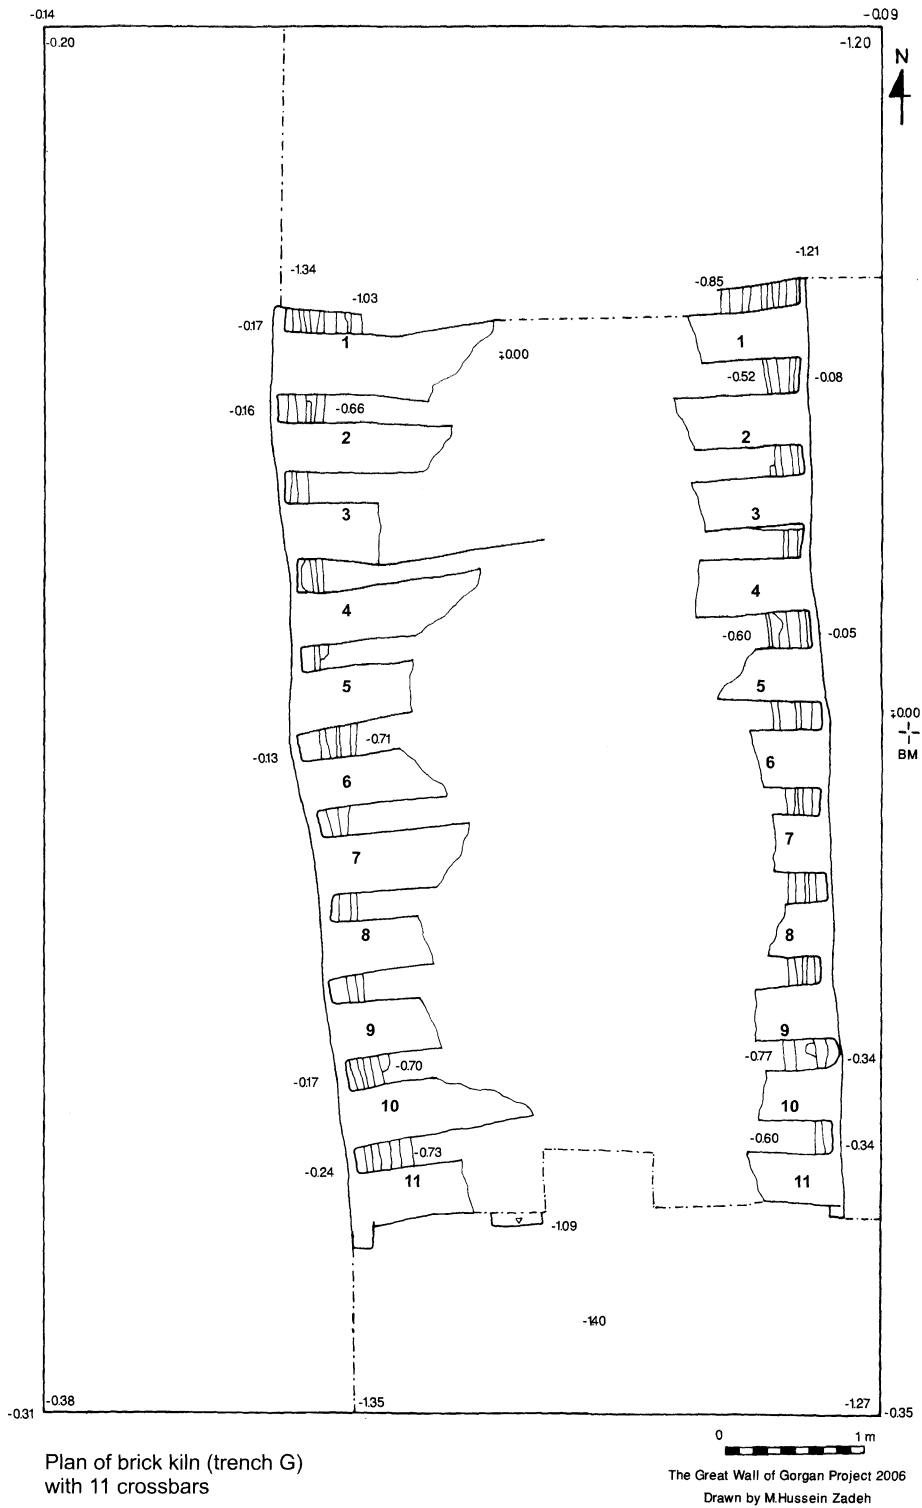
Fig. 17. Plan of Trench G, drawn by Maryam Hussein-Zadeh.

The southern and northern side of the kiln were excavated, but virtually none of the interior, except for a small sondage in the south (Figs 17 and 20). In the light

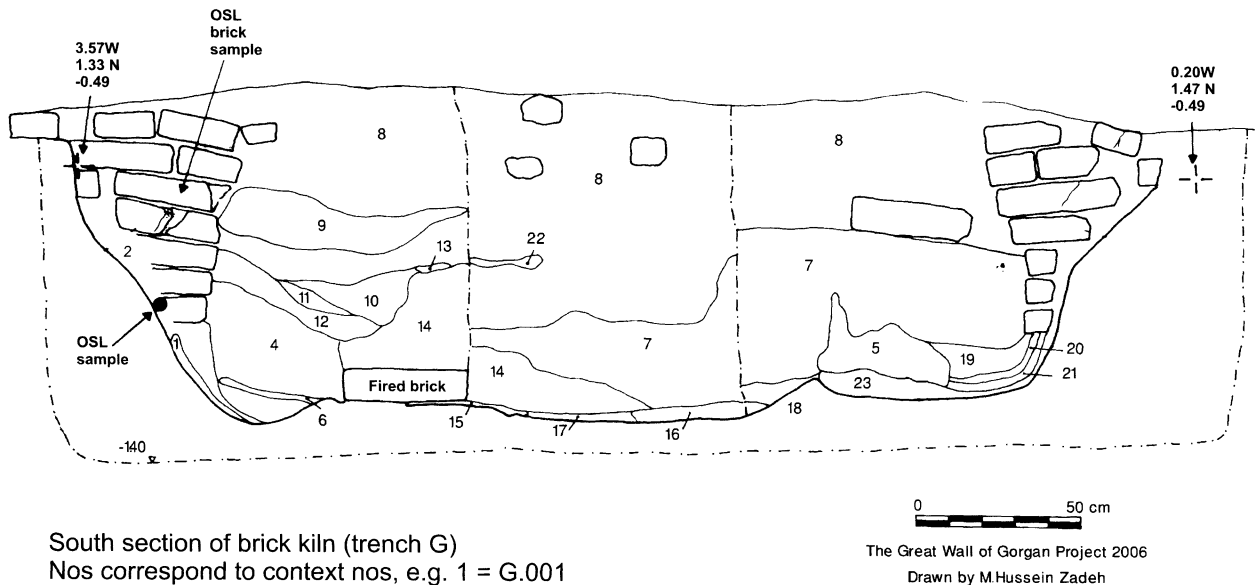
Fig. 18. South-facing side of the kiln in Trench G, drawn by Maryam Hussein-Zadeh.

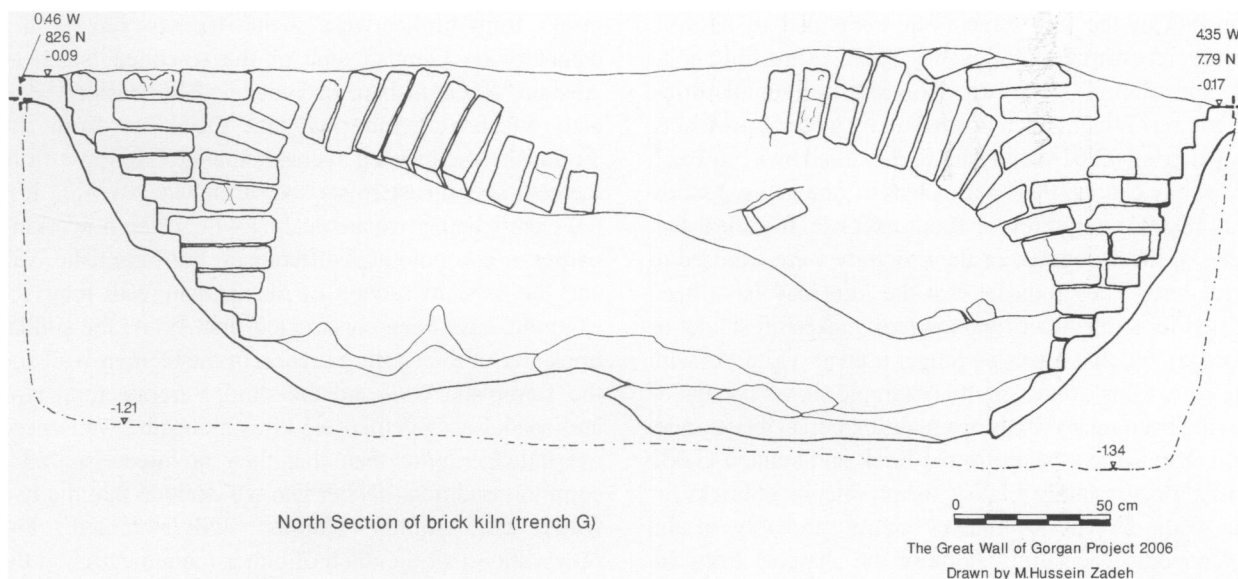
Fig. 19. North-facing side of the kiln in Trench G with collapsed arch, drawn by Maryam Hussein-Zadeh.

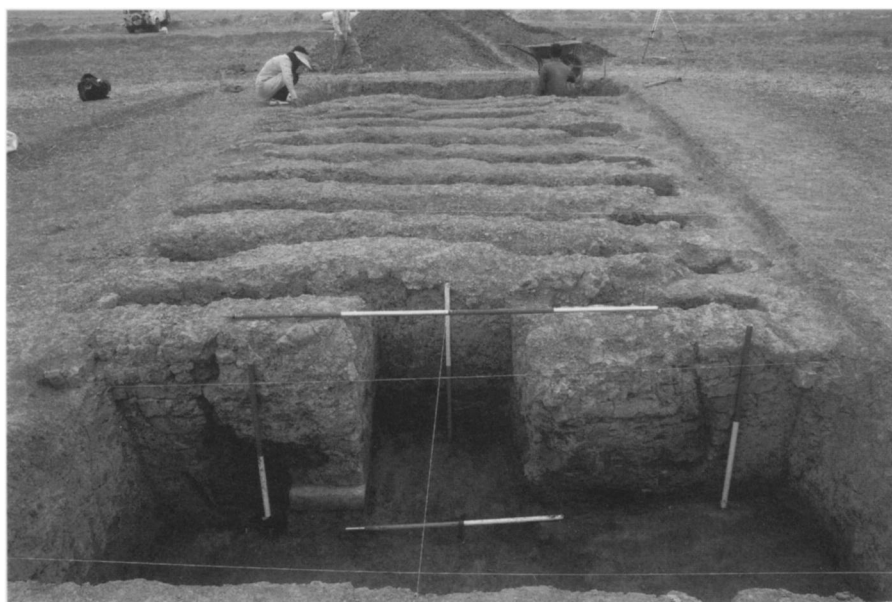
Fig. 20. The kiln in Trench G seen from the south. Each segment of the scales corresponds to 0.50 m.

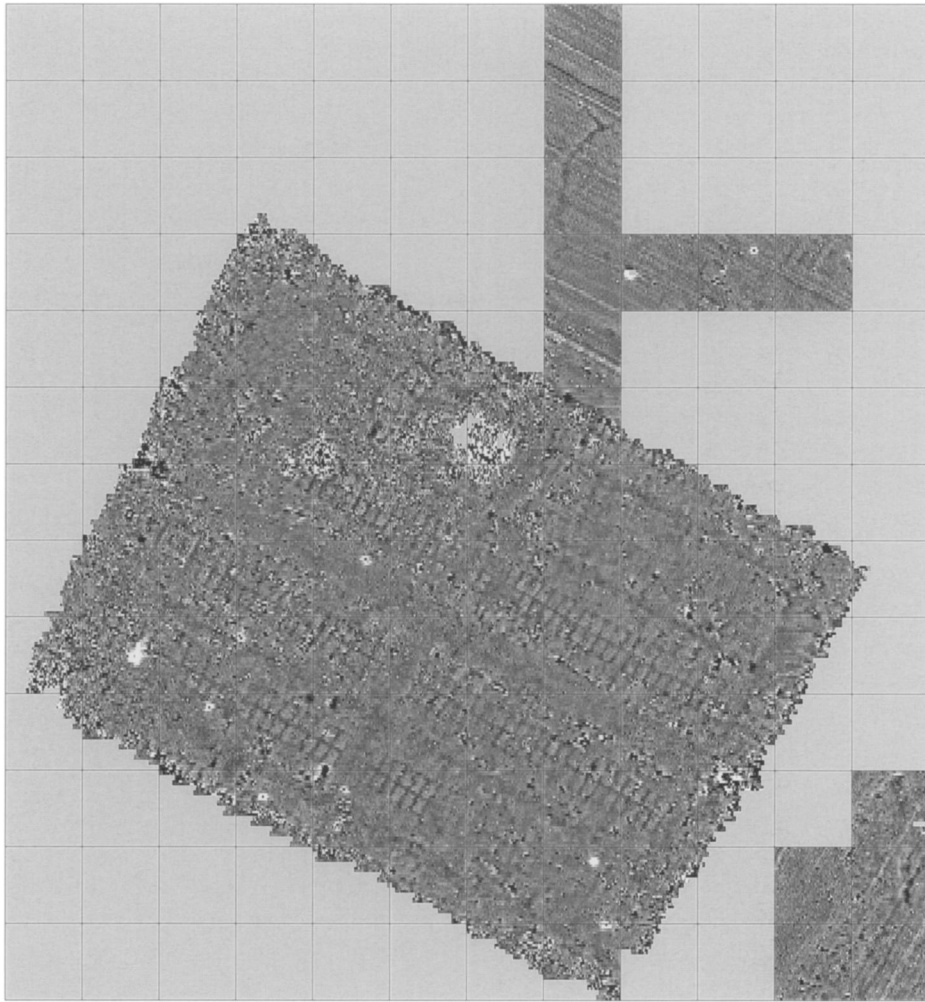
Fig. 21. Magnetometer survey of the interior of Fort 4 and selected extramural areas by RA (Abingdon Archaeological Geophysics), HO (ICHTO), EST, JJ, ME, SG & AN. For scale and north arrow see Fig. 22.

It thus came as a pleasant surprise that the 2006 magnetometer survey of Fort 4 (Figs 21–22), by Abingdon Archaeological Geophysics and the ICHTO, under the direction of Roger Ainslie, provided us with astonishingly clear results. On either side of a NW–SE-running central road we found two parallel anomalies of *c.* 228 m. length. The regular subdivisions leave no doubt that these have to be interpreted as elongated buildings, divided into two parallel rows of rooms. A third, virtually identical, anomaly, parallel to the other two was detected in the SW of the fort. At first sight, the plot may suggest that there are six rather than three such buildings, each of the three long double rows of rooms divided in the middle by a road, running from SW to NE. However, while further fieldwork will be necessary to prove or disprove this theory, this route, which is now visible as a shallow hollow way, is probably a secondary feature. The linear anomalies, thought to be walls of the three buildings, do not appear to come to an end on either side of this track, but to run across it, suggesting that we are dealing with three very long, rather than six shorter, buildings. The absence of any suggestion of a SW or NE gate in alignment with this track is a further argument for it being a secondary feature, perhaps added in a later phase to facilitate movement from the

Whilst scarcely visible on the magnetometer survey (Fig. 21), it seems probable that Fort 4 was provided with a series of projecting towers. That the remains of such towers do not form strong magnetic anomalies is unsurprising: heavy erosion at the edge of the fort or brick robbing will have severely damaged or removed their foundations, not to mention that the uneven ground made survey near the platform edge difficult or impossible. On the SW, SE and NE sides of the upper edge of the fort platform small hillocks are visible, where the sloping sides of the fort bulges out, as first observed by Julian Jansen Van Rensburg and Seren Griffiths. On the NE and SW sides the hillocks are roughly 31 to 32 m. apart. Distances on the SE side seem to be identical, except that the SE gate seems to be flanked by two such features at about half the distance. There is little doubt that these hillocks represent eroded towers. Their slight elevation may have been thrown into relief as a result of human and animal traffic bypassing these obstacles, thus accelerating erosion on either side of them. We counted eight such hillocks on the SE side (including the two flanking the gate and one each at the south and east corners) and nine each on the SW and NE side (again including the ones at the south and east

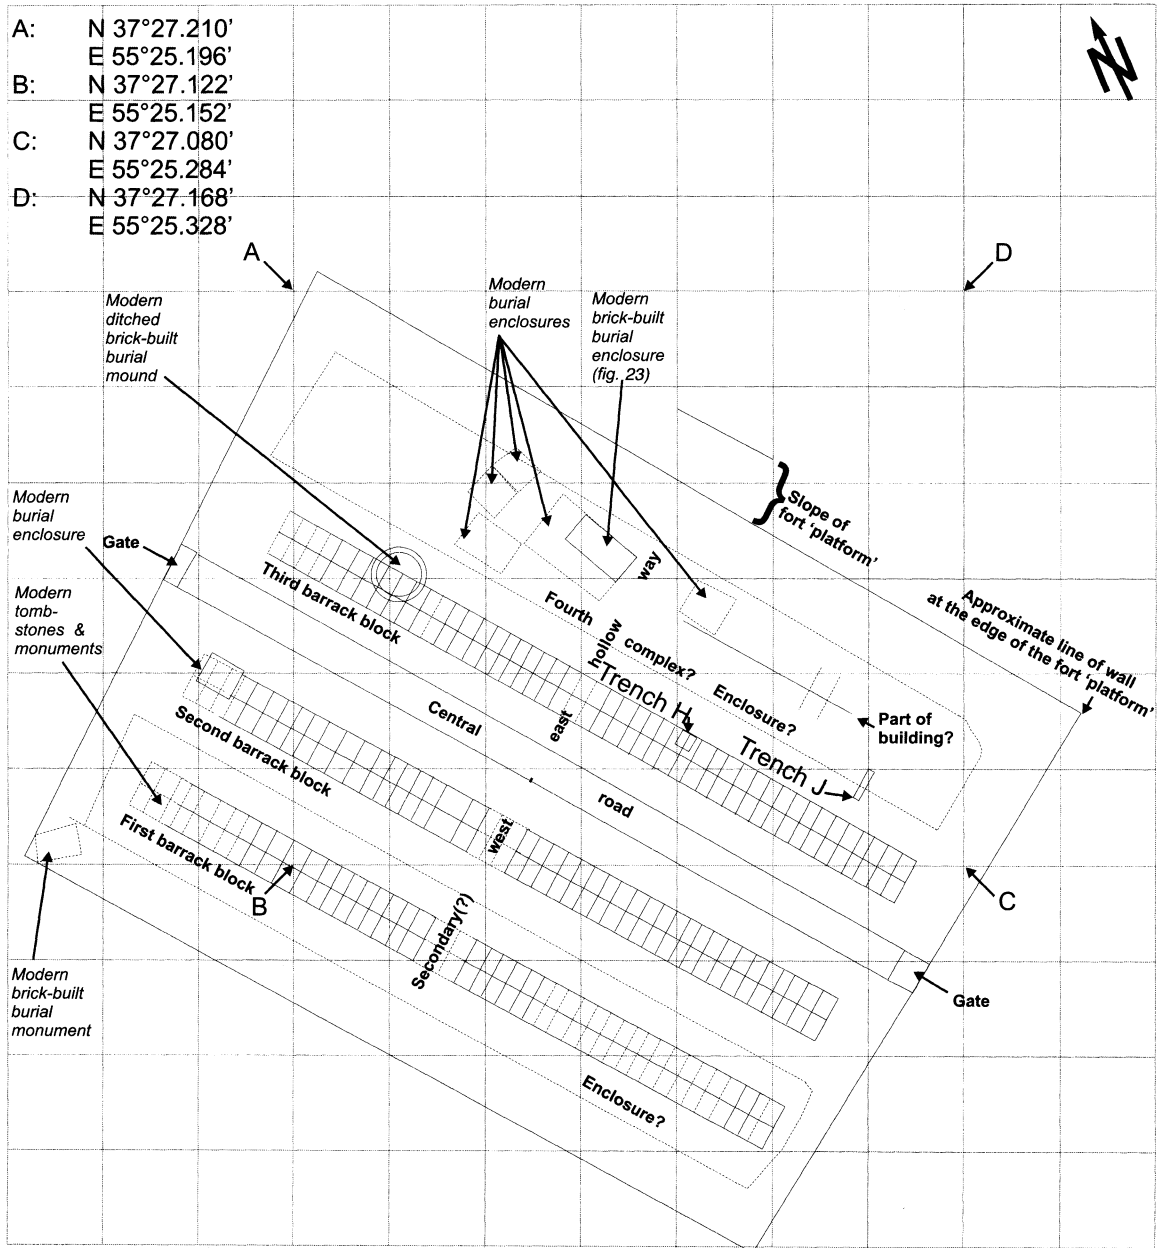
Fig. 22. Interpretative plot of Fort 4 with the location of trenches H and J. Each grid corresponds to 30 × 30 m. The projecting towers are not plotted as they cannot be pinpointed on the magnetometer survey. Only some of the modern burial enclosures and mounds have been plotted. They have not been surveyed and their extent is only approximate.

Due to considerable pressure of time, we confined ourselves to excavating two small trenches (H and J) (Fig. 22) under the direction of Hamid Omrani, Eberhard Sauer and Esmail Safari. Only Trench H could be fully explored within the 2006 season. We first marked out a 1×3.5 m.-large test trench through a well-defined anomaly, thought to be a room division of the building NE of the central road, to establish the depth of the stratigraphy. It soon became clear that we were dealing with a mud-brick wall reaching much deeper than we had anticipated. There was not enough time to excavate an entire room, but as the trench (H) had to be extended for reasons of safety and to allow us to understand the wider context, we enlarged it to 5×5 m. at the top, and it covered an area of c. 4.10×3.25 m. at

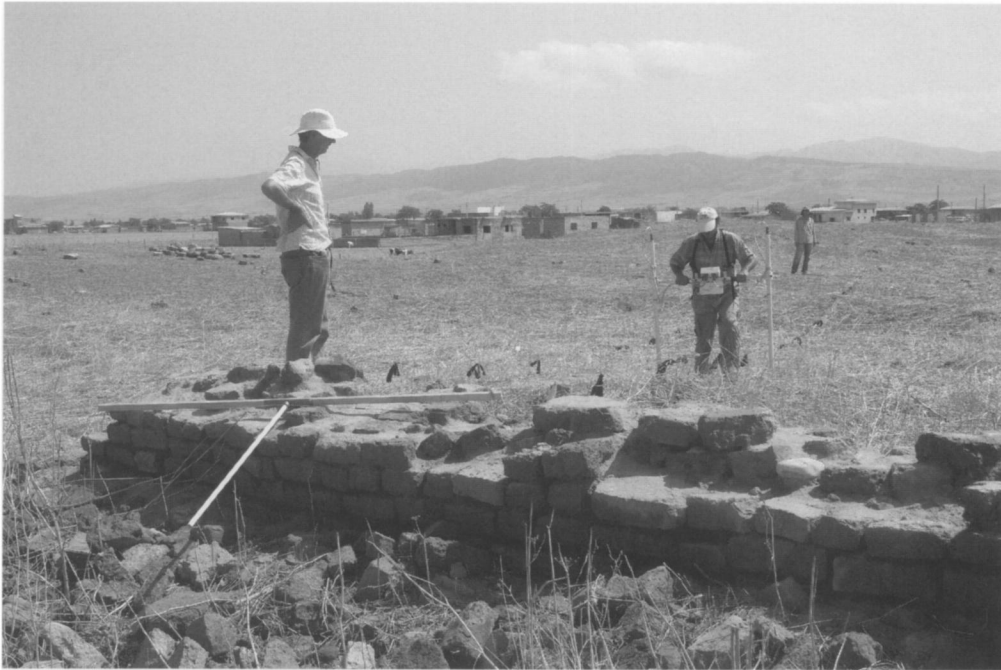
Fig. 23. A modern burial enclosure made of reused Gorgan Wall bricks (see Fig. 22) and the magnetometer survey in progress.

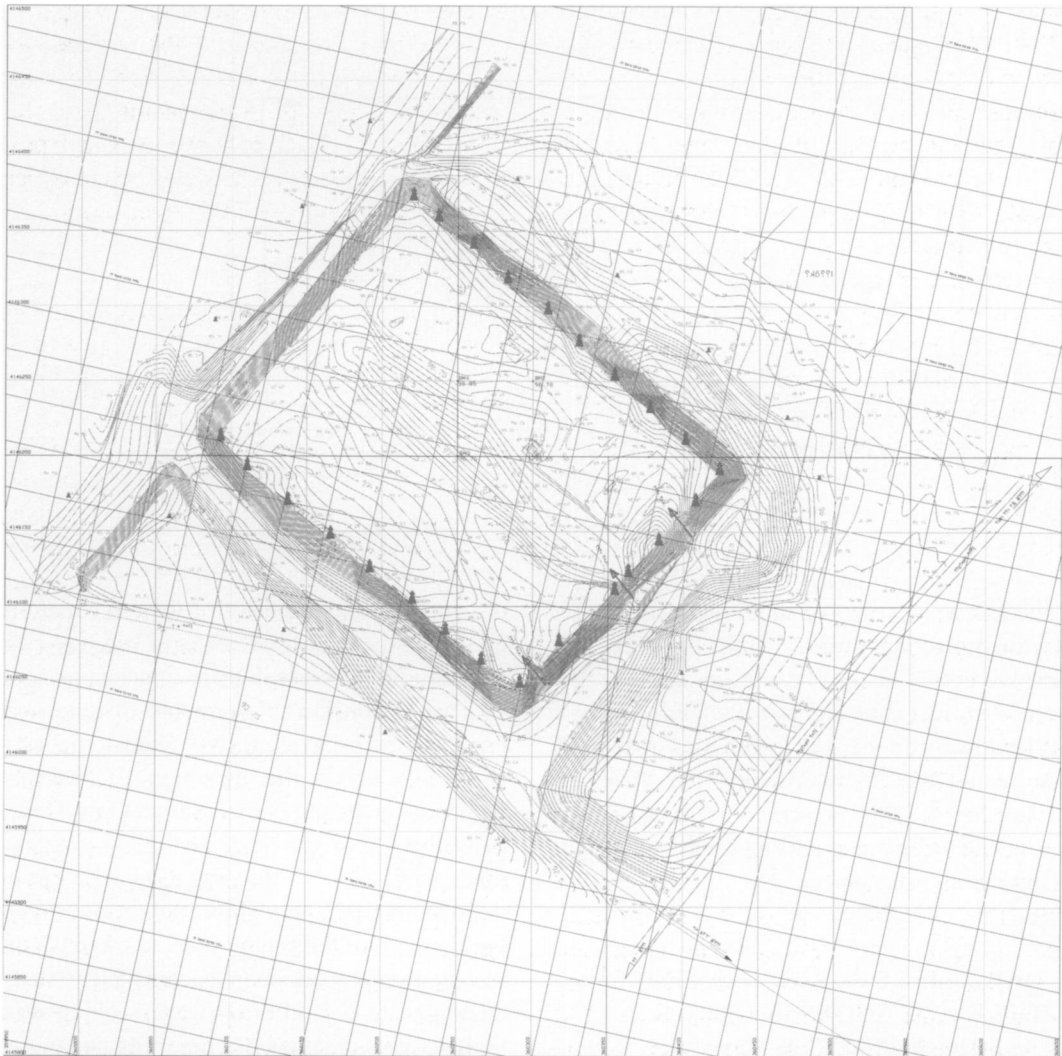
Fig. 24. The topographical survey of Fort 4 on behalf of the Gorgan Wall Base (ICHTO) by Mr Hosseini and Mr Hamidi, checked by Hamid Omrani. The vertical arrow symbols around the edge of the fort platform mark the position of the preserved remains of possible projecting towers. The small grids of 30 × 30 m. are identical to those on Figs 21 and 22; see Fig. 22 for scale and north arrow.

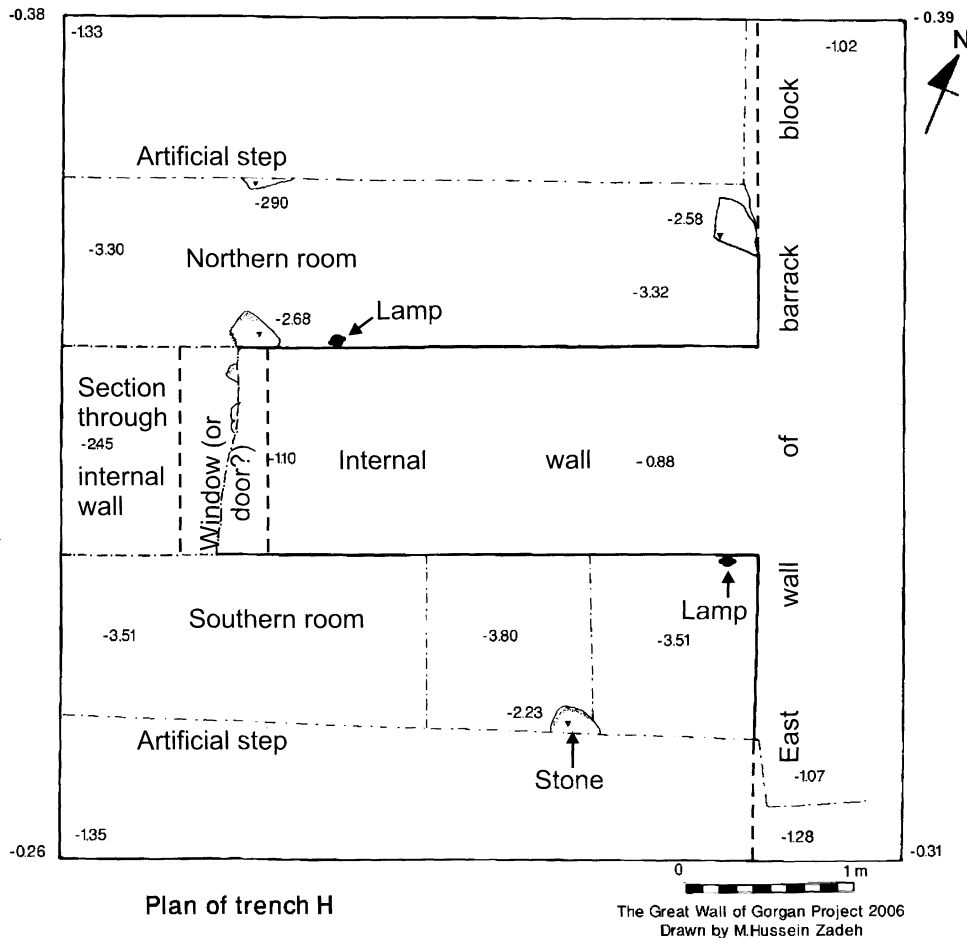
Fig. 25. Plan of Trench H, drawn by Maryam Hussein-Zadeh.

Interestingly, one lamp each was found in either room, both a similar level (3.23 m. below the benchmark in the southern room and 3.14 m. below in the northern), each immediately next to the wall (Figs 25 and 32.1–2), perhaps as a result of each having dropped off some
