AN IMPERIAL FRONTIER OF THE SASANIAN EMPIRE: FURTHER FIELDWORK AT THE GREAT WALL OF GORGAN

Source: *Iran*, Vol. 45 (2007), pp. 95-136

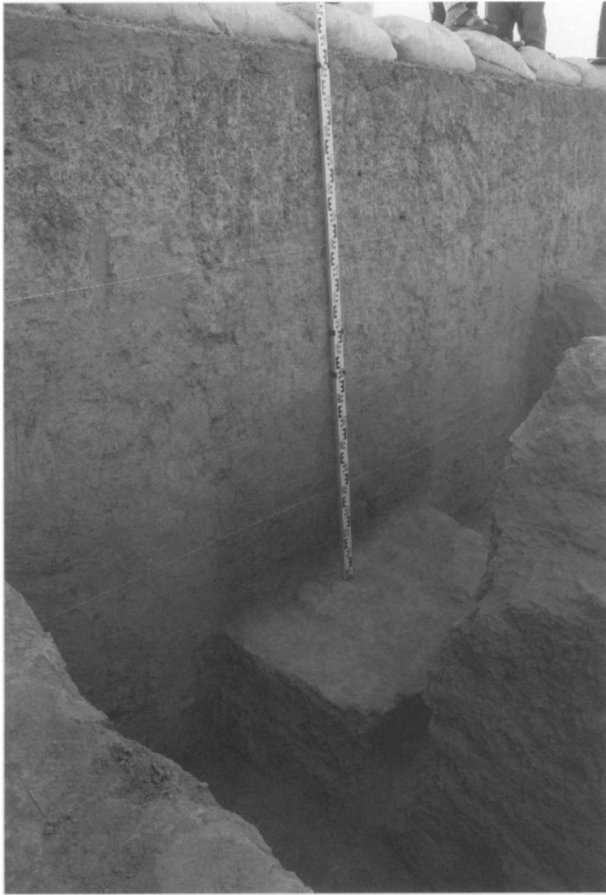
Fig. 26. East-facing section of Trench H, showing clearly the 1.20 m.-wide mud-brick wall.

The room division consisted of a substantial 1.20 m. wide mud-brick wall (corresponding approximately to the diameter of three bricks). In section (Fig. 26) it was visible as a vertical band of slightly darker colour (greyish-brown clayey silt with lime flecks) than the deposits which had built up on either side of it, presumably as a result of organic components in the mud-brick; we observed traces of possible straw imprints in the mud-bricks. The discoloration extended right to the modern surface, but no individual bricks were found preserved in the uppermost 1.50 m, probably due to natural processes, such as insect and root activity; in fact some plant roots were found in over 2 m. depth and sometimes they grew in the joints between mud-bricks. The colour difference to the deposits which had built up on either side of the wall in the east-facing profile (Fig.

26) was almost imperceptible for the uppermost 0.50–0.56 m., but was distinct at deeper levels. The impression that the preserved wall extends right to the modern surface is, however, confirmed by two crack lines which formed when the soil dried out, and ran in direct alignment with either side of the wall (Fig. 26). In contrast to the lack of evidence for any surviving brick surfaces at a higher level, the bottom courses, notably in the north-east corner of the southern room, were well preserved (Figs 27–30).

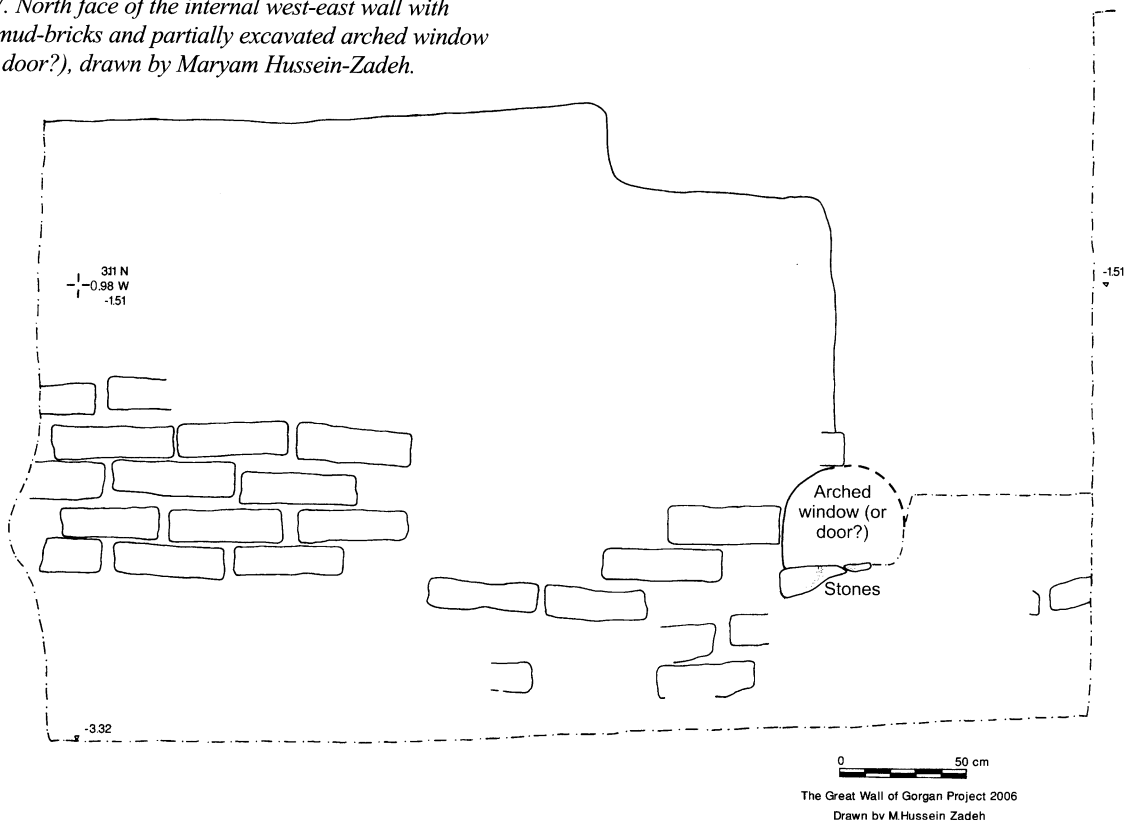
Fig. 27. North face of the internal west-east wall with preserved mud-bricks and partially excavated arched window (or door?), drawn by Maryam Hussein-Zadeh.

Between the rooms we found one arched window (or door?) opening (Fig. 27), first observed by Esmail Safari, which could not be fully explored for safety reasons, because of the substantial weight of the overhanging wall. We are thus unsure whether the stones (Fig. 27) mark the bottom of a c. 0.40 m. high window or whether it was an up to 1.40 m. high doorway, blocked later. During the latest phase of occupation (see below), all of this would have been below ground. The initial connection of the two rooms (whether passable for a person or not) would have facilitated communication between the rooms. Practical advantages in passing messages or goods from one room to another may have been the sole reason for the door or window. It is, however, also conceivable that it might have been intended as a control mechanism, so as to make it more difficult for ordinary soldiers to secretly discuss any grievances with each other.

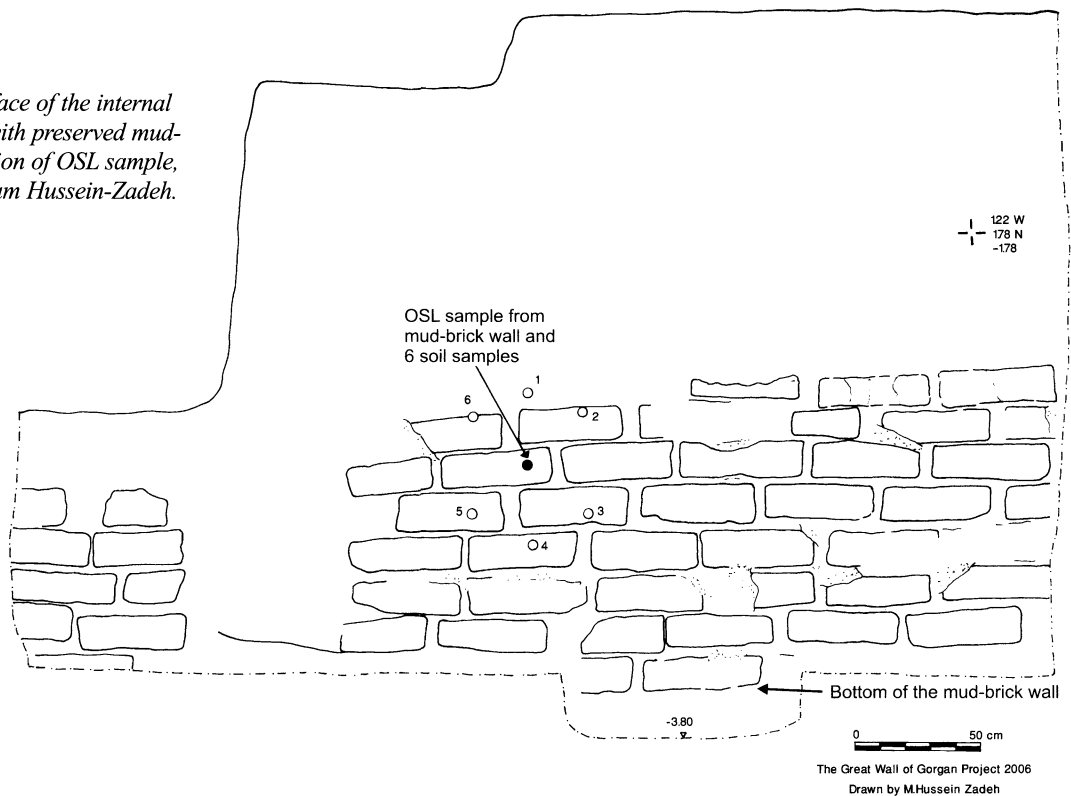
Fig. 28. South face of the internal west-east wall with preserved mud-bricks and location of OSL sample, drawn by Maryam Hussein-Zadeh.

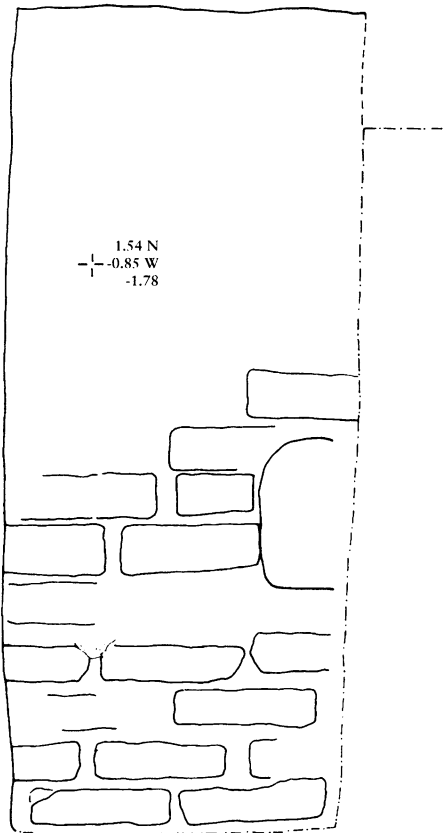
Fig. 29. West face of the eastern north-south wall of the barracks blocks with preserved mud-bricks in the southern room, drawn by Maryam Hussein-Zadeh.

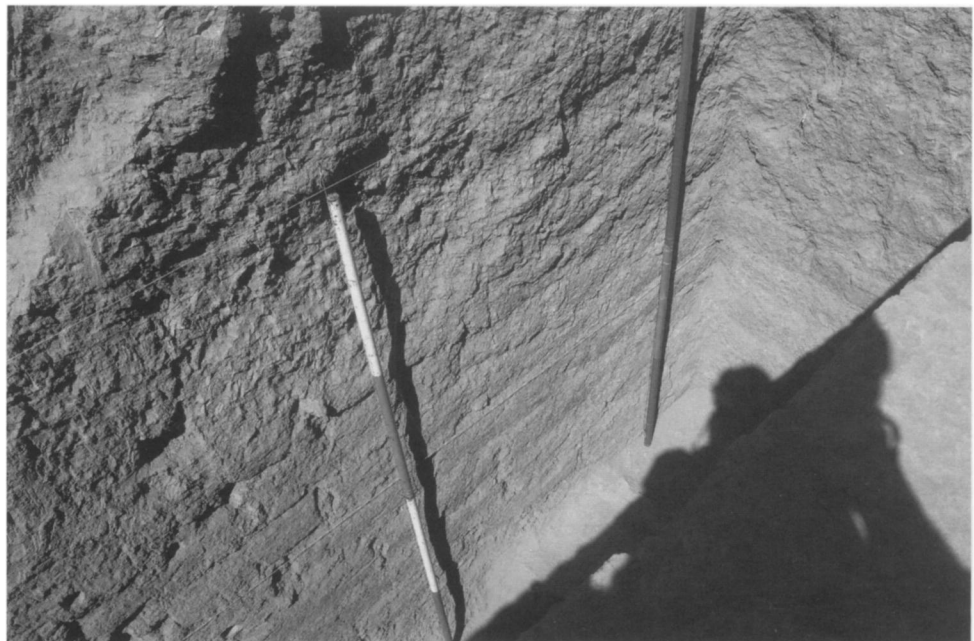
Fig. 30. The north-east corner of the southern room with preserved mud-bricks.

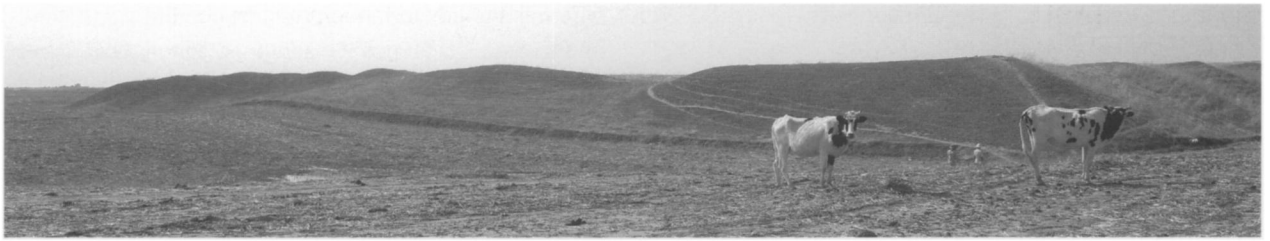
Fig. 31. Fort 4 (like the other forts on the Gorgan Wall) forms a substantial platform, here the small side seen from the south-east. Note the human scales (between the cows) in close vicinity to the fort.

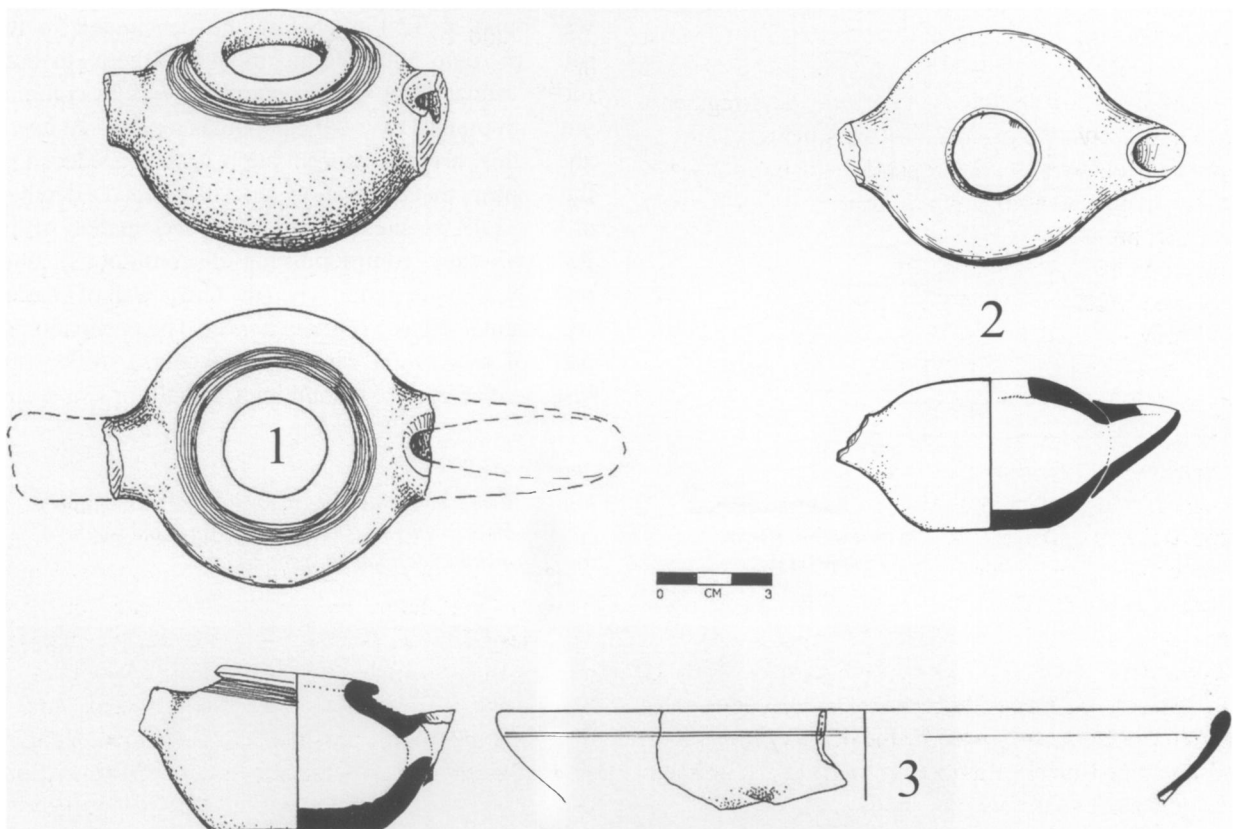
Fig. 32: 1. Lamp found in the southern room; 2. Lamp found in the northern room; 3. Fragment of a glass vessel (H.006), drawn by Mohaddeseh Mansouri Razi.

Interestingly, one lamp each was found in either room, both a similar level (3.23 m. below the benchmark in the southern room and 3.14 m. below in the northern), each immediately next to the wall (Figs 25 and 32.1–2), perhaps as a result of each having dropped off some

narrow ledge. The lamp from the northern room apparently had broken *in situ*, its fragmented nozzle, with wick-hole, still being attached to the lamp when found. While we still await the results of scientific analysis of the possible traces of the lamp fuel, fragments of charcoal from the occupation layers indicate that the fort occupants used beech (or possibly plane), alder and willow or poplar as fire wood (see “XIX.2. *Charcoal Analysis*” pp. 132–3), shedding light on the types of trees growing in the surroundings at the time.
