Predicting In-situ Heat Pump Performance: An Investigation into a Single Ground-Source Heat Pump system in the context of 10 similar systems.

A. Stafford^{a*} and D. Lilley^b

^aCentre for the Built Environment, Leeds Metropolitan University, Northern Terrace,
Queen Square Court, Leeds LS2 8AG

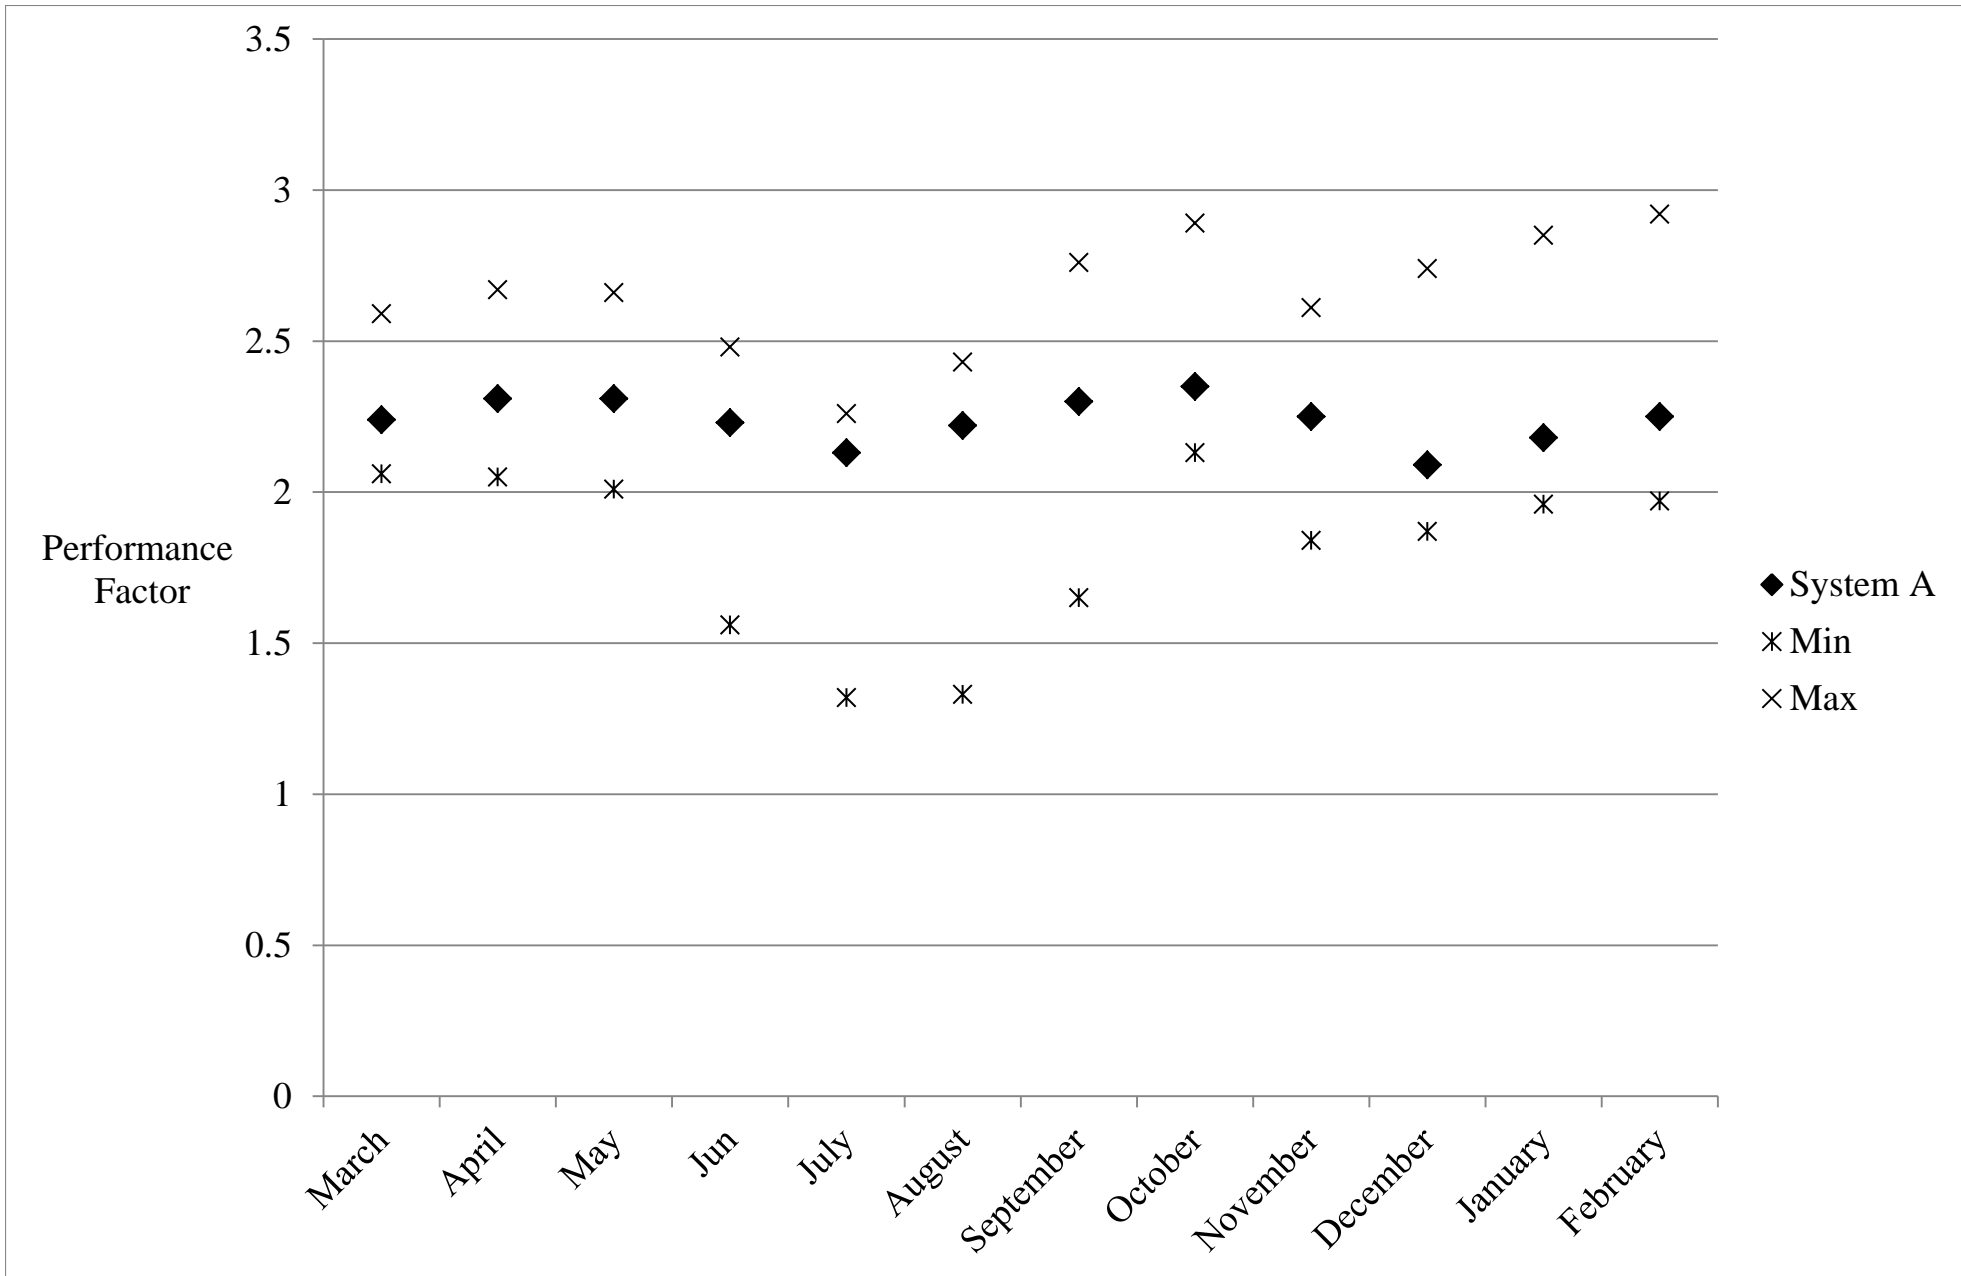
Fig 1: Month by Month Performance Factor of System A, compared with the maximum and minimum performance factors from all 10 systems.

Fig 1 shows the performance factor of system A on a month by month basis, during this year. The spread of values from all 10 systems is also shown in the diagram.

Whilst system A is at no time the best or worst performing system in the group, Fig 1 shows that it is performing relatively well during the summer months, when many of the systems show a significant drop in performance (due to the output being dominated by DHW production). Similarly, the performance in the winter months is relatively poor compared with the other nine systems. In itself this might suggest that this system is producing DHW relatively efficiently, and space heating relatively inefficiently compared with the remainder of the group.

Thus both Fig 1 and Fig 2 suggest that the heat pump system A is performing relatively well with respect to DHW production.

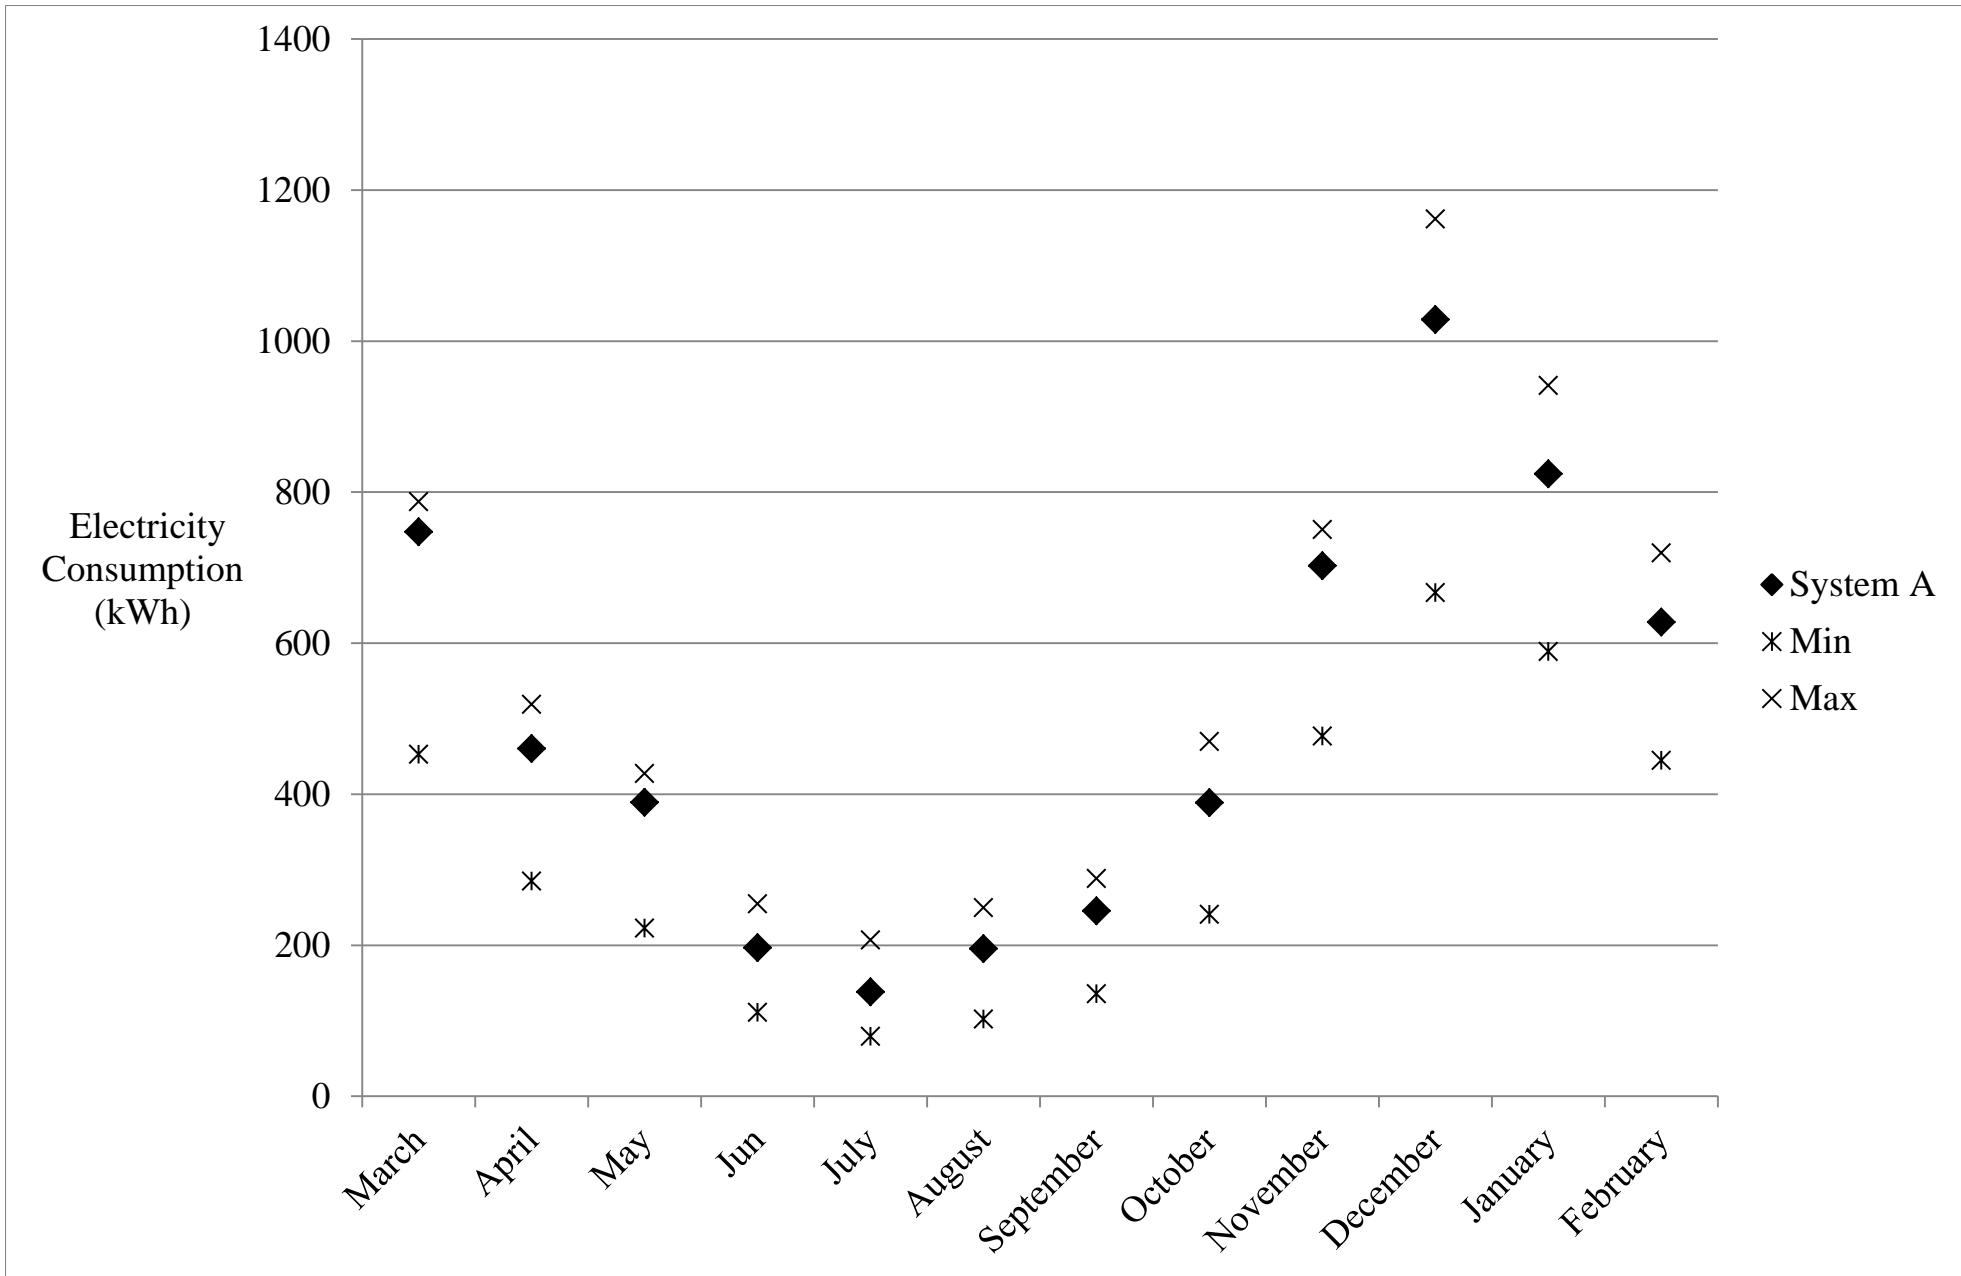
Fig 2: Month by Month Electricity Consumption of System A, compared with the maximum and minimum electricity consumptions from all 10 systems. .

Fig 2 shows a similar plot for the total electrical consumption of the heat pumps on a month by month basis.

Again, system A is at no time the maximum or minimum consumer of electricity within the group of 10 systems, but this time it is clear that during the colder months the consumption tends to be somewhat higher than average. Conversely during the summer months consumption is somewhat below average.

(Note that 4 days of consumption data for system A during October is missing due to a faulty transmitter, so this data point represents a slight underestimate of actual consumption).

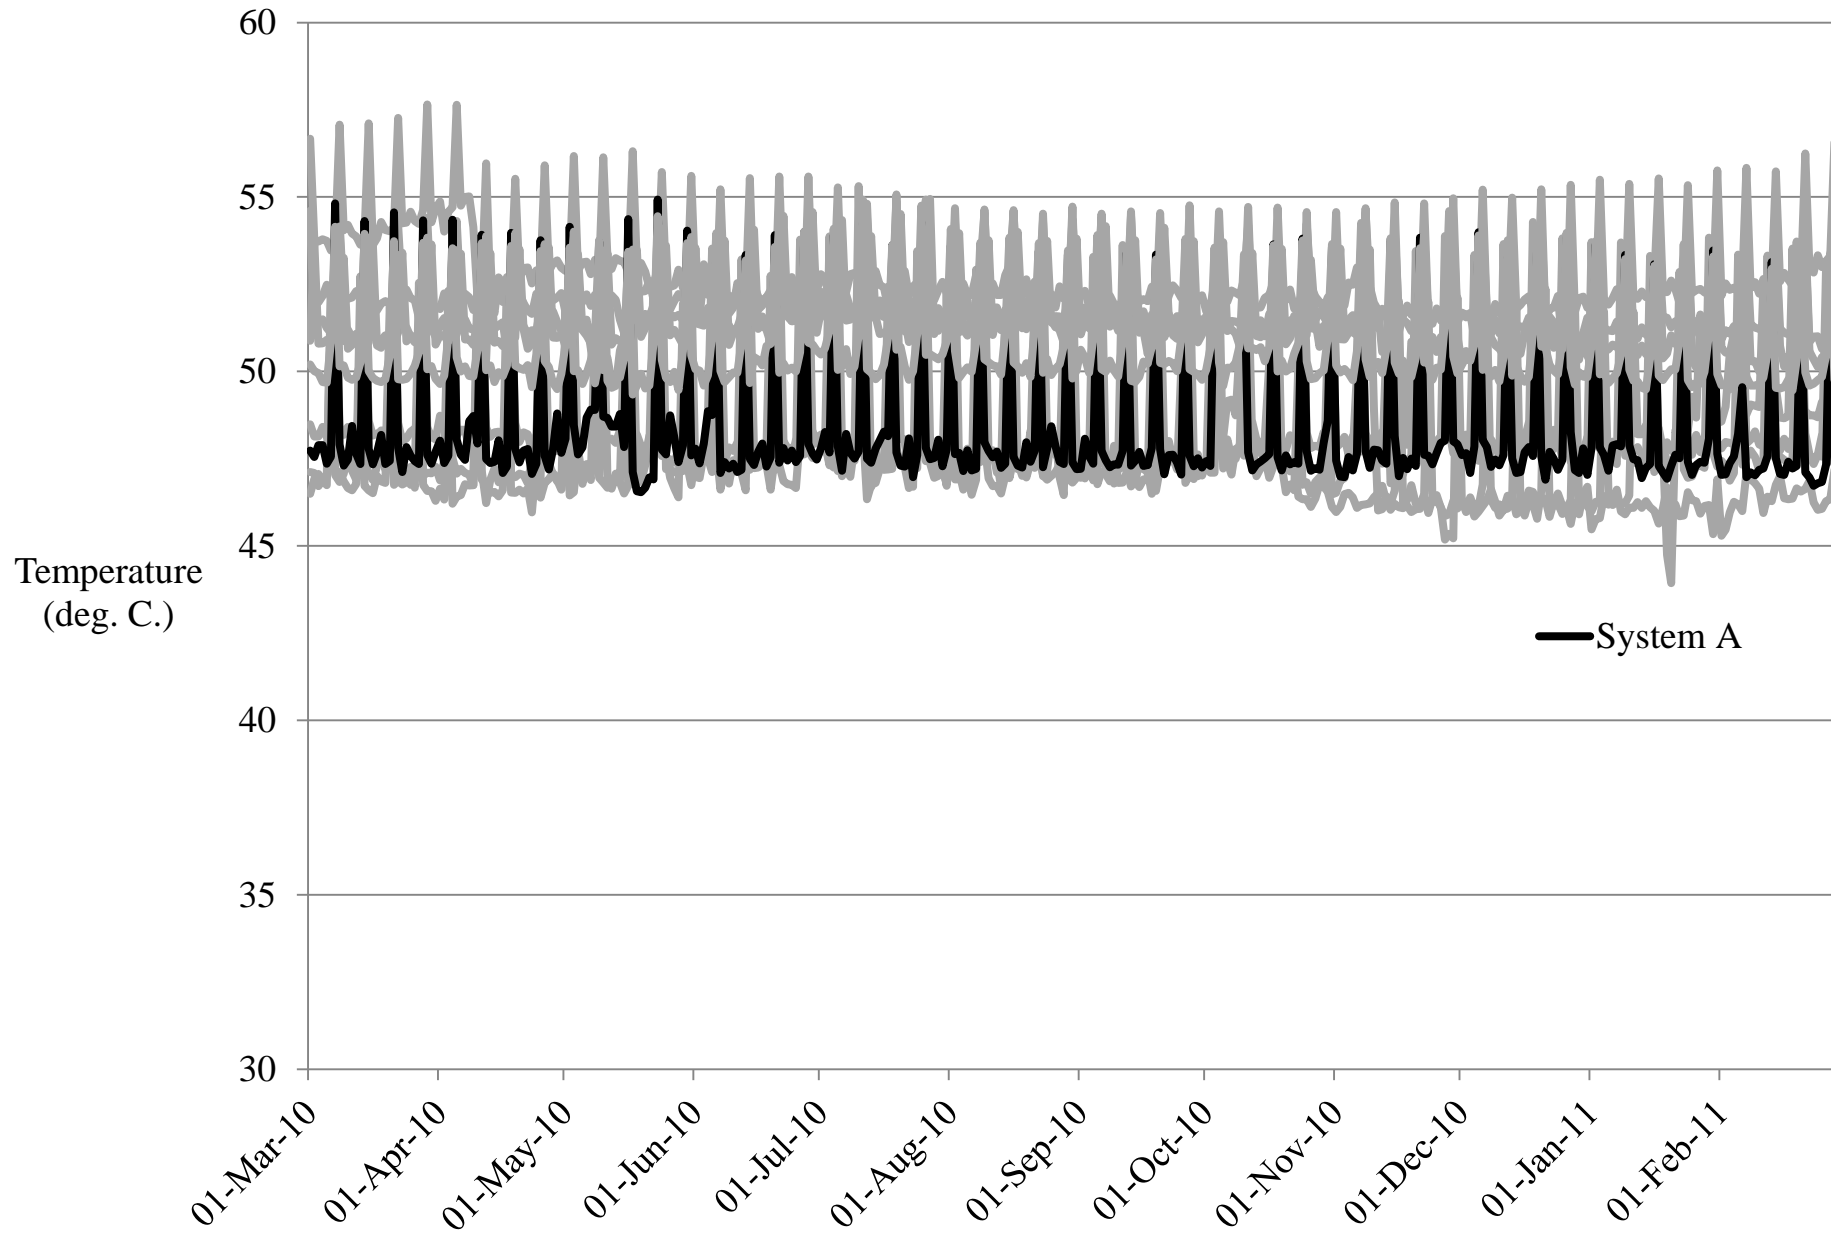
Fig. 3: Surface temperature at top of DHW tank. (Daily average calculated as a mean from data sampled at 10 minute intervals)

From Figs 1 and 2, we might expect that the set-point temperature for DHW in system A is set relatively low (leading to good efficiency and low electricity usage in the summer months). Fig 3 shows the daily average temperature as measured by surface probe at the top of the DHW tank for 9 of the 10 systems including System A. (The tenth system was excluded for reasons relating to system malfunctions). Clearly system A operates at a relatively low baseline DHW tank temperature as expected.

The regular peaks shown by the majority of systems represent weekly pasteurisation cycles where the tank temperature is raised briefly to 60°C to mitigate the risk of legionella growth.

However, since these are daily average values (averaged from data sampled at 10 minute intervals), all temperatures shown on the plot are in fact less than 60°C. There is a loss of pasteurisation cycle for one of the group from October onwards, but this is unrelated to the present discussion.

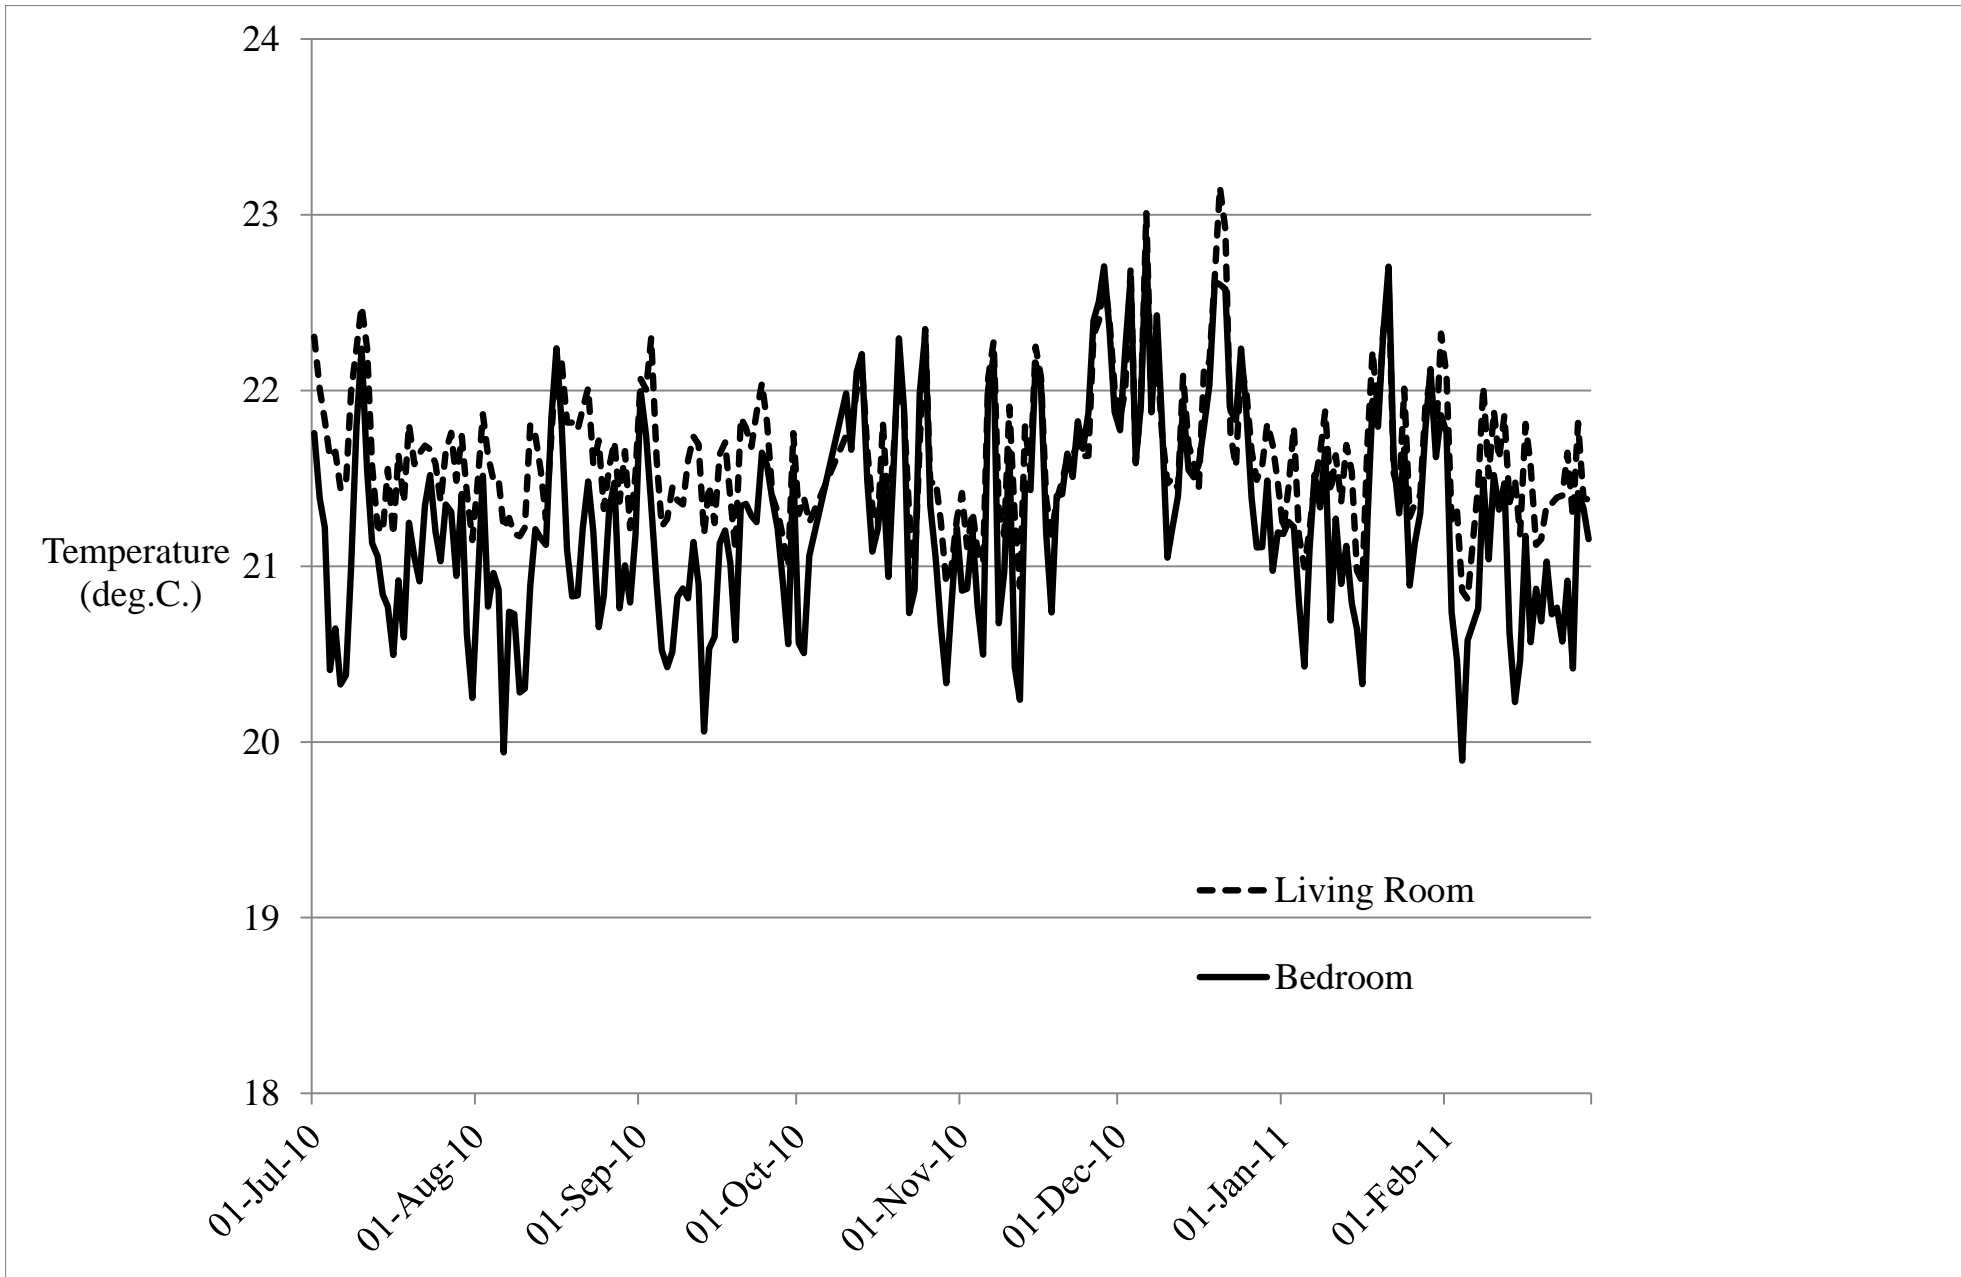
Fig 4: Daily Average Living Room and Bedroom Temperatures for system A (July 10 to February 11). (Daily average calculated as a mean from data sampled at 10 minute intervals).

Taking a simple view we might expect to see either fairly high internal dwelling temperatures, or low ground-loop temperatures, leading to relatively high electricity usage and lower efficiency during the heating season. Internal temperatures in the system A dwelling were measured in four locations (living room, bedroom, kitchen and bathroom) and found to be reasonably consistent and stable throughout the dwelling. Fig 4 shows living room and bedroom temperatures only for the sake of clarity, but kitchen and bathroom temperatures followed the living room temperature closely. The somewhat lower and less stable bedroom temperatures, during all of the year except for the coldest period in late November and December may be explained by the window-opening behaviour discussed in section 2.7.

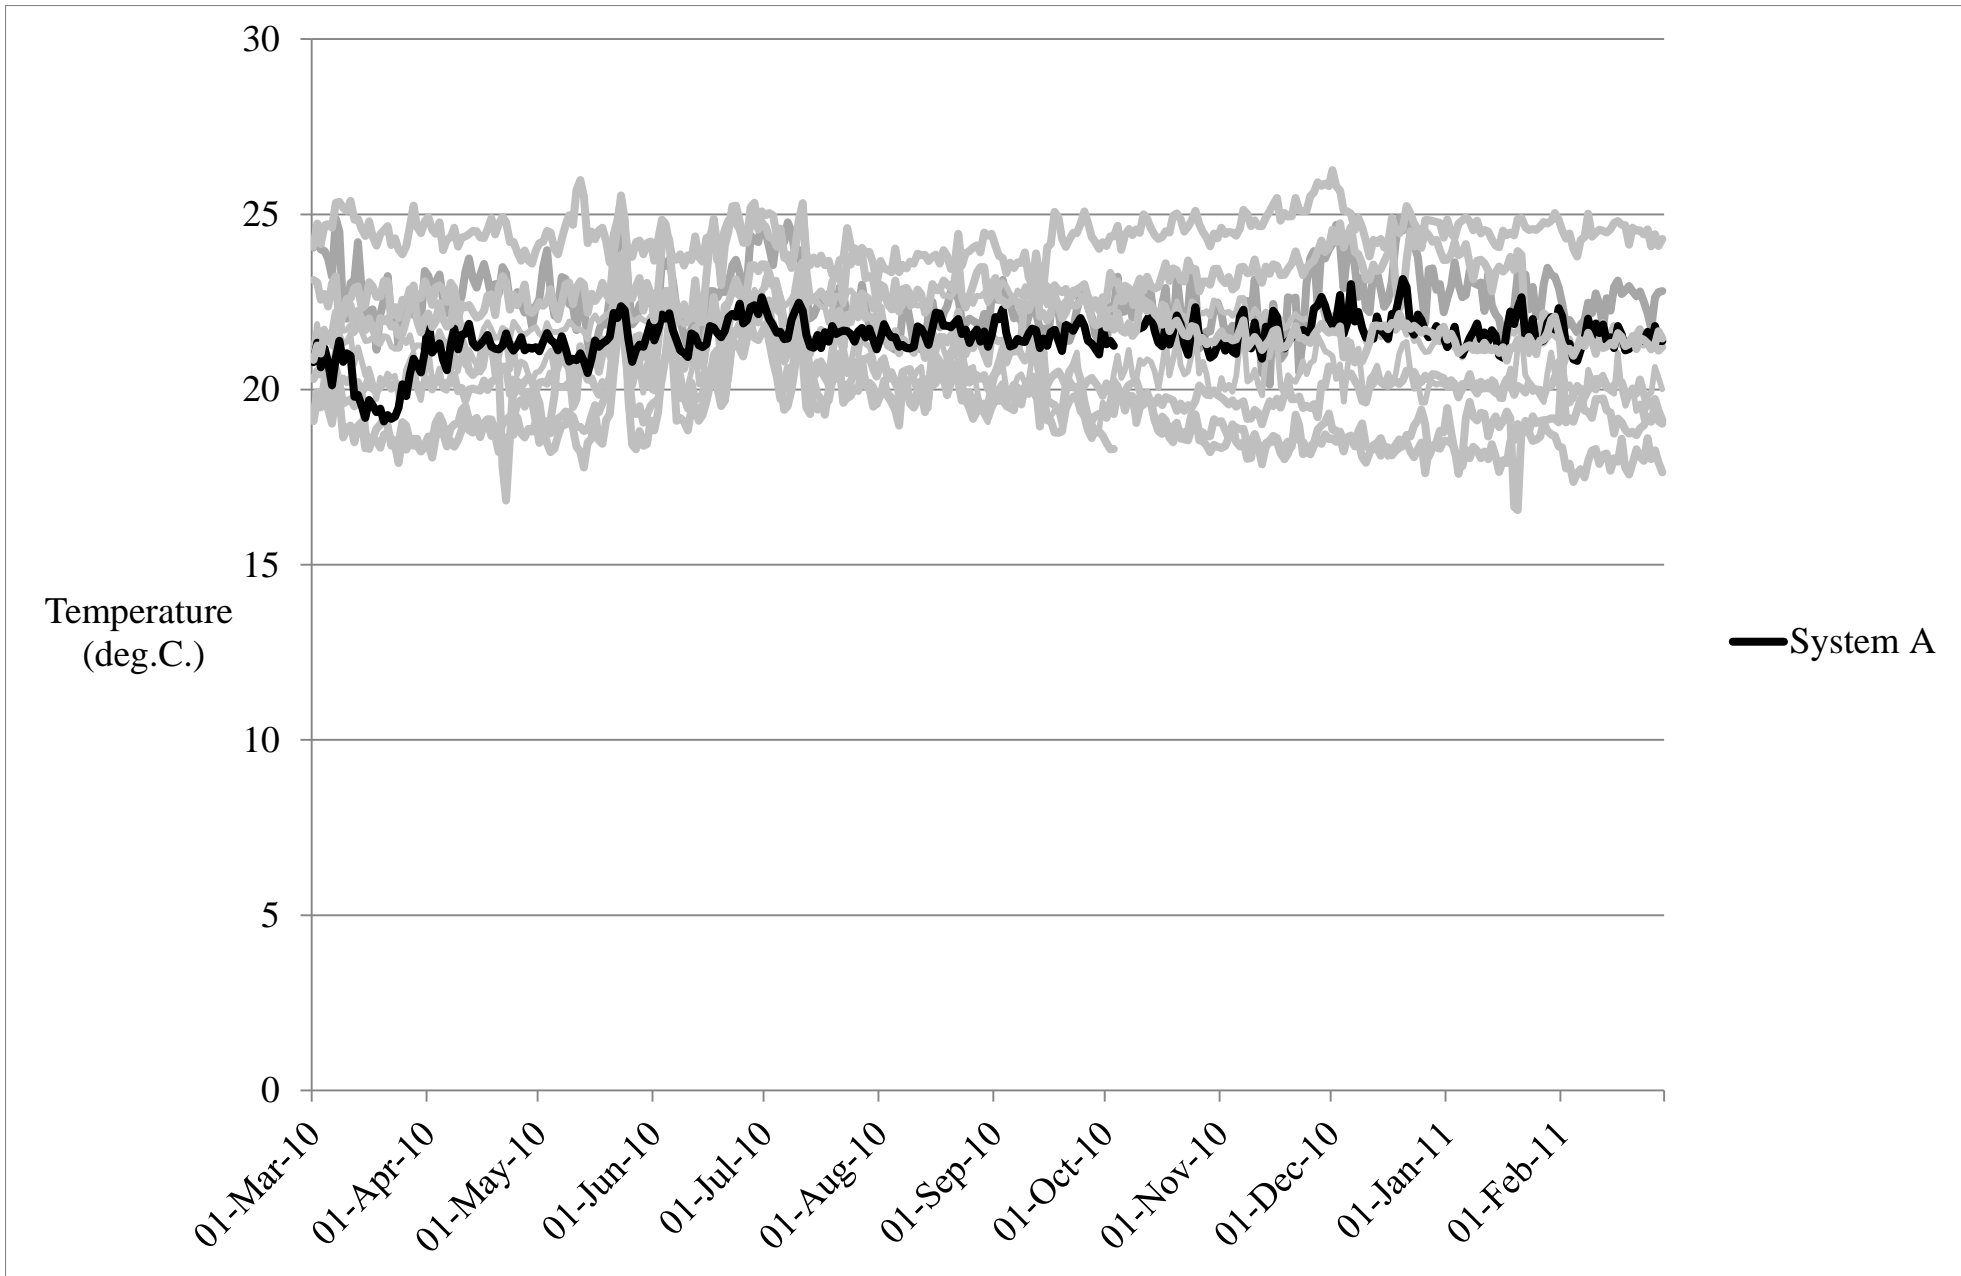
Fig 5: Daily Average living room temperatures – all systems. (Daily average calculated as a mean from data sampled at 10 minute intervals).

Figs 5 and 6 track the living room temperatures and ground-loop fluid temperatures for all the systems. In the case of Fig 6 the plot is restricted to the months of November and December 2010. A full year plot would be misleading since during the warmer months, when the heat

Figs 5 and 6 show that in the context of the other systems, system A is around average for both internal temperature and ground-loop fluid temperature. We might therefore expect to see average performance during the winter months, when the efficiency is dominated by space-heating, but in fact the performance tends to be below average. Factors which may cause this apparent anomaly are discussed in the following sections.

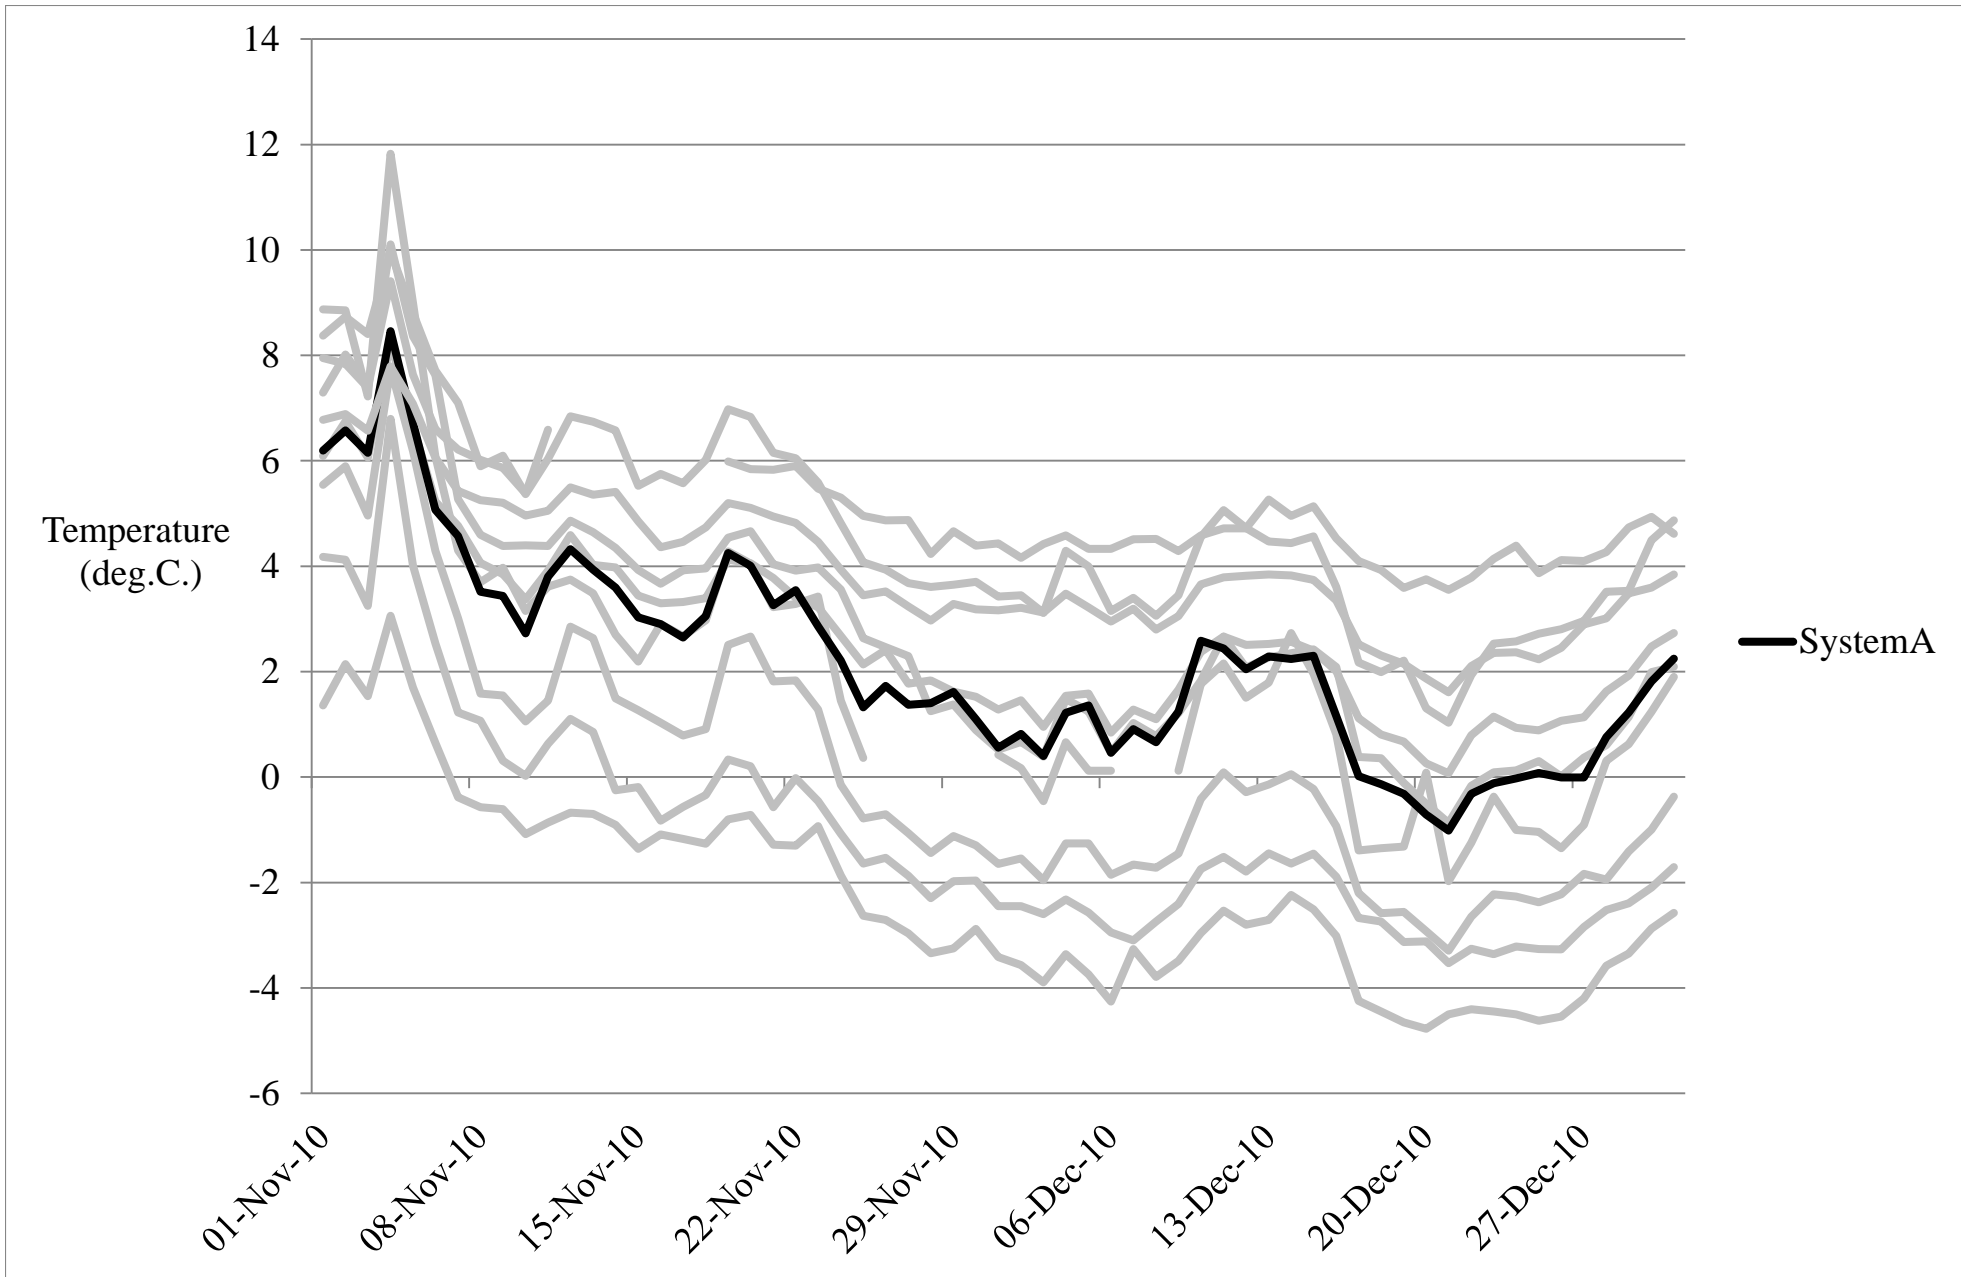
Fig 6: Daily Average Temperature of fluid from Ground Loop for all 10 systems (November/December 2010). (Daily average calculated as a mean from data sampled at 10 minute intervals).

pump is operating intermittently, the temperature measured may represent only that of stagnant fluid in the pipework.

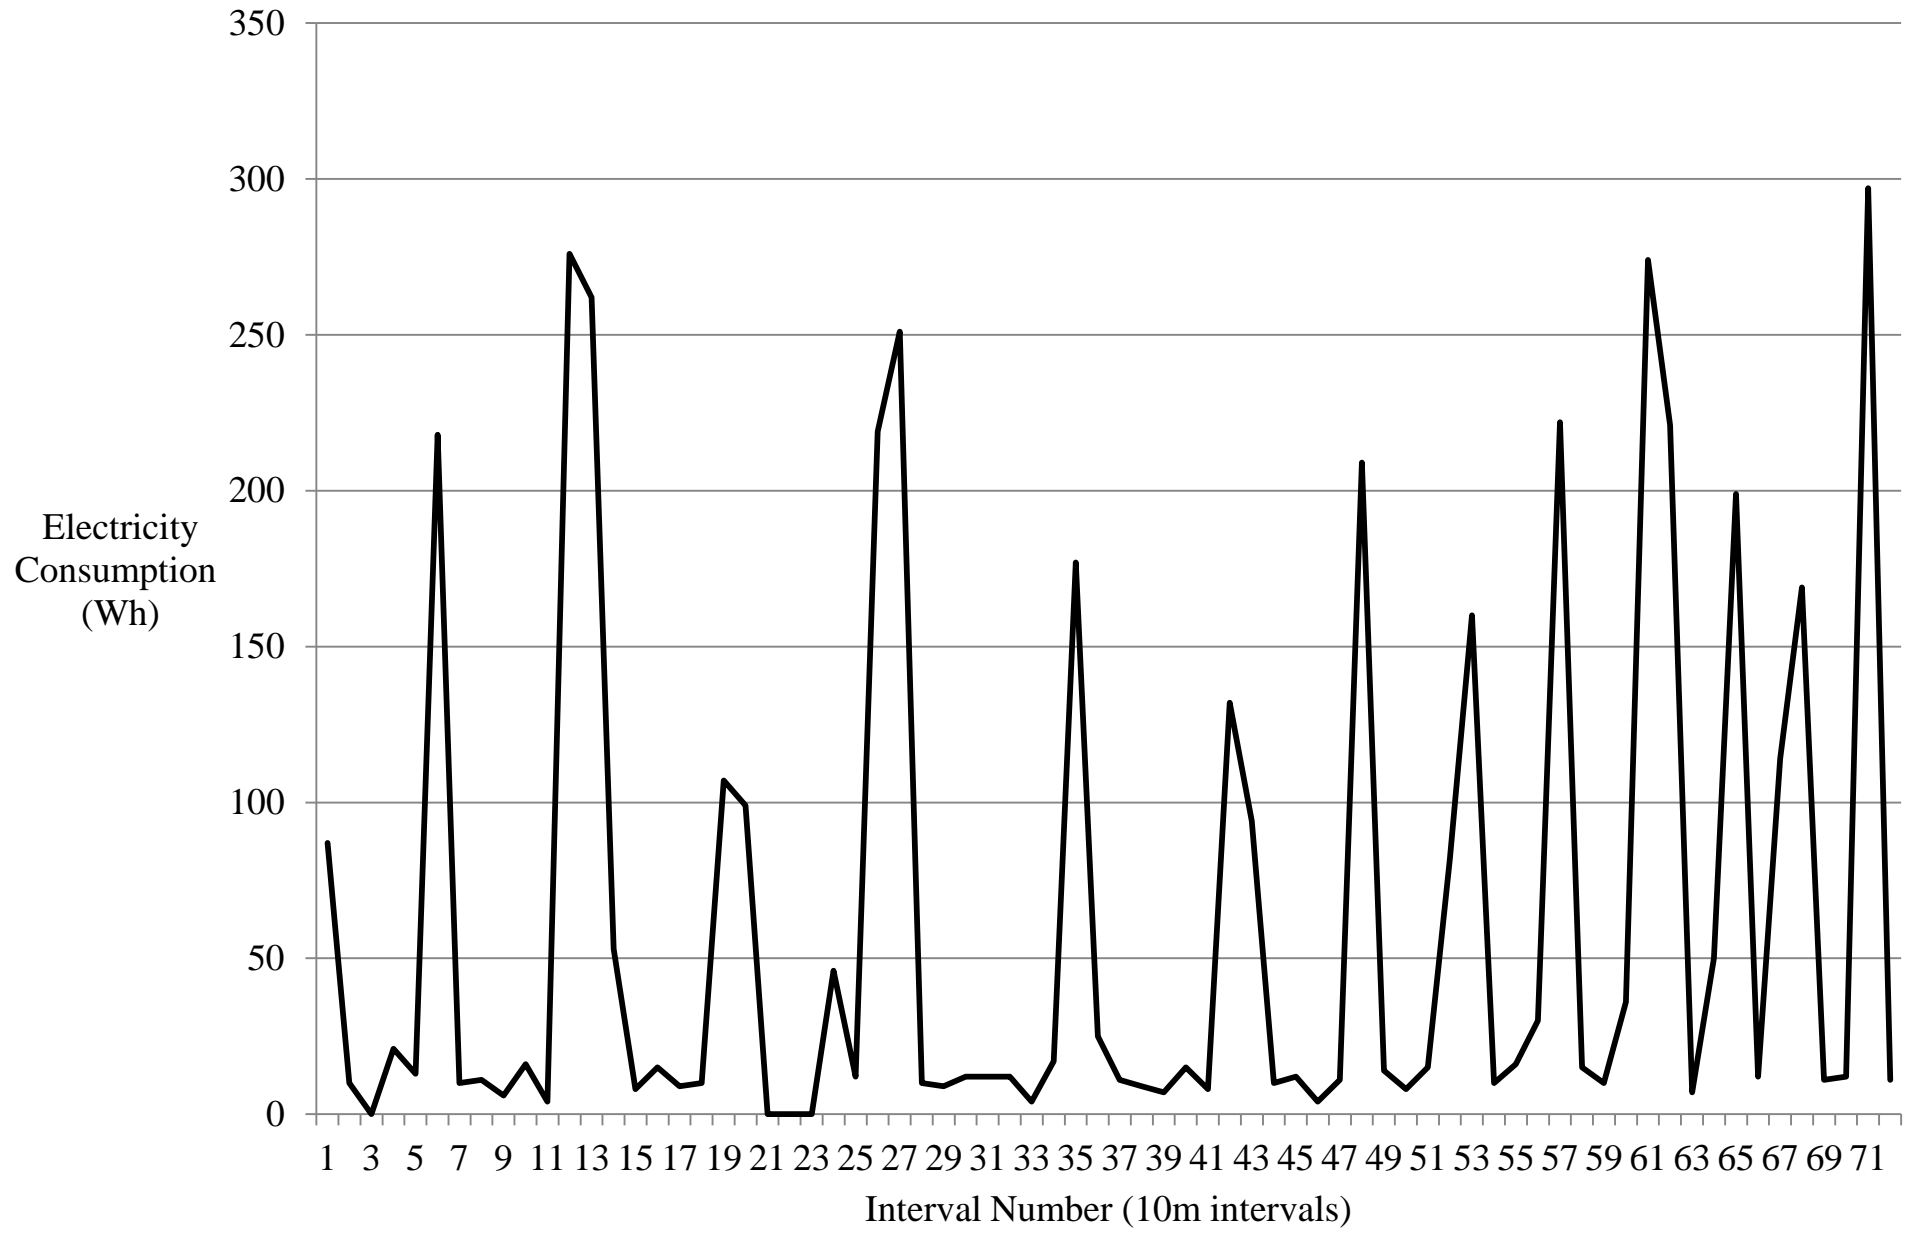
Fig. 7: Compressor cycling in System A.

The compressor cycling behaviour in system A, together with the other 9 systems is illustrated by looking closely at a 2-day period (1st- 2nd October 2010). October was chosen as a period when space heating could be expected to occur, but on the other hand demand was not so constant as to blur the distinction between on and off periods. For each system, the total heat pump electricity consumption was plotted at 10 minute intervals, and the clear peaks simply counted. Fig 7 gives an example of the type of data obtained, showing the period 12 noon – 12 midnight on 1st October for system A.

Whilst an element of human judgement exists in counting peaks in this way, it is nevertheless reasonably clear. Double peaks (i.e. where a shoulder exists on the main peak) are counted as one. It must be remembered however, that some of these peaks may be due to compressor start-up for the purpose of DHW production, and should therefore be discounted. It proved to be possible to separate the two by inspection using the data available in this study, since DHW tank temperature was monitored throughout, and so peaks coinciding with a rise in DHW temperature could be ascribed to DHW production. (DHW demand takes precedence over space-heating demand in these systems).

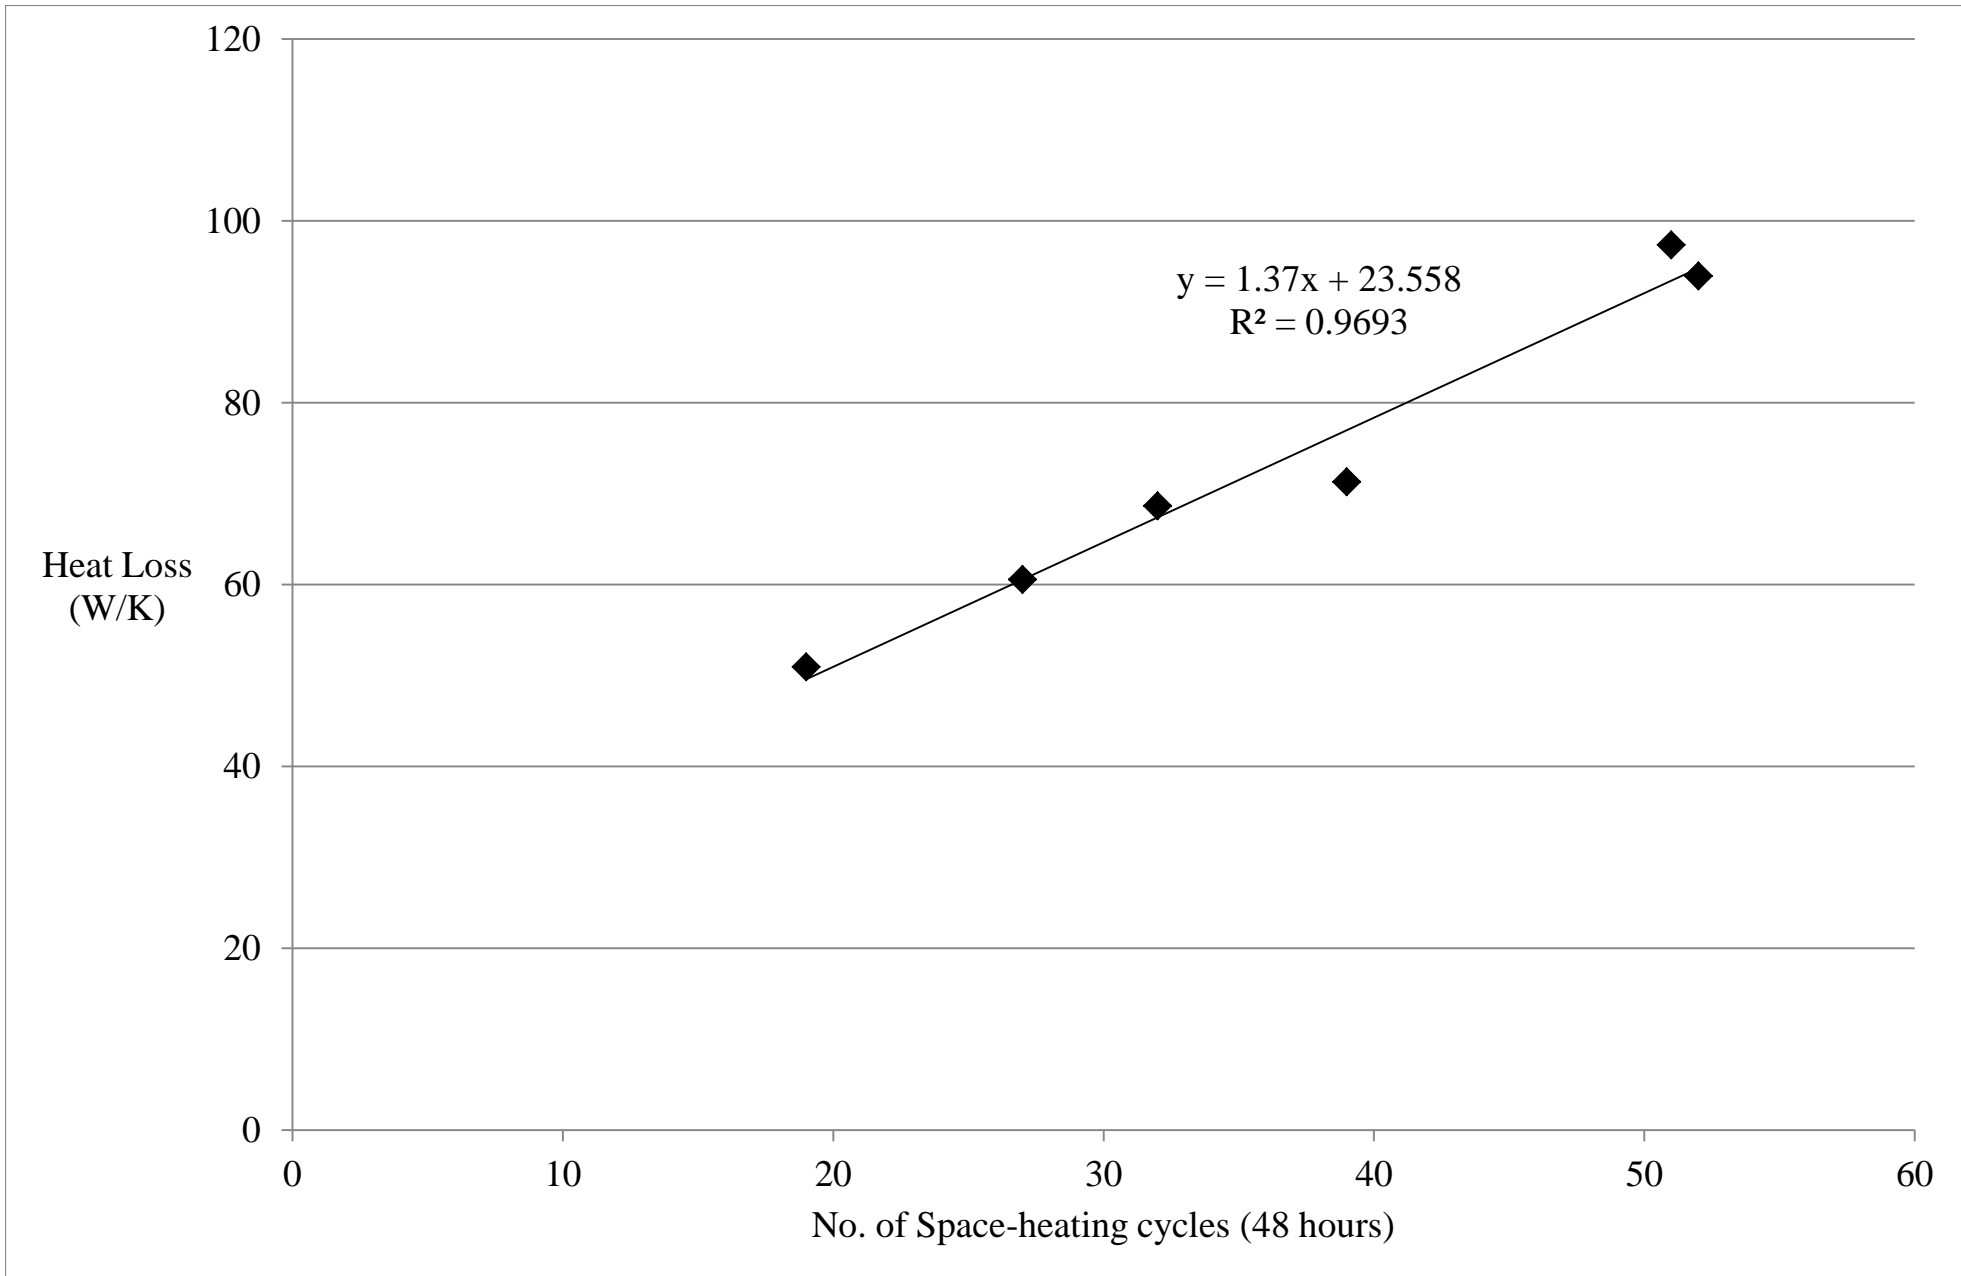
Fig. 8: Correlation of Space-heating Compressor Cycling with Estimated Daily Heat Loss rate (6 co-located systems).

Fig 8 shows a plot of the cycling attributed to space-heating vs the estimated daily heat loss rate in W/K, (average of 1st and 2nd October). The latter was calculated from space-heating heat output and temperature difference as measured by internal and external temperature sensors. This method assumes that the heat production rate of the heat pump (for space-heating) is equivalent to the heat loss rate from the building, which seems a reasonable assumption in view of the observed stability of internal temperatures. Of course it is understood that there will be other contributions to heat input to the building, such as metabolic and appliance gains, so the figures should not be taken as absolute values, but as indicative only.

Fig. 8 demonstrates that space-heating cycling rate can act as a good proxy for heat loss rate for these systems, under the conditions described. This is a potentially useful result since electricity consumption can be monitored more easily than heat output.
