PILOT LAKE RESTORATION INVESTIGATIONS
IN THE FOX CHAIN OF LAKES

V. Kothandaraman, D. Roseboom, and R. L. Evans

Illinois State Water Survey
Urbana, Illinois
1978

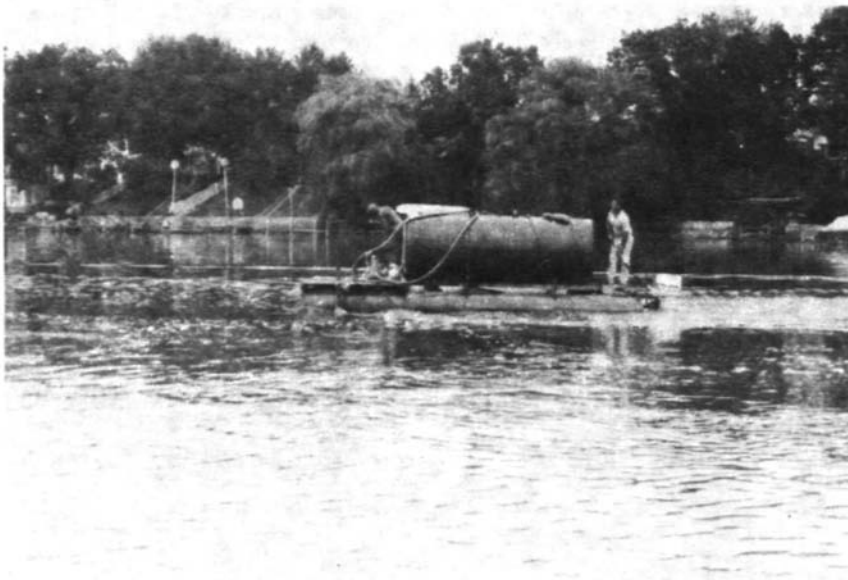
Figure 6. View of the pontoon tank fully loaded

The barge was powered by a 25 hp outboard motor. The steering mechanism of the outboard was modified to enable the operator of the barge to look ahead over the tank (figure 6). The barge is shown loaded to the maximum extent. Though the tank has a capacity of 940 gallons (4-foot diameter, 10 feet long), the barge can safely carry only about 5000 pounds of liquid.

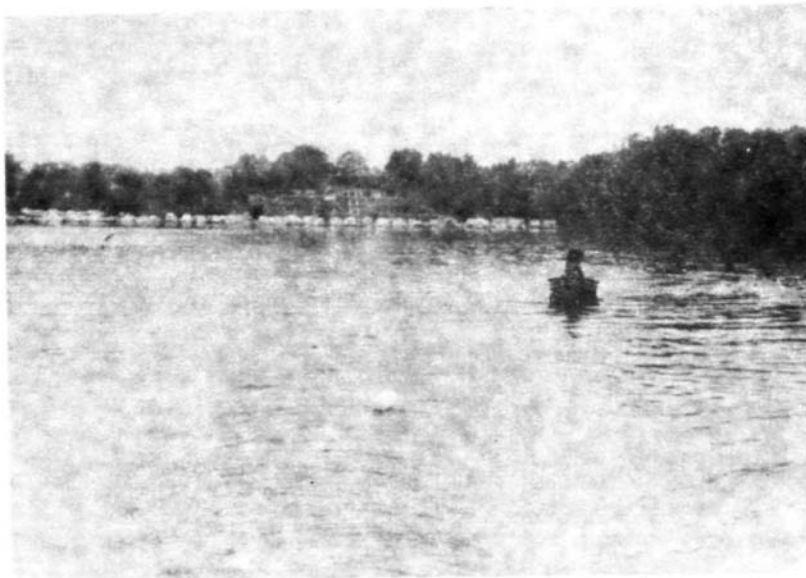
Figure 10. A row of floats in the lake

After two consecutive strips were treated, floats from the edge of the outer strip were retrieved and reused. Figure 10 shows a row of floats in the lake and the retrieving boat.

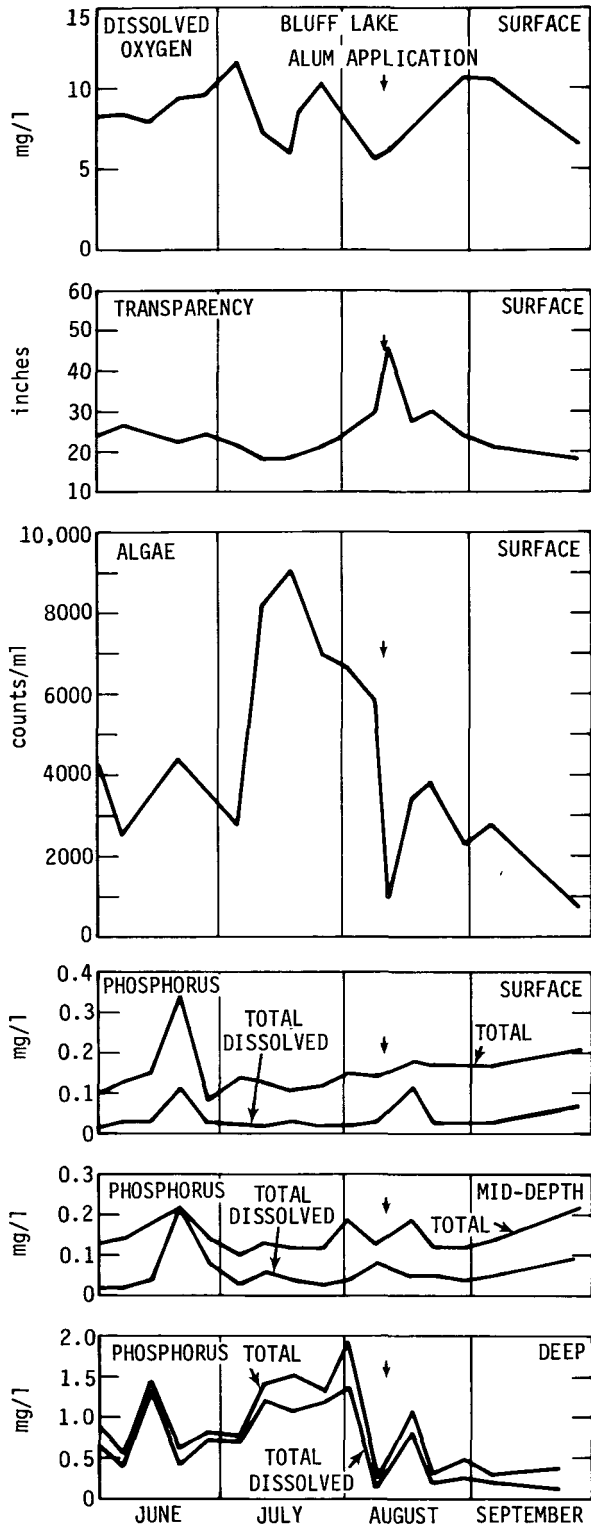
Figure 11. Bluff Lake water quality characteristics

Water quality characteristics of Bluff Lake for Stations 1 and 2 are given in tables 2 through 6. Figure 11 shows the temporal variations in surface dissolved oxygen concentrations, secchi disc transparency, algal counts, and total and dissolved phosphorus. The figure also includes the phosphorus concentrations in mid-depth and deep water samples.

As seen from figure 11 and table 2, these improvements did not last more than a few days. The conditions of lake clarity and algal density reverted to normal levels. This is mainly because of the interchanges in flows between Bluff Lake and adjacent lakes. The problem is compounded by the heavy usage of high speed boats and yachts in the lake system. Even though the algal

counts in the lake indicate a declining trend after the alum application (figure 11), aesthetic conditions in the lake did not improve except during a very short period after the alum application. A comparison of the algal densities in Bluff Lake for the year 1975 (Kothandaraman et al., 1977) indicates that an algal bloom of the magnitude that occurred in mid-September 1975 did not recur in September 1977.

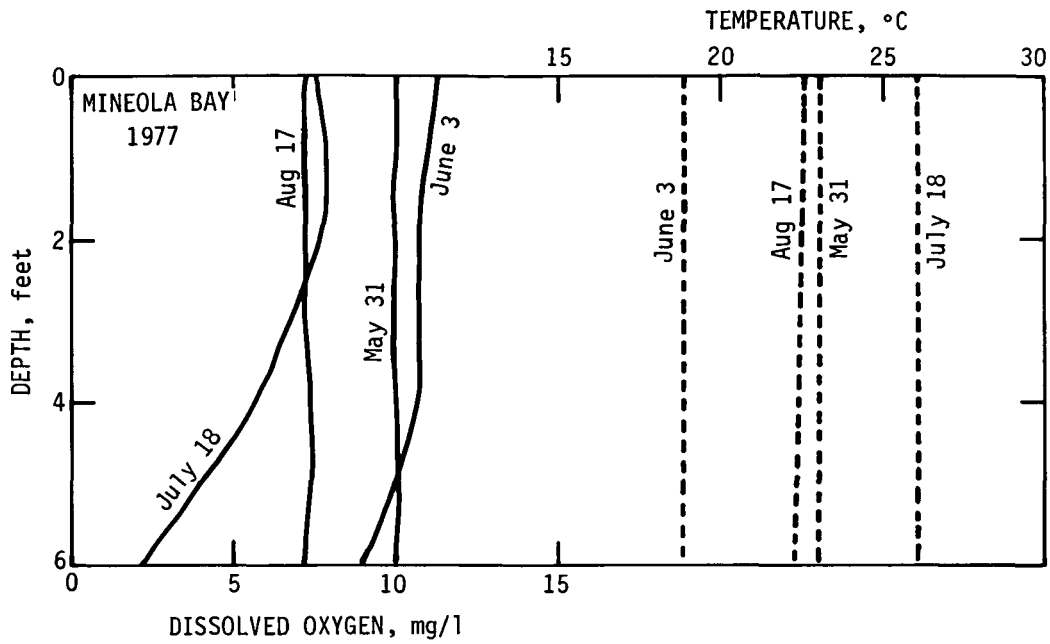
Figure 18. Temperature and DO profiles in Fox Lake

Secchi disc transparency values did not show any differences between the treated and untreated portions of the lake. Temporal variations in surface dissolved oxygen concentrations were similar in magnitude and shape (figures 16 and 17). Temperature and dissolved oxygen profiles shown in figure 18 for these two sampling sites indicate that the lake is isothermal and that during the summer months (June and July) the lake sediments exert a higher oxygen demand than is replenished from the atmosphere.
