# Failure Mechanism in Geobag Structure

*Abstract:* - This paper presents observed failure modes for a geobag structure from a series of physical model tests. Six hundred bags were employed to observe the failure in terms of friction force, water depth, flow rate and bag aging. Three different failures are reported. An analysis of the effect of bag aging shows that 52% of saturated bags gain weight in the range 0 to 5% and about 70% of initially dry bags gain weight in the range 10 to 20%. The outcome indicates the importance of bag aging in the 'incipient failure'. These observations will eventually be used to validate an existing numerical model.

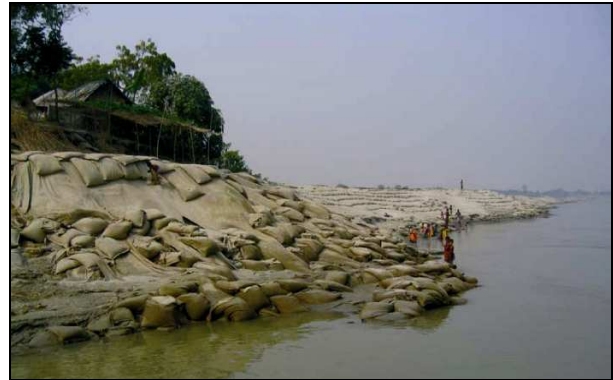
(a) Plug Zone

Fig. 1 (a), (b) and (c): Failure zones in geobag protection in the Jamuna riverbank [6]

the riverbank steep and lumpy in the plug zone (Fig. 1 a). In the slump zone, infill sands become compacted and hard (Fig. 1 b). Slip causes the bag above the water level to become frayed at the exposed surface rather than the underside which shows minor fluffing (Fig. 1 c) [6, 7]. Big eroded areas normally have no bag coverage in the slope against current. Some scatter bags may be found in the bottom of the slope or in a group of bags in anti-current direction [6].

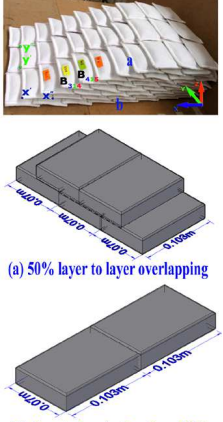
Table 1: Failure mode observes in “dry” test rig

<p>(a) 50% layer to layer overlapping</p> <p>(b) Face to face (or less than 10%) interlayer overlapping</p> <p>Total bags : 153 nos</p>

<p>(ii) Soaked bags</p>	<ul style="list-style-type: none"> <li>• Sliding starts at 6 cm scour depth;</li> <li>• Failure line observed at 7 cm scour depth; and</li> <li>• At 9.82 cm scour depth the bottom series bags of the 4th row stand perpendicular to the mobile bed. Two bags, from the middle and at the far end have dropped.</li> </ul> <ul style="list-style-type: none"> <li>• Failure line observed at 8 cm scour depth; and</li> <li>• The structure height decreases by 2.43% (i.e., 0.5 cm) from dry condition.</li> </ul>

A total of 10 model runs using dry and soaked bags have been undertaken using two different set-ups (Table 1): (i) layer-to-layer overlapping and (ii) inter-layer overlapping. The length ( $y = 33.3$  cm) and width ( $x = 57$  cm) remained the same for all cases; note that the width is the sum of the rigid and mobile portions.

The difference between dry and soaked bags shows the effect of friction coefficient on rigid beds giving about 10% (i.e. 1 cm) of scour difference. Comparisons of horizontal and vertical displacements show soaked bags are more stable (Table 1). The structure height decreases by approximately 2.5% of the dry condition in model; Krahn et al (2004) observed a 5% difference in the height of a sand bag dike due to densification by wetting in large scale experiment [25].

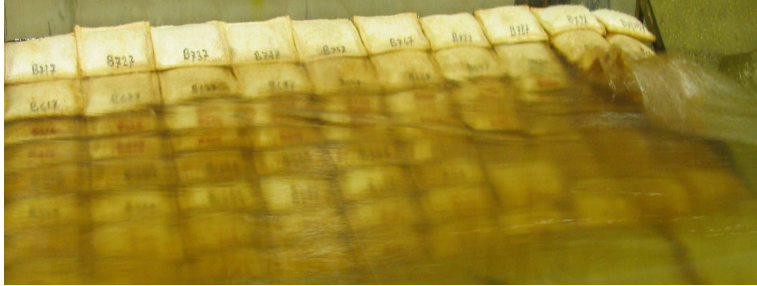
<p><b>Case I: Piping</b></p> <ul style="list-style-type: none"> <li>• Secondary flow gradually creates piping in between 4th and 5th layer; and</li> <li>• Failure starts by uplifting.</li> </ul>

- At low water flow rates, failure occurs due to secondary flow and follows similar mechanisms of piping failure in dam,
- At higher water depths, failure occurs due to local vortices and the failure progresses neighbouring bags as well, and
- Overtopping water level causes the rapid failure.

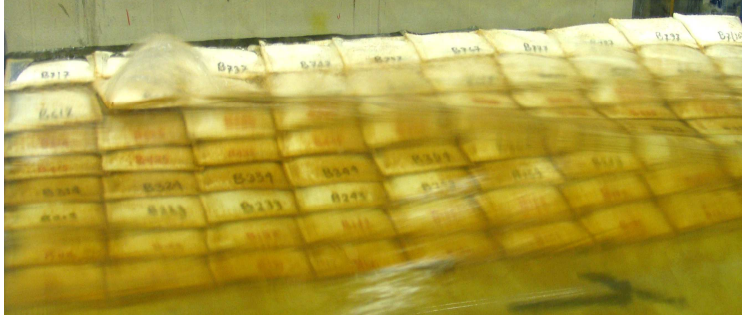
<p><b>Case II: Local Vortices</b></p> <ul style="list-style-type: none"> <li>• Local vortices start just below the water surface; and</li> <li>• Anticlockwise rotation of the bag progresses failure.</li> </ul>

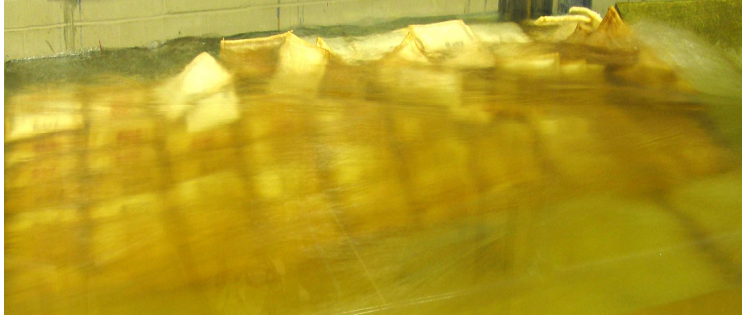
<p><b>Case III: Overtopping</b></p> <ul style="list-style-type: none"> <li>• Overtopping cases quick removal of the three top layer of bags from upstream; and</li> <li>• Two major zone of displacement observed.</li> </ul>

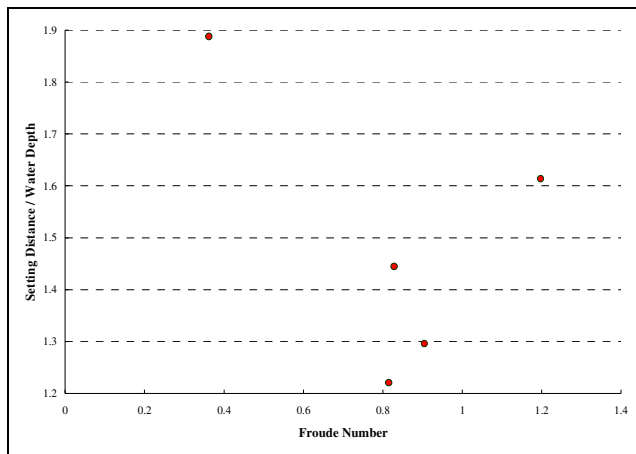
Fig. 3: Relationship between relative settling distances and flow type

Each model run in flume records the time of first failure, the settling distance and weight of the individual bags washed away and settling distance observed in terms of Froude number (Fig.3). Bag aging has justified on the weight gained by washed away bags. Structure built with saturated bags results 52% of the total washed away bags gain weight in the range of 0 to 5%. On the other hand 7 day dry bags results about 70% of the total washed away bags gain weight in the range of 10 to 20%.
